Identification and Analysis of the Riparian Corridor in the Black & Oatka Creek Watersheds

Identification and Analysis
Of the
Riparian Corridor
In the
Black & Oatka Creek Watersheds

March 2005

With funding provided by the Great Lakes
Commission for the Controlling Sediment in the
Black & Oatka Creek Watershed Project

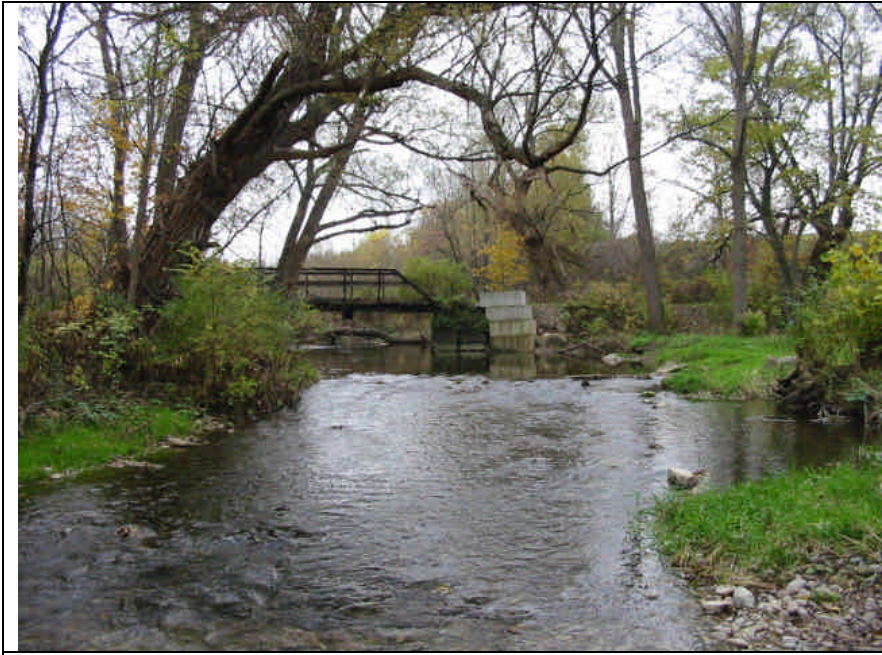
Photo 1. View of Black Creek near Morganville Road, looking upstream (south) from Station N1+32. Bridge in photo center is Station 0+00.

Statement of Problem: A large scour hole has formed at the northwest abutment of the bridge site. This scour hole may eventually undermine the bridge foundation, causing collapse of the structure. High flows also deposit large amounts of sediment in the channel and cause the formation of gravel bars. A thin line of riparian shrubs is located along the west bank of the creek. Although this vegetation provides some protection for the bank, the field is cultivated as close to the creek as possible, contributing soil erosion to the channel. Some evidence of channel degradation is seen in the formation of mid-channel bars downstream from the bridge site. Downed trees deflect currents into the banks, causing additional undercutting north of the bridge.

1. Construct a rock J-vane to deflect flow toward the middle of the channel, away from the northwest bridge abutment.
2. Encourage farmers and property owners to maintain at least a 50 ft. wide buffer of woody riparian vegetation along the channel.
3. Utilize deadfalls in the stream as root wads to stabilize failing banks.

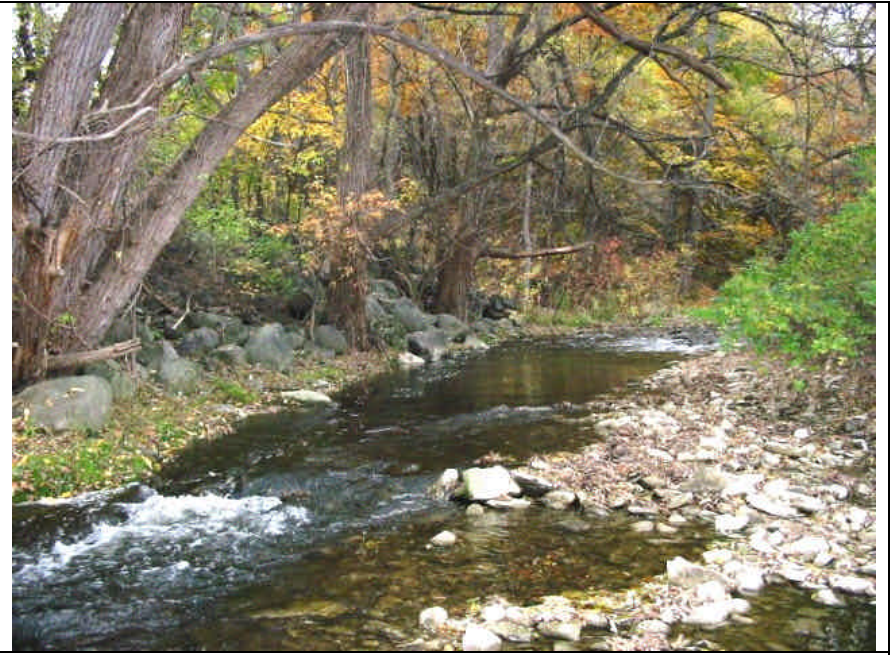
Photo 2. View of Black Creek near Morganville Road, looking upstream from Station S1+90, approximately 190 feet south of the private road bridge over Black Creek.

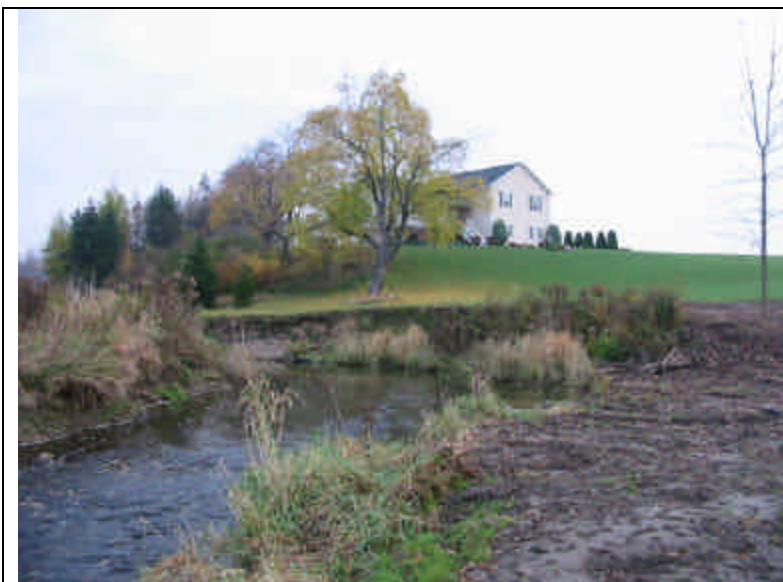
Photo 1. View of project site showing exposed soil on high, undercut bank at outside edge of meander, near Station 4+00, looking northeasterly. Bare soil at photo right is due to mechanical vegetation clearing.

Statement of Problem: The stream channel appears to be downcutting actively at this site. Bank sloughing evident in Photo 3, exposed tree roots, and scoured, undercut outside meander banks all point to a channel in transition. Increased frequency of bankfull flows may contribute to the accelerated rate of channel degradation. Removal of woody vegetation from the top of bank on the east side of the channel has resulted in an accelerated rate of undercutting and bank erosion due to the loss of stabilizing plant roots. Channel currents are undercutting the east bank, causing significant soil erosion and increased channel deposition. Undercutting on the east side of the creek is creating a significant erosion hazard, and loss of property by adjacent landowner.

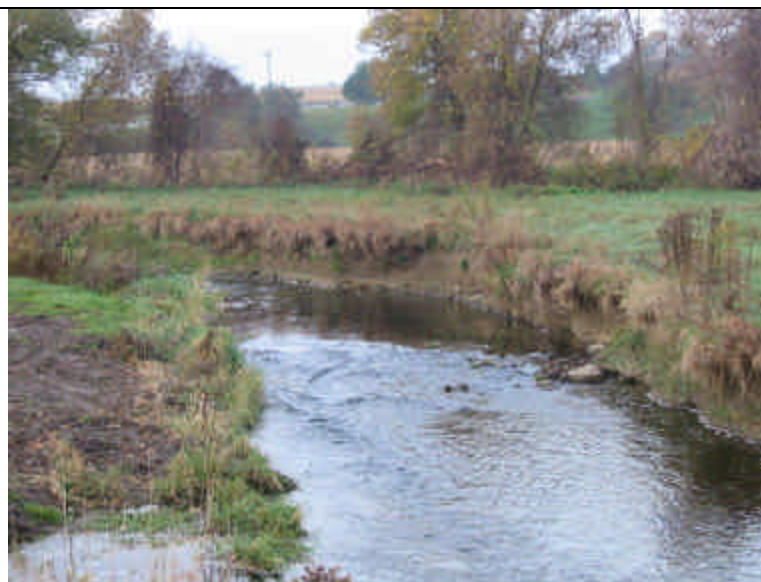
Photo 2. View of exposed soil along west bank of creek at Station 2+10, looking south. Bank height is approximately 2-2.5 feet above water level.

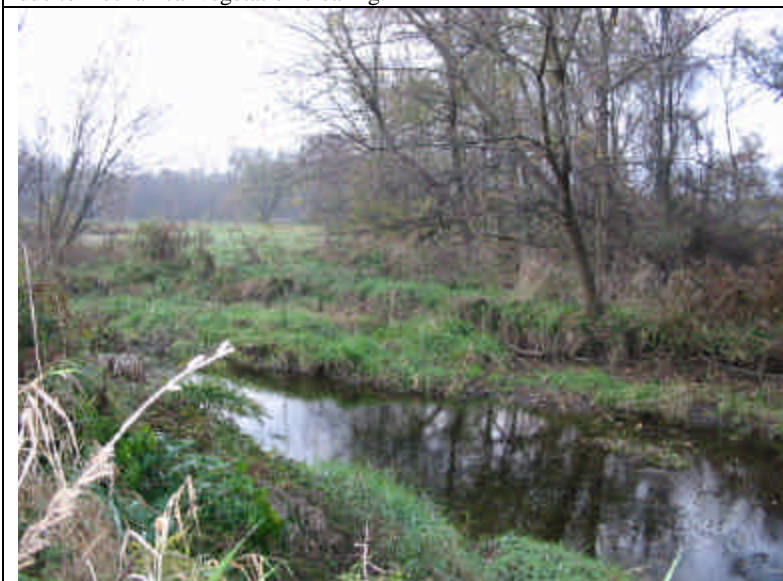
Photo 3. Frequent bankfull flows have caused sloughing of west bank into formerly stable section of stream channel, causing formation of mid-channel bars. Diversion of current around the mid-channel bars contributes to bank undercutting and instability.

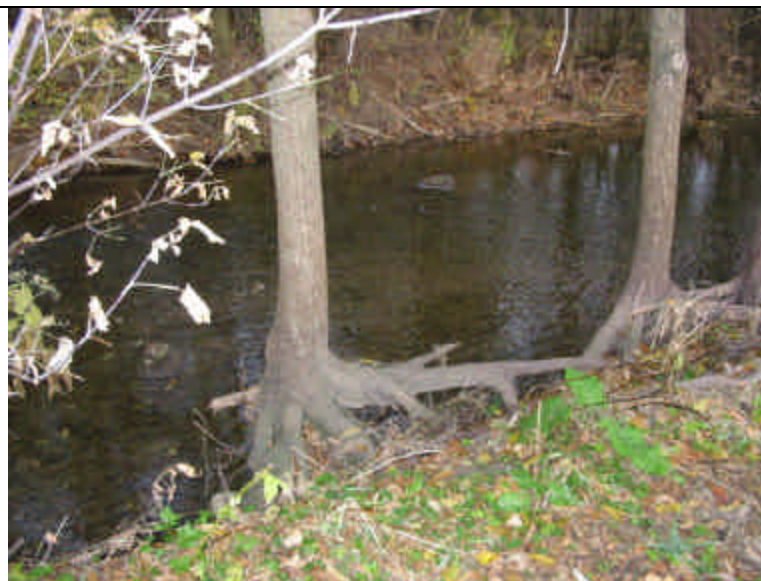
Photo 4. Scouring and undercutting have exposed root systems of numerous trees lining the stream channel.

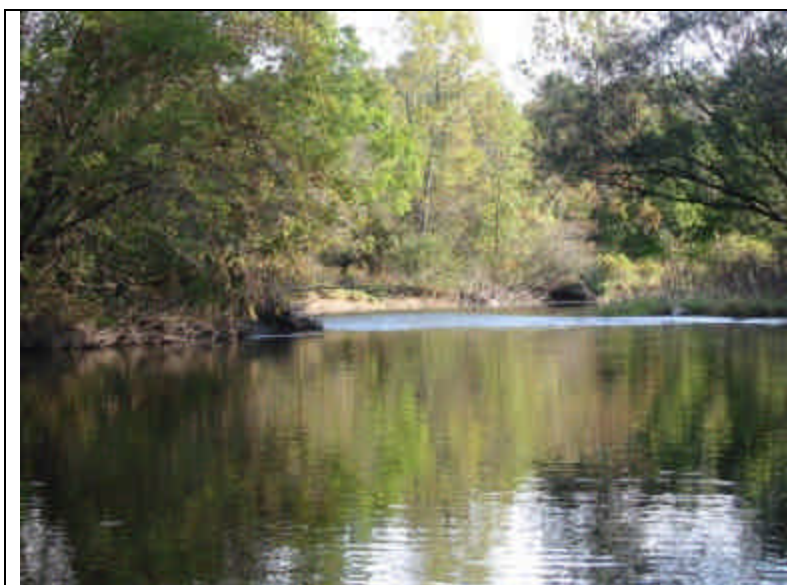
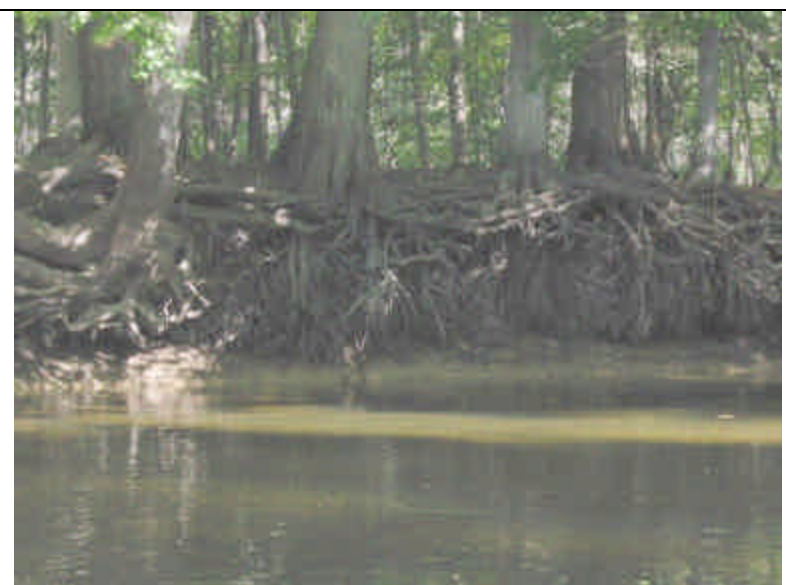
<p>Exposed high banks on outside edge of meander, near Chili Avenue.</p>	<p>Undercut root systems of sugar maples, south bank of Black Creek, Union Station Park, Chili</p>

Statement of Problem: The project study area is located in a rapidly developing watershed area. A developed watershed area creates more frequent bankfull flow events, eventually leading to deteriorated stream conditions. Where woody riparian vegetation is removed or exists in thin strips along each bank, more frequent high flows undercut banks and create sloughing. Undercutting is more severe when the bank soils consist of fine sands and silts. In this reach, the mapped soil types are predominantly Genesee silt loam and Eel silt loam, both of which are fine sandy to silty alluvial soils. Several large trees were observed on scoured banks, with exposed root systems. Continued undercutting during bankfull flow events will eventually undermine these trees, and cause them to fall into the stream channel. Downed timber in the creek channel creates problems by directing stream flow against easily eroded bank areas. Southern banks near Stottle Road are high (6-8 feet) and show some erosion as the creek makes a broad sweep south and east. Some erosion and exposed tree roots occur here. Several expanses of high, undercut banks were observed on both the north and south creek banks. Undercut banks adjacent to Chili Avenue and Stottle Road may eventually threaten road and utility infrastructures if not corrected.

5. Embed large stone rip rap in the scoured areas adjacent to vulnerable roadways and repair the embankment using vegetated geogrids, root wads, and willow stakes.

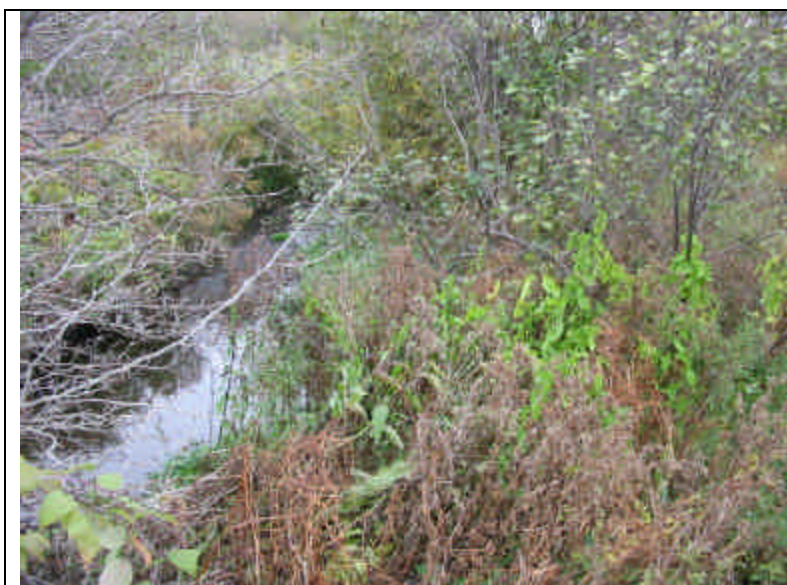
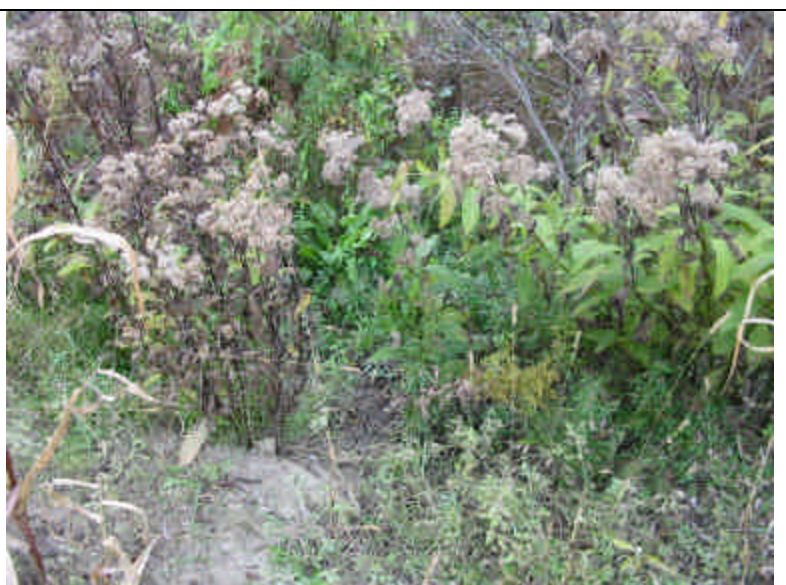
<p>Warner Creek channel at Site W4. Site has about 20 feet of riparian vegetation on the east side of the channel. West side of the channel is well-vegetated.</p>	<p>Erosion from cornfield concentrates at corner of field in a rill, discharging into Warner Creek, one of the headwaters for Oatka Creek.</p>

1. Increase the width of the vegetated riparian zone from about 20 feet to about 50 feet from the stream channel top of bank. Create a grass filter strip at the edge of the field to retard the formation of rill erosion channels and to provide nutrient uptake and filtration of sediments suspended in sheet flow. The use of switchgrass (*Panicum virgatum*) or other thick, sod-forming grass is recommended. Use of this technique would remove about 0.036 acre from cultivation in this field.
2. Use brush wads or other woody vegetation to repair rills. Fill in rills where possible. Stabilize rills with willow or dogwood switches.

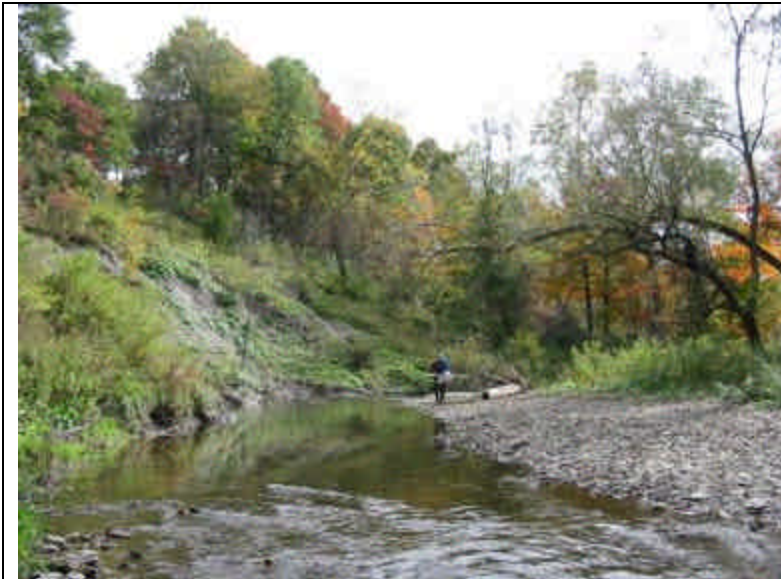
View of Oatka Creek at Martinsville Station N1+00 (approximately 400 feet south of Martinsville Road), looking south. Note high eroding bank at photo left.

Statement of Problem: Site observation showed that influent streams contribute a high sediment load, resulting in the formation of mid-channel gravel bars, and divided thalwegs in the channel. Large trees have been undercut by high flows, and have fallen into the channel. Resulting log jams direct stream flow into steep, erodible, clay banks on the east side of the channel. Undercutting has caused slumping from Station N1+00 to approximately S0+60.

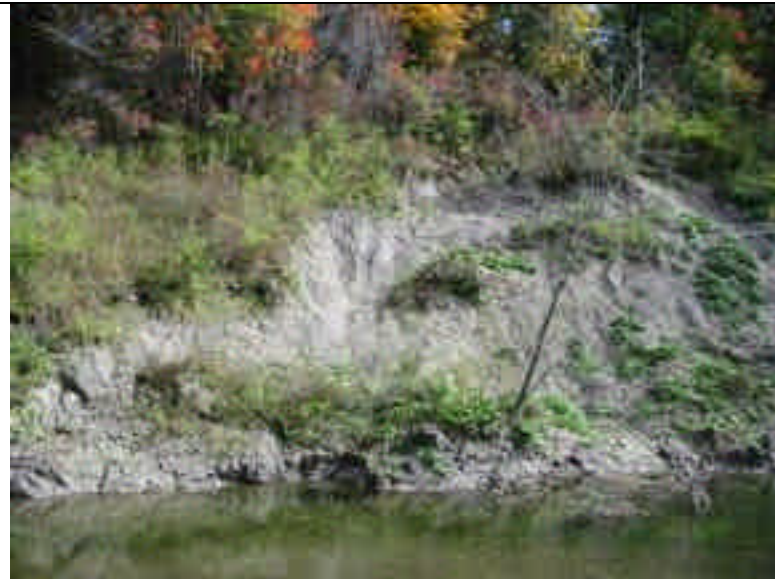
Detail of eroding bank in photo at left. Deep pool in stream channel undercuts clay bank, causing rotational slumping. Re-direction of channel flow away from this bank is needed to allow stabilization.

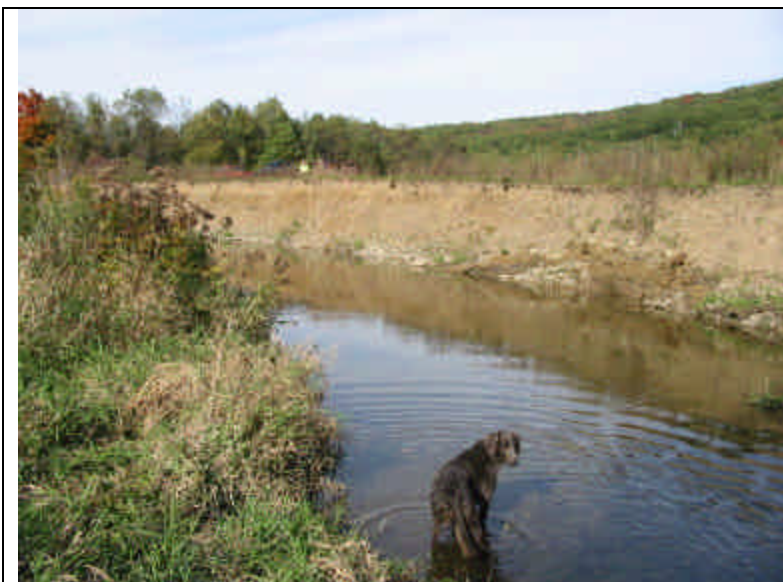
View of Oatka Creek exposed soil bank near Station 2+38, looking north.

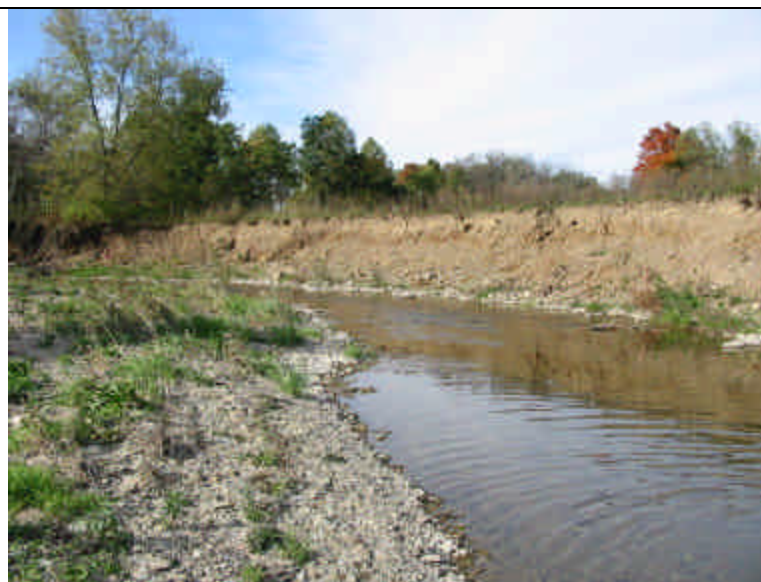
View exposed soil bank at Station 4+38, looking northeast.

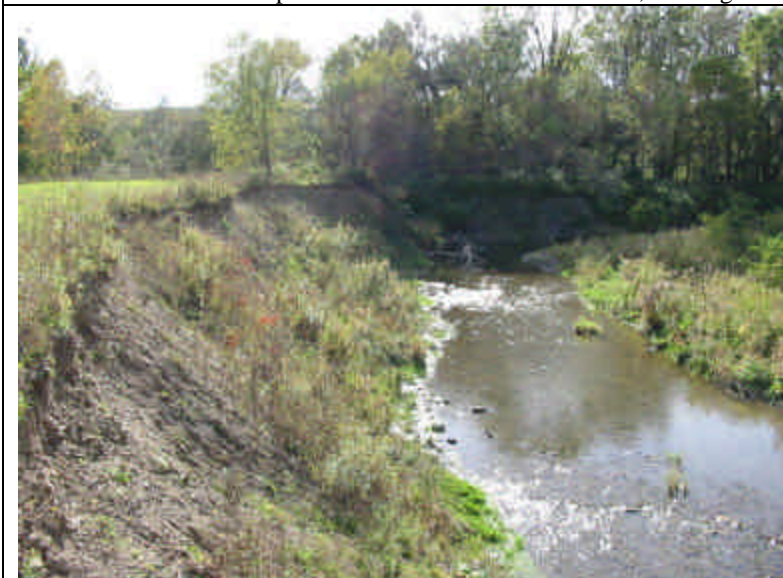
View of Oatka Creek exposed soil bank near Station A0+600, looking northwest along channel.

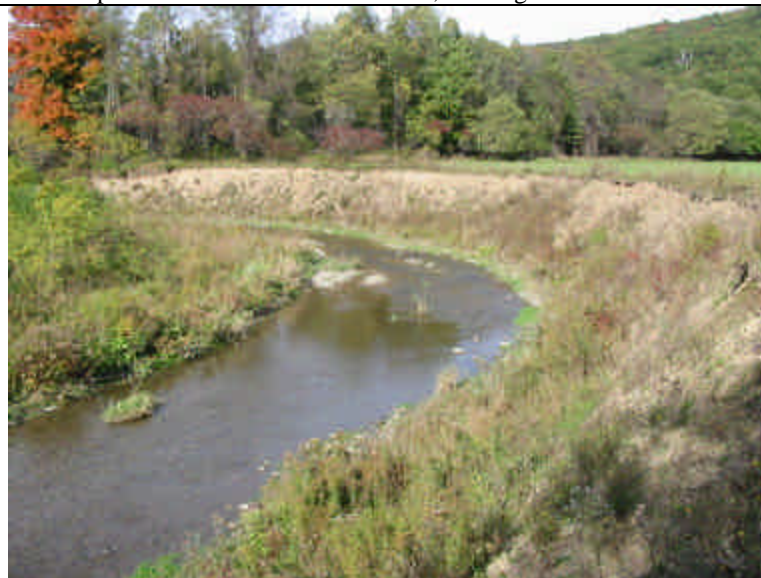
View of exposed soil bank at Station A0+800, looking northeast.

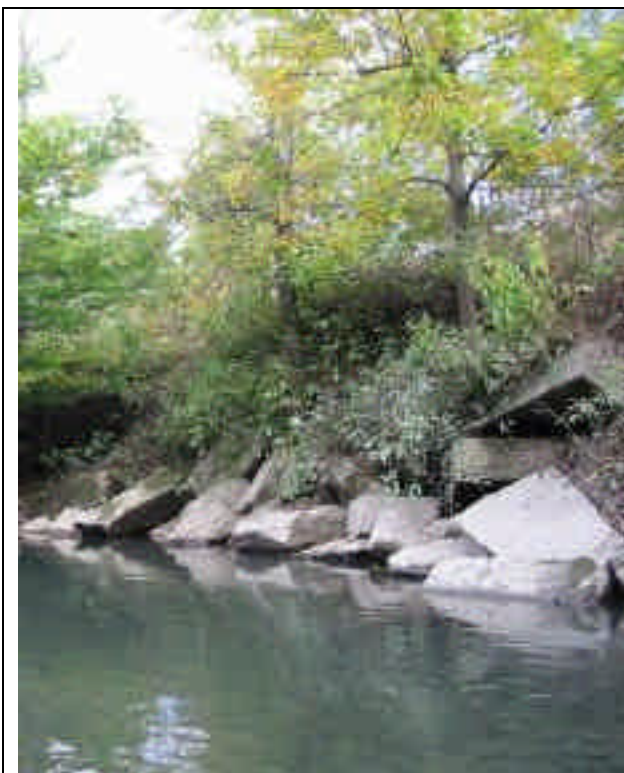
Photo 1. Detailed view of Rochester & Southern Railroad embankment adjacent to Oatka Creek south of Pavilion. Note placement of large concrete blocks, stones and rip rap to protect toe of slope.

Statement of Problem: This site was selected because the outside edge of the creek is located at the toe of the Rochester and Southern Railroad embankment. The railroad embankment has been damaged during previous flood events. Although large stone riprap has been placed at the toe of the slope to protect the embankment ballast, portions of the embankment are vulnerable to undercutting from the current. Erosion from this site was estimated at 0.395 tons of soil per year.

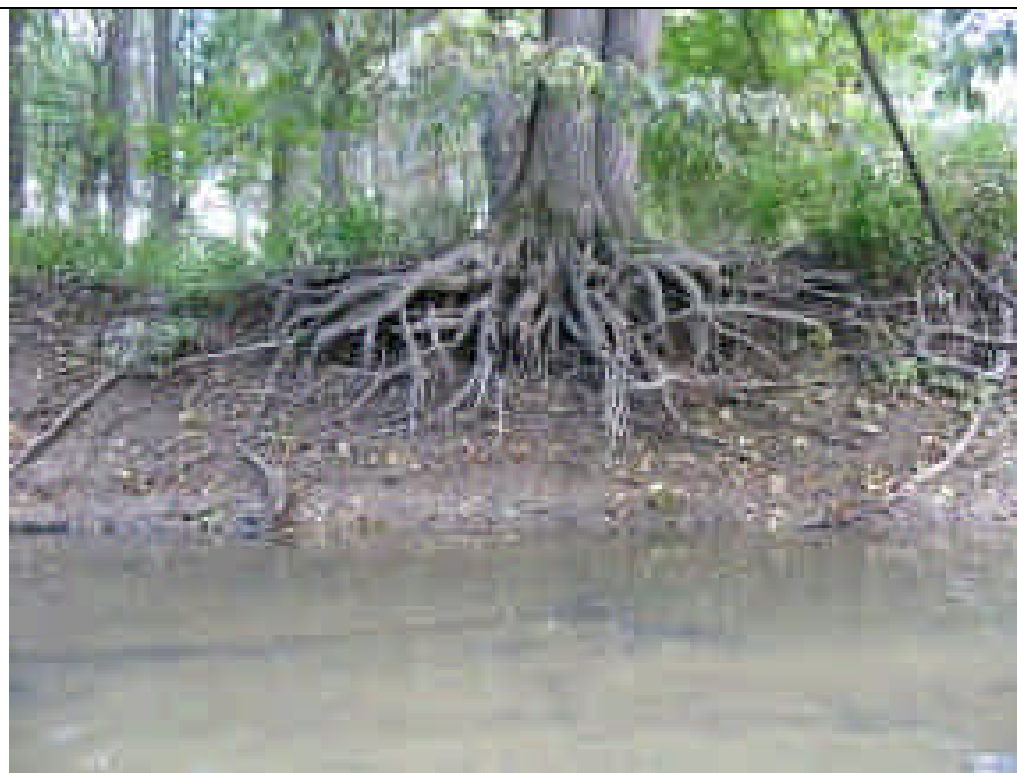
Photo 2. Detailed view of exposed roots on large silver maple tree on east bank of Oatka Creek at Pavilion. This condition is typical of many large trees along the bank. Located on the outside curve of a meander, the roots are undercut when the channel flows at bankfull. Frequent bankfull flow conditions exacerbate undercutting and cause trees to fall into the channel.

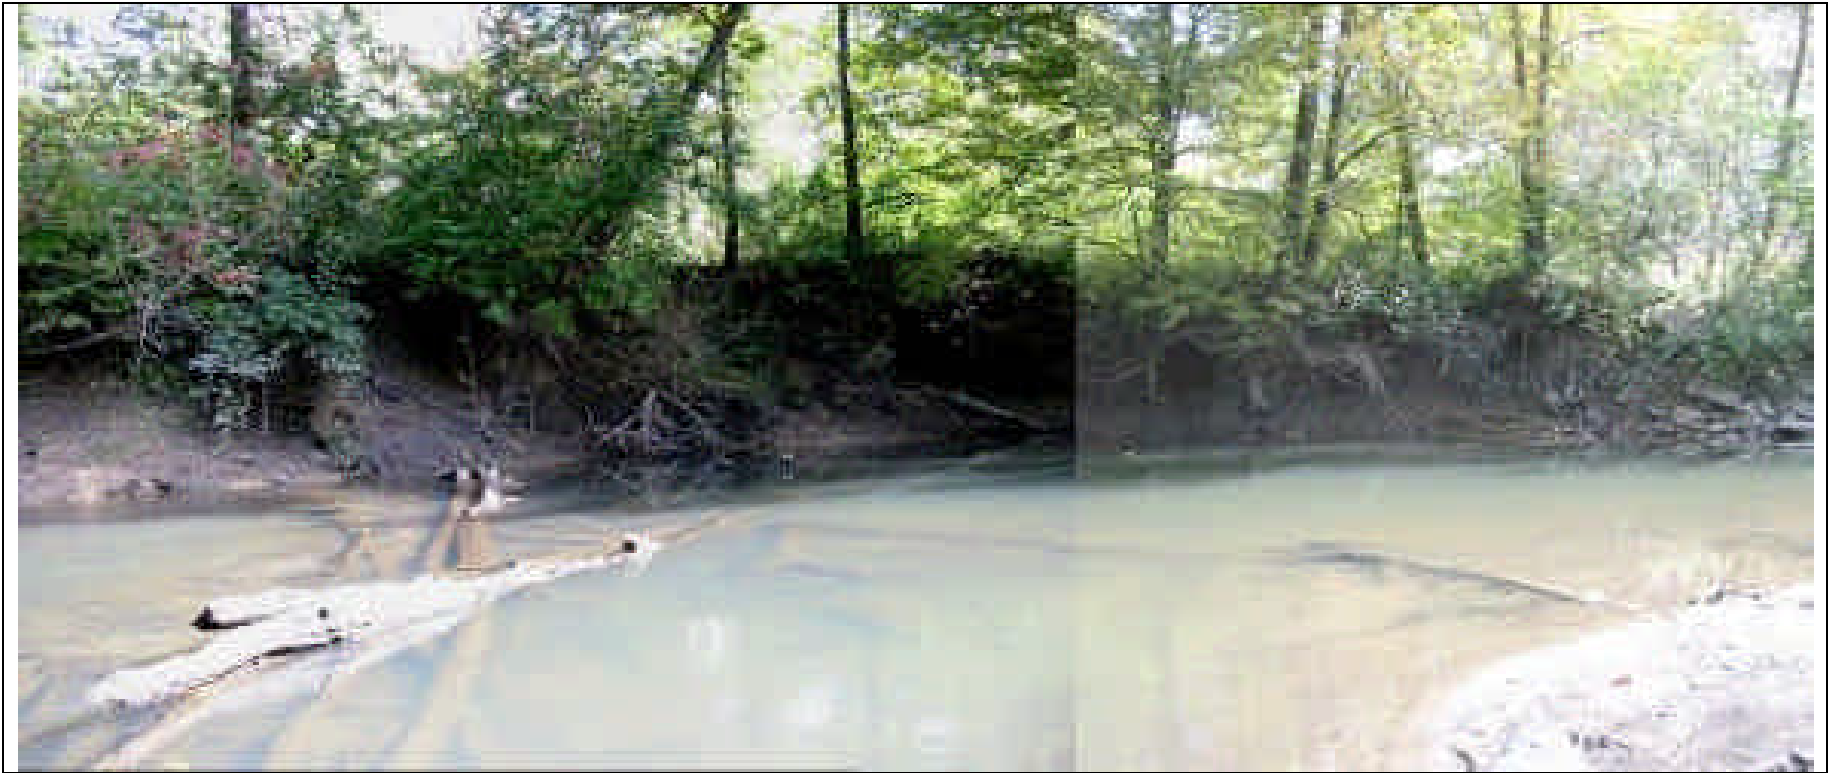
Photo 3. Panoramic view of exposed bank along outside edge of meander adjacent to Rochester & Southern Railroad tracks. Note the accumulation of large woody debris, high exposed soil banks.

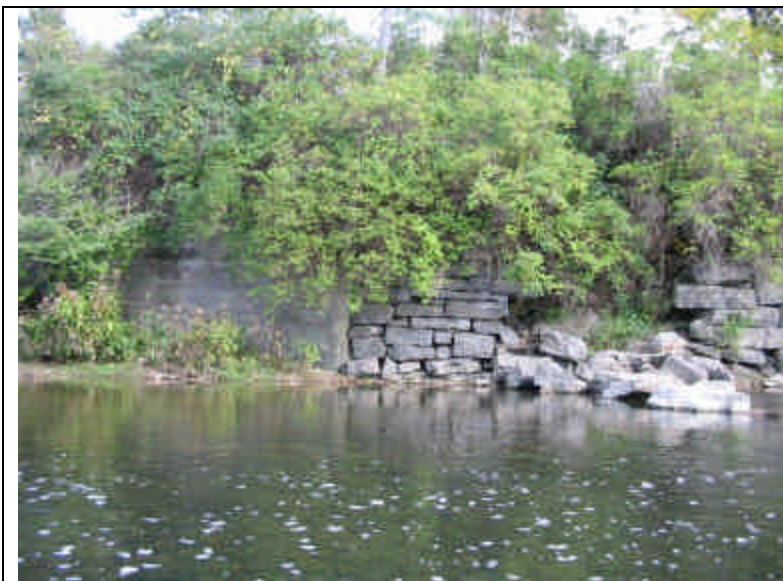
Failing retaining wall at southwest quadrant of Rochester & Southern Railroad bridge over Oatka Creek

2. Inspection of the southwest quadrant of the bridge showed that a stone retaining wall has partially collapsed into the creek. Further evaluation is needed to determine an appropriate repair strategy before the entire embankment fails.

- Install a rock J-vane upstream of the northwest abutment to direct current away from the structure into the main channel of the Oatka.
- Install a rock J-vane upstream of the southwest abutment to direct current away from the failing retaining wall.
- Contact the railroad to advise them of the failing retaining wall.

Costs for construction of a J-vane to redirect water away from the failing retaining wall were not estimated due to complicated access issues. Further review by the railroad is needed to address this issue.

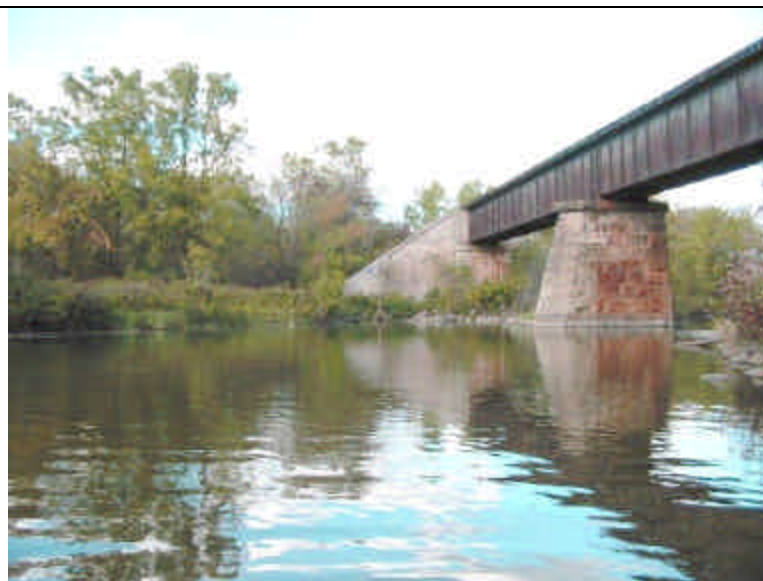
View of northwest quadrant of bridge. Current hits abutment at near right angle, creating scour hole at northwest quadrant.

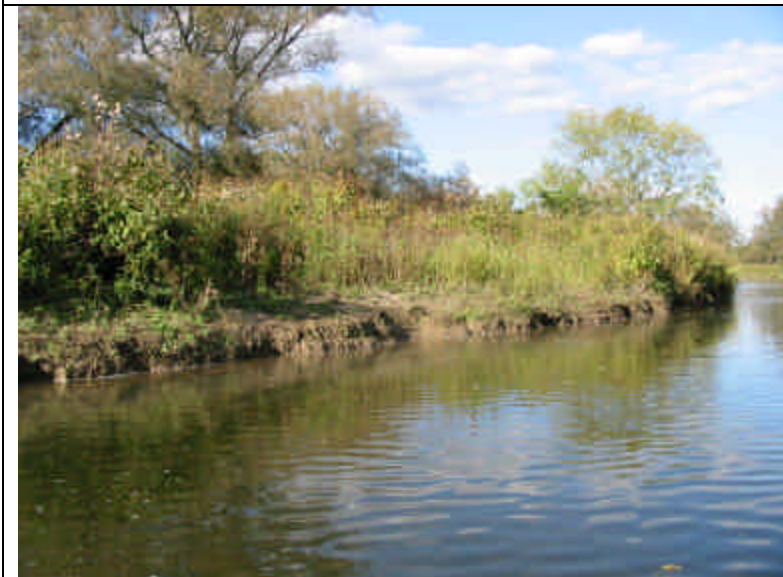
West/north bank of Oatka Creek near railroad bridge (typical). Note exposed soil in scour areas.

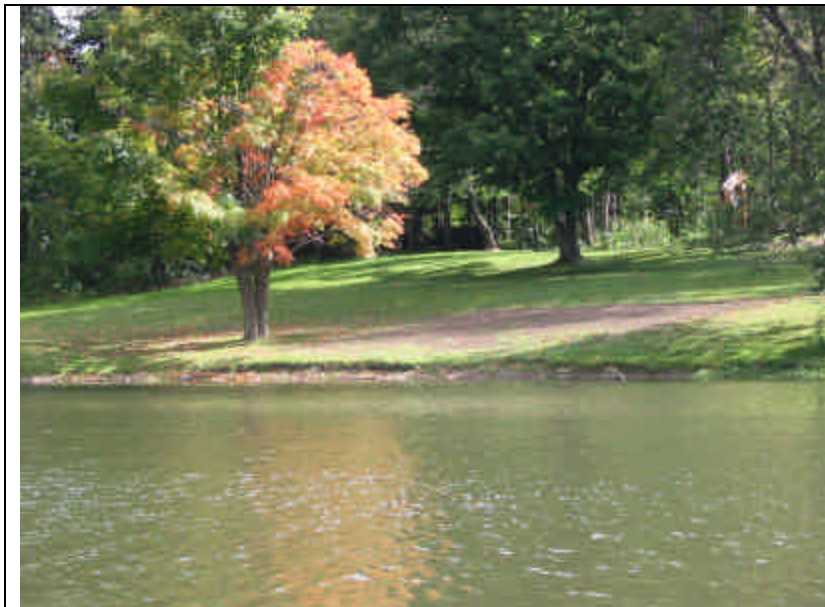
Photo 1. Eroded bank conditions typical of south side of Oatka Creek, immediately east of Rt. 19 bridge

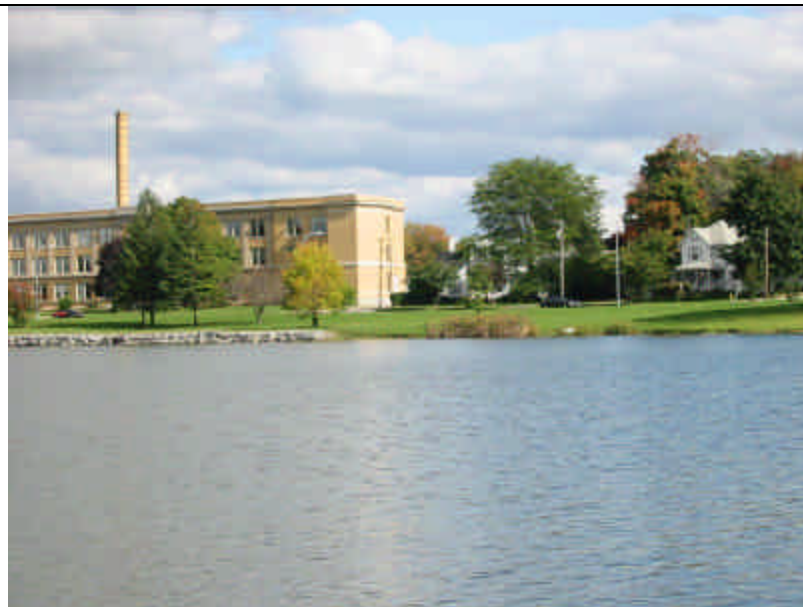
Photo 2. View of south bank of Oatka Creek, with Wolcott Street in the background. Note partial stone riprap along bank at photo left, and growth of riparian vegetation (bur-reed) at photo center.

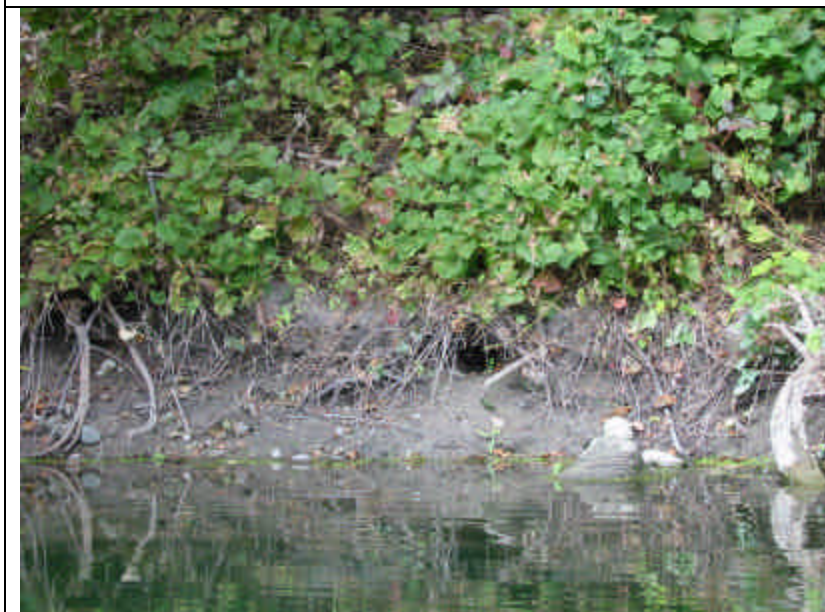
Photo 3. Bank conditions typical of north bank approximately 1500 feet east of Munson Street bridge. Note muskrat hole in bank just above water level.

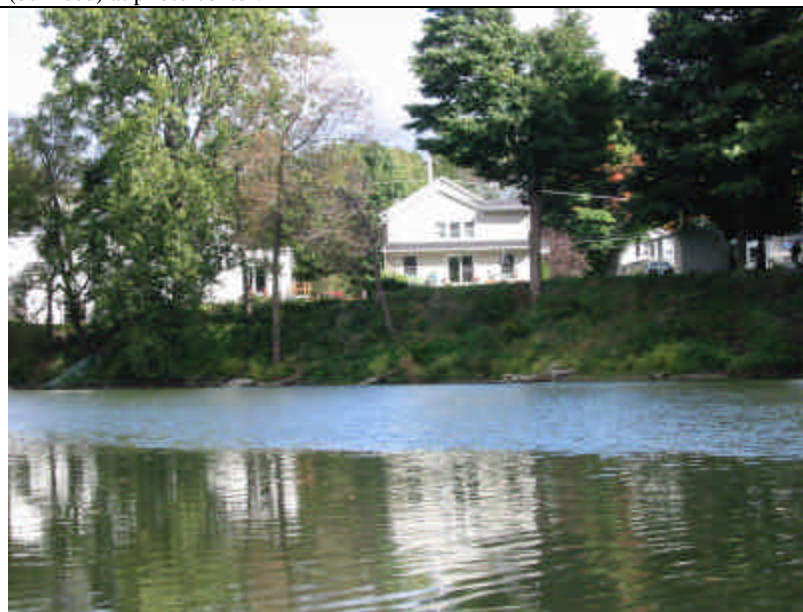
Photo 4. Typical bank conditions along south bank west of Rt. 19 bridge.

Some bank erosion is also evident along the south bank of the creek west of the Route 19 bridge. Erosion in this area is also caused by fluctuating water levels, and a lack of woody vegetation to hold the bank in place.
