# City of Rhode

City Council Meeting January 14, 2021  
Facilities Assessment/Conditions Report

# Facilities Assessment/Conditions Report

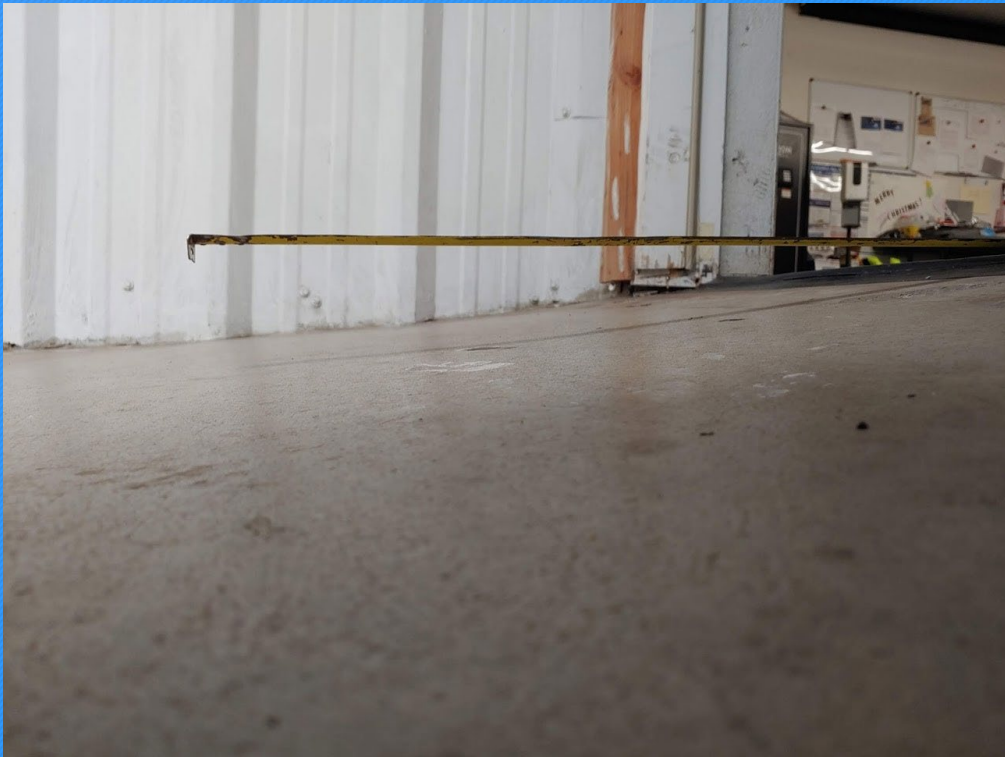
Floor transition between bldgs. - slope does not meet ADA requirements

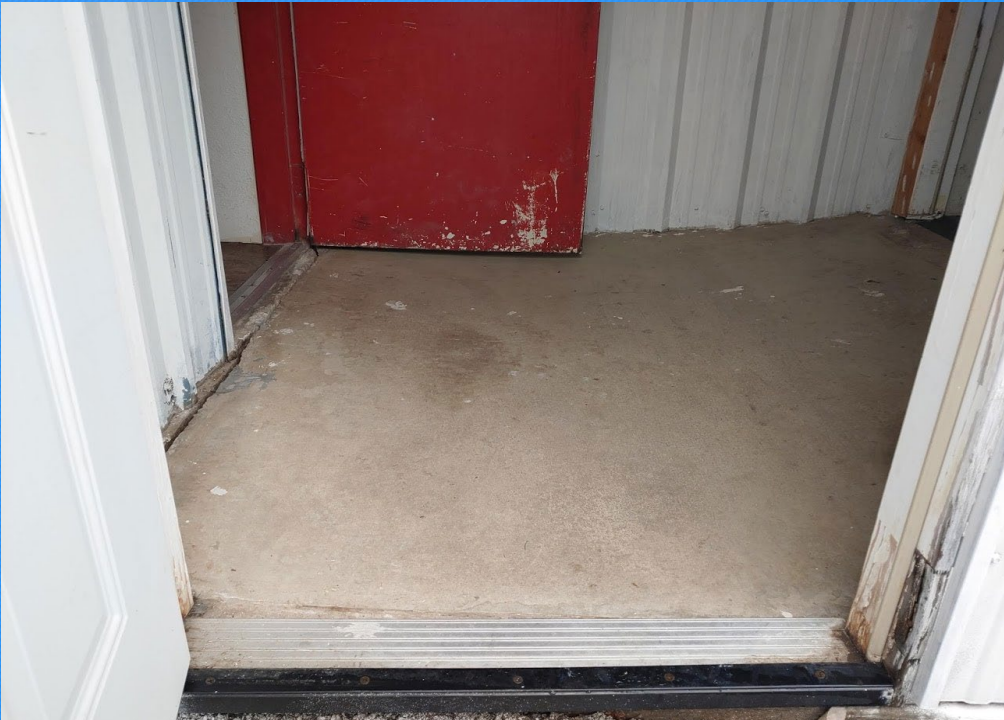
Exterior doorway will need to be removed and sealed off

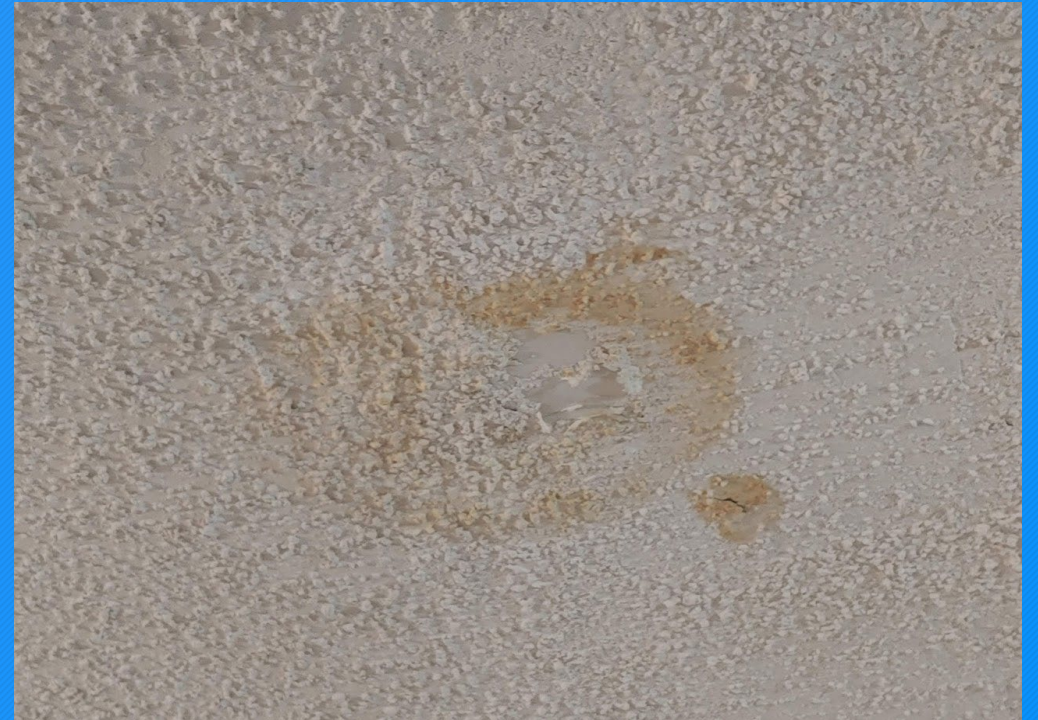
Multiple roof leaks

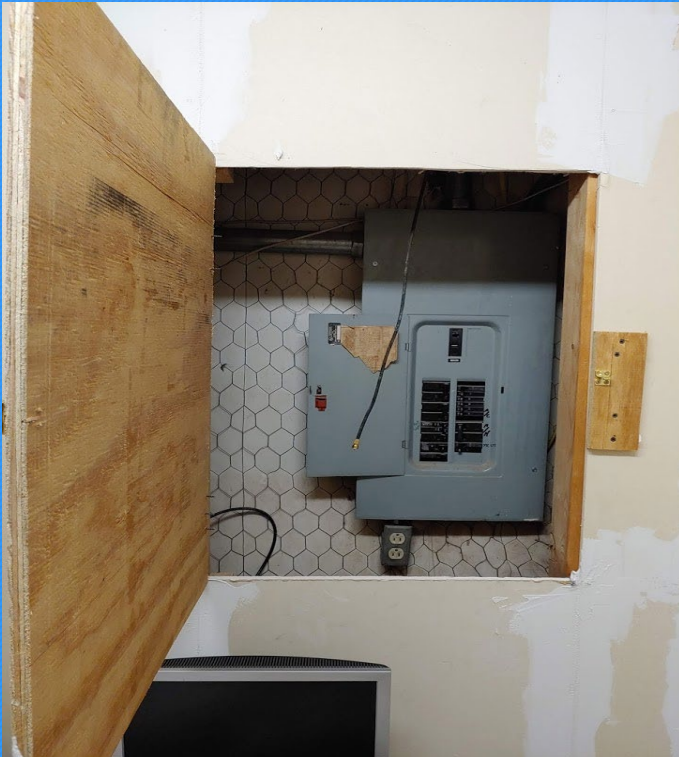
Electrical panel and wiring needs to be replaced and updated

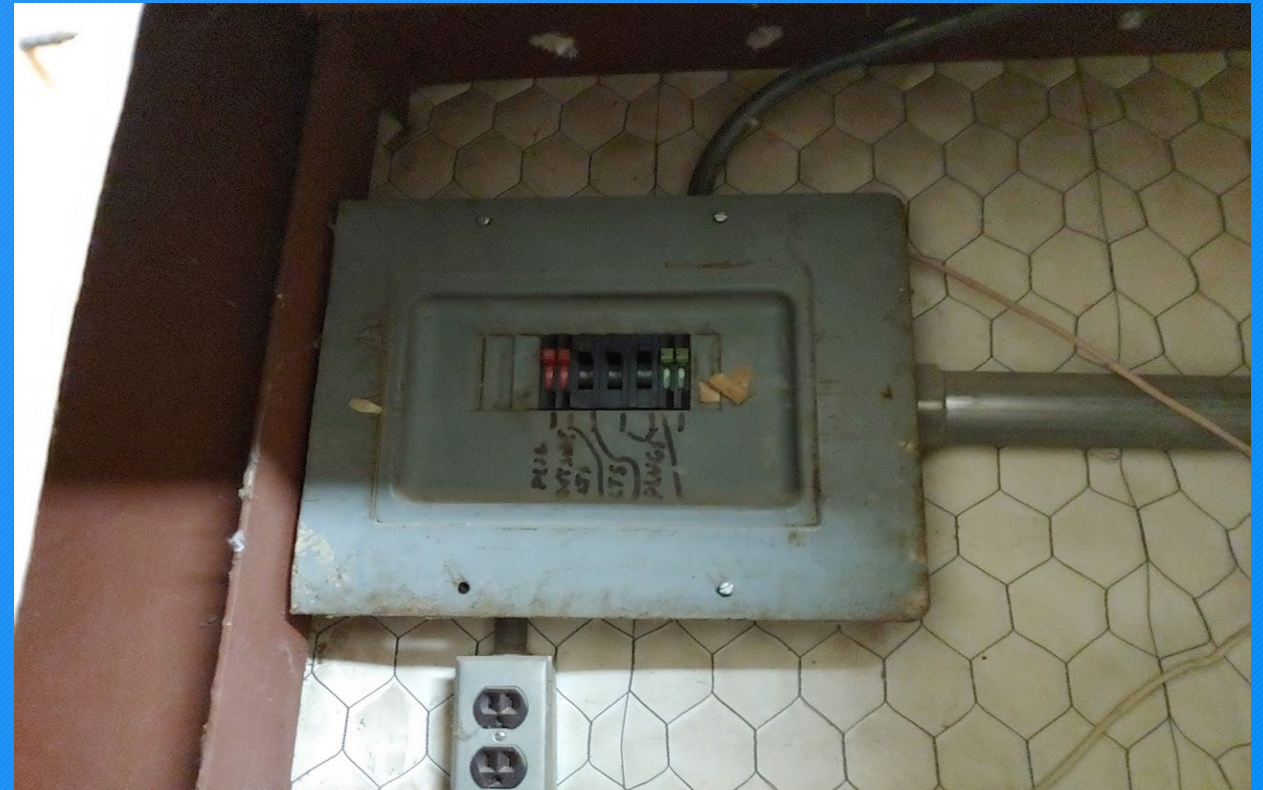
Update and replace breaker box

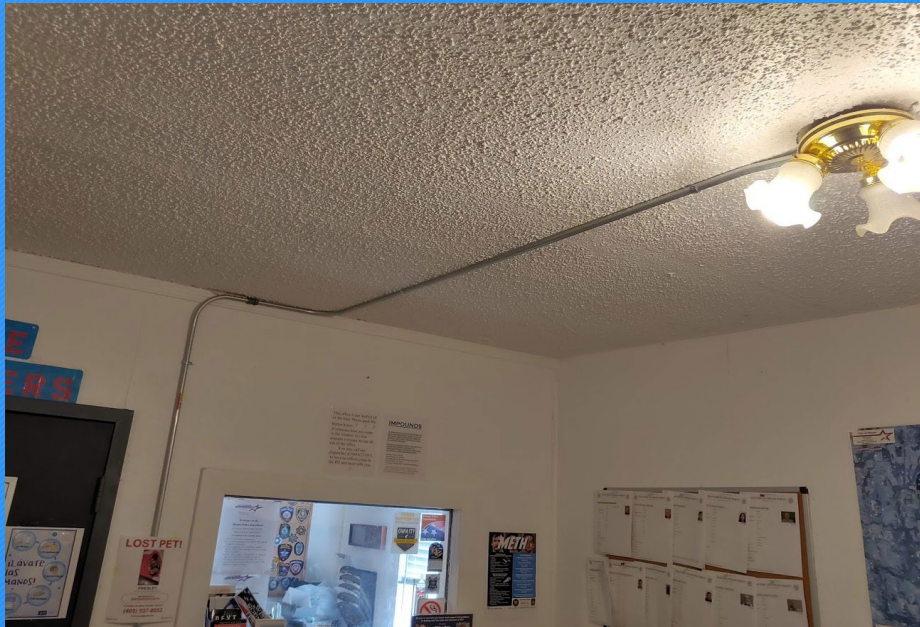
All wiring needs to be upgraded and compliant with codes

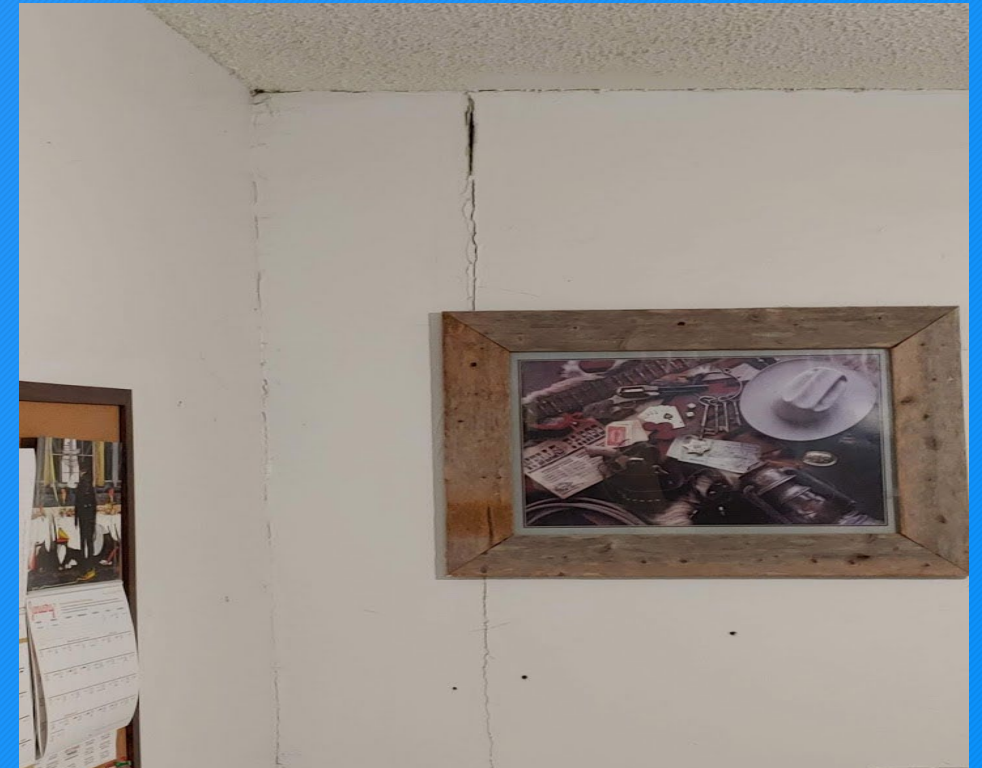
Floor drops 2 inches on E & W side of bldg. - foundation repair will be needed

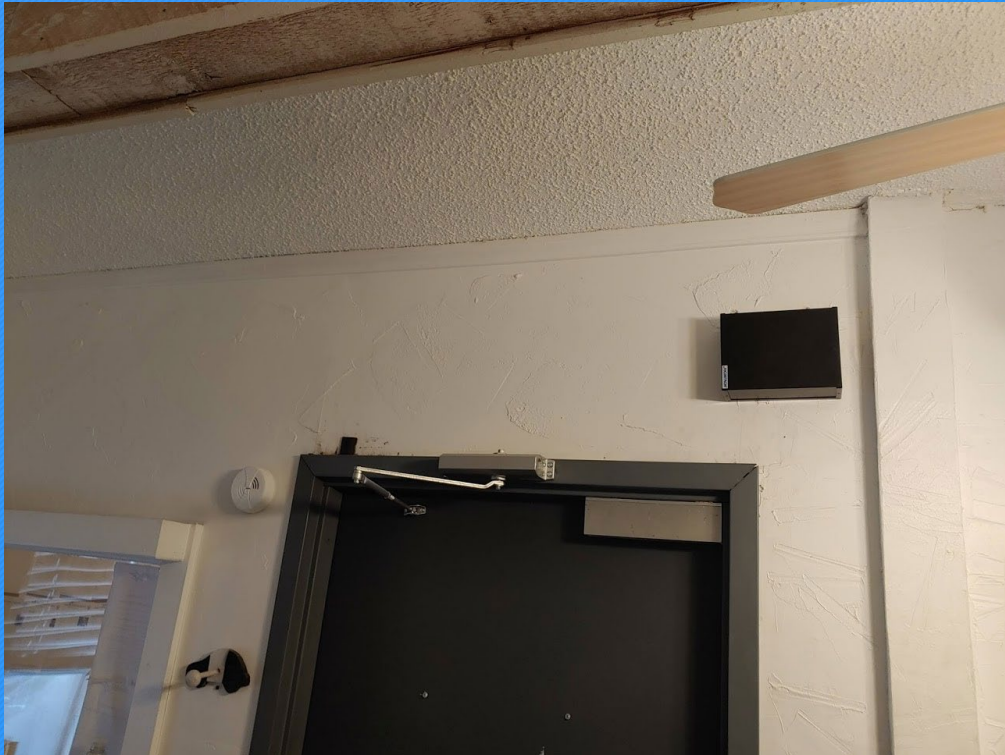
Needs hard-wired exit sign

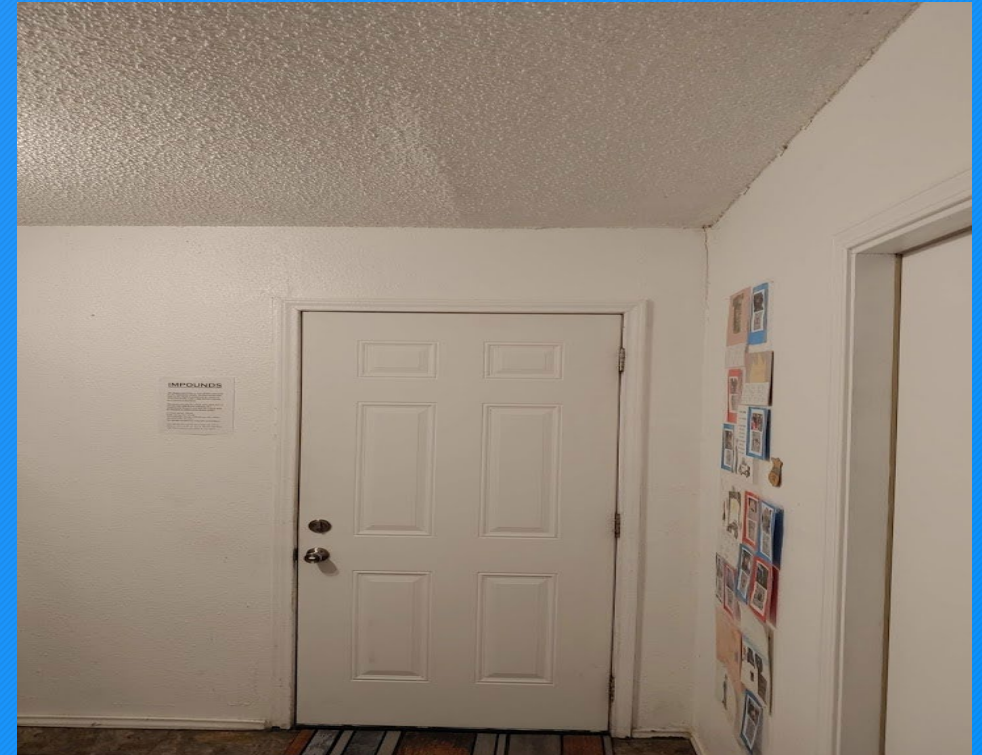
Needs exit sign

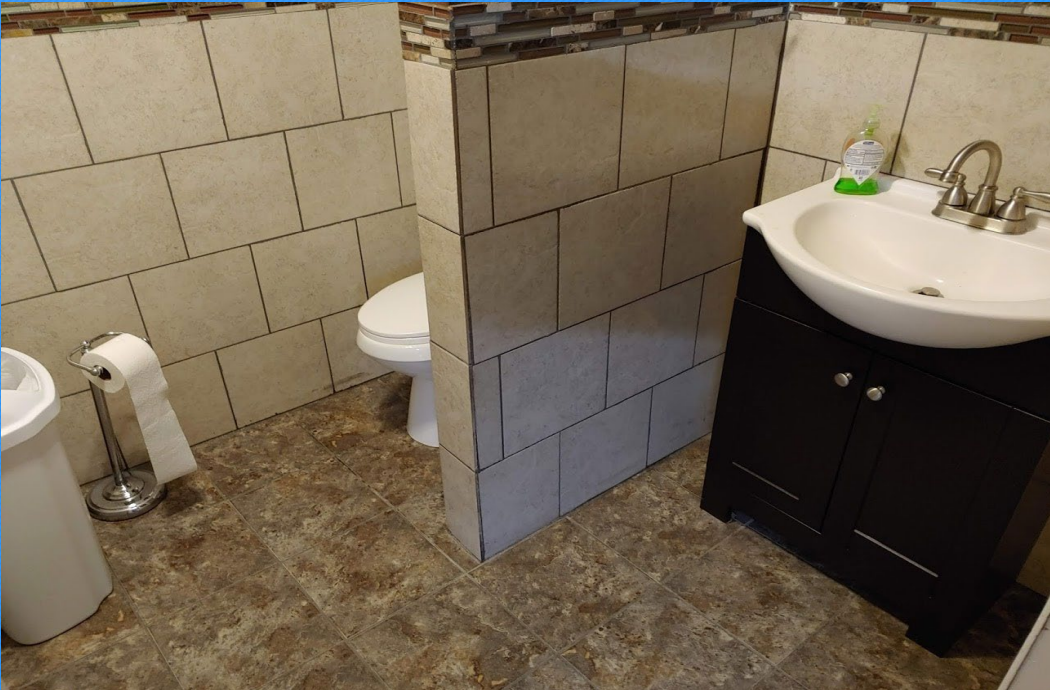
Bathroom does not meet ADA requirements

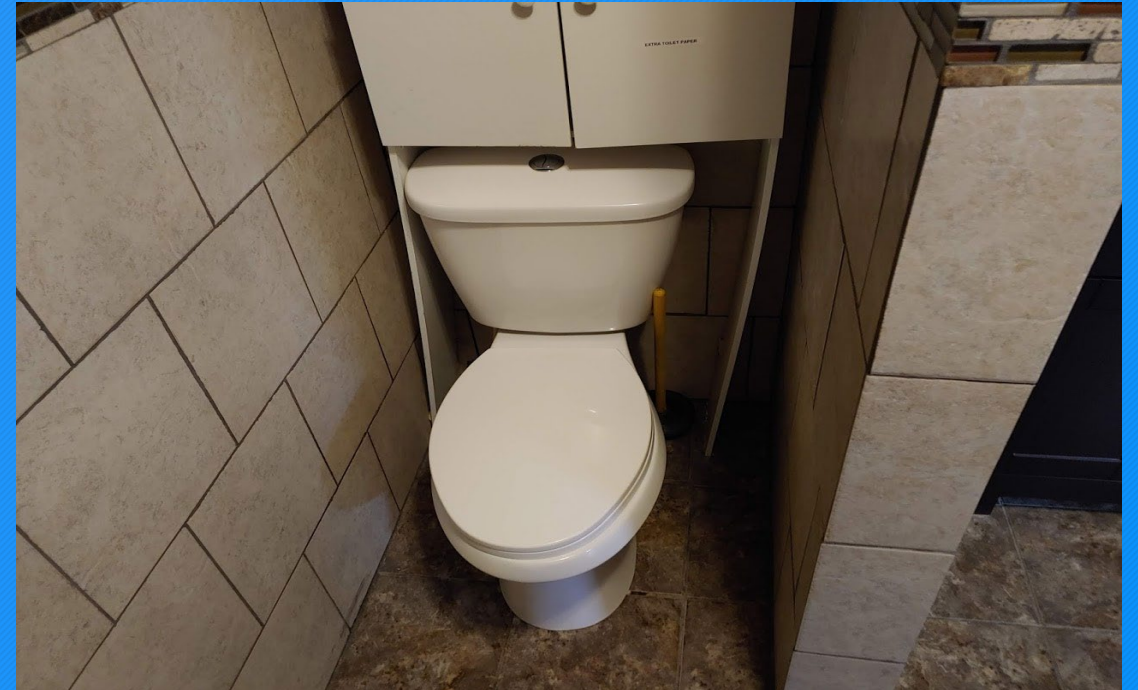
No hand rail - too narrow

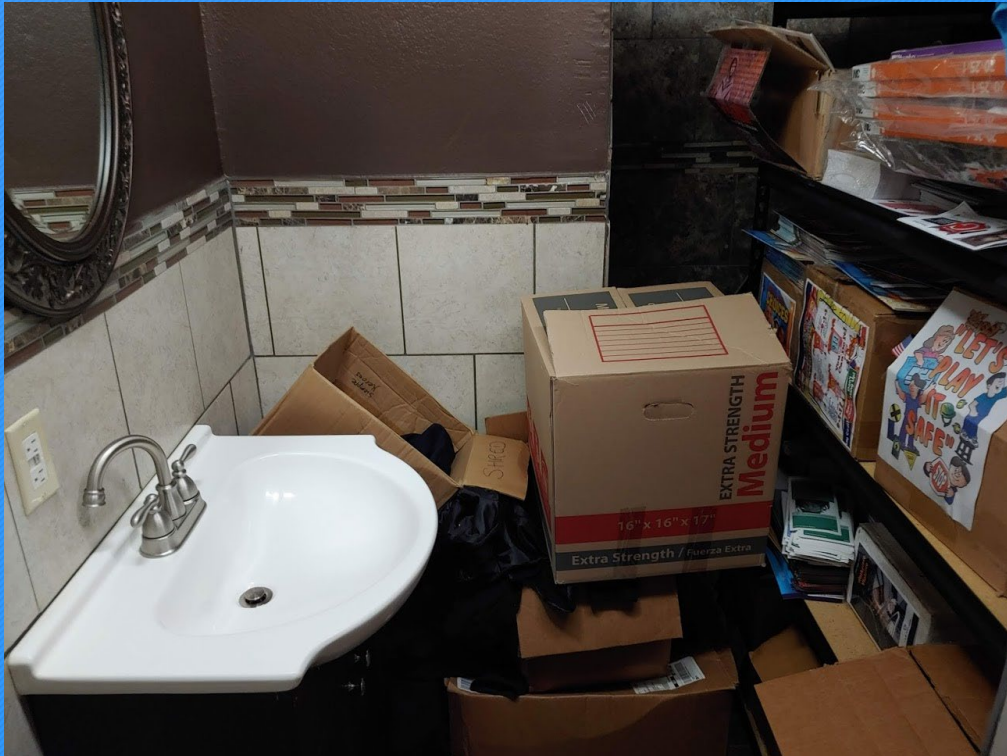
Shower area not ADA compliant - currently used as storage due to lack of storage space

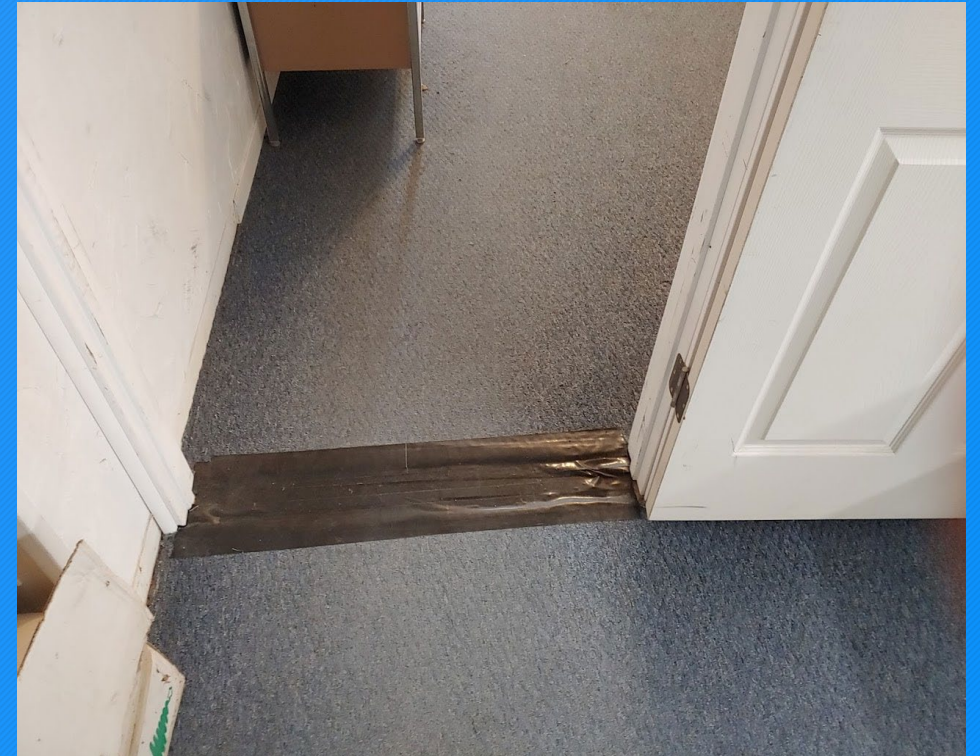
Flooring needs to be replaced - carpet is worn and coming apart

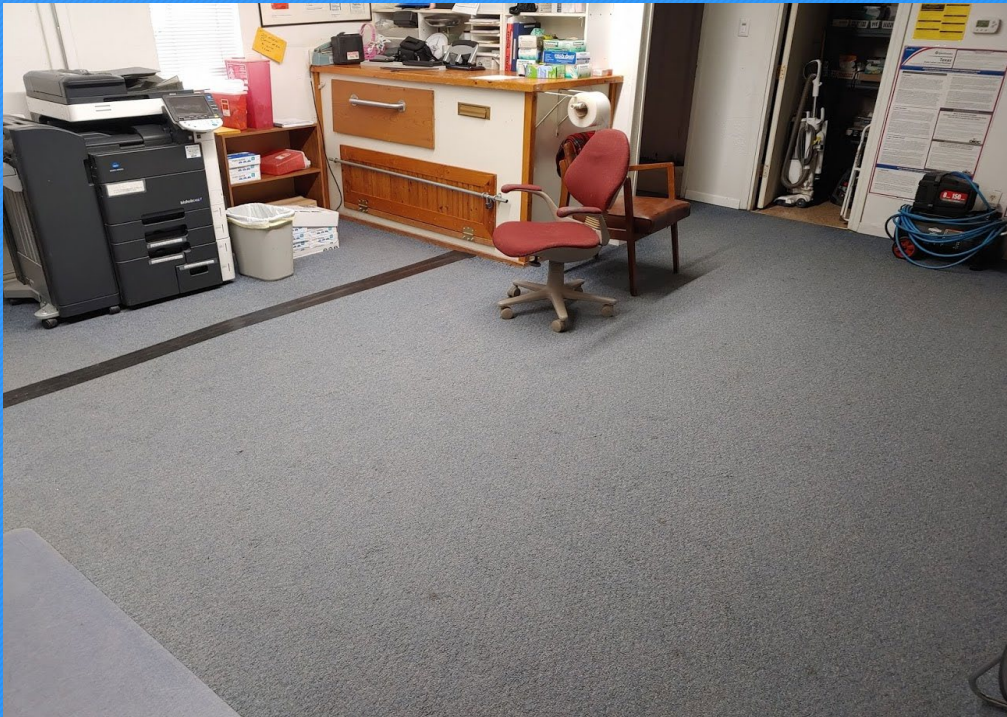
Carpet worn - taped together

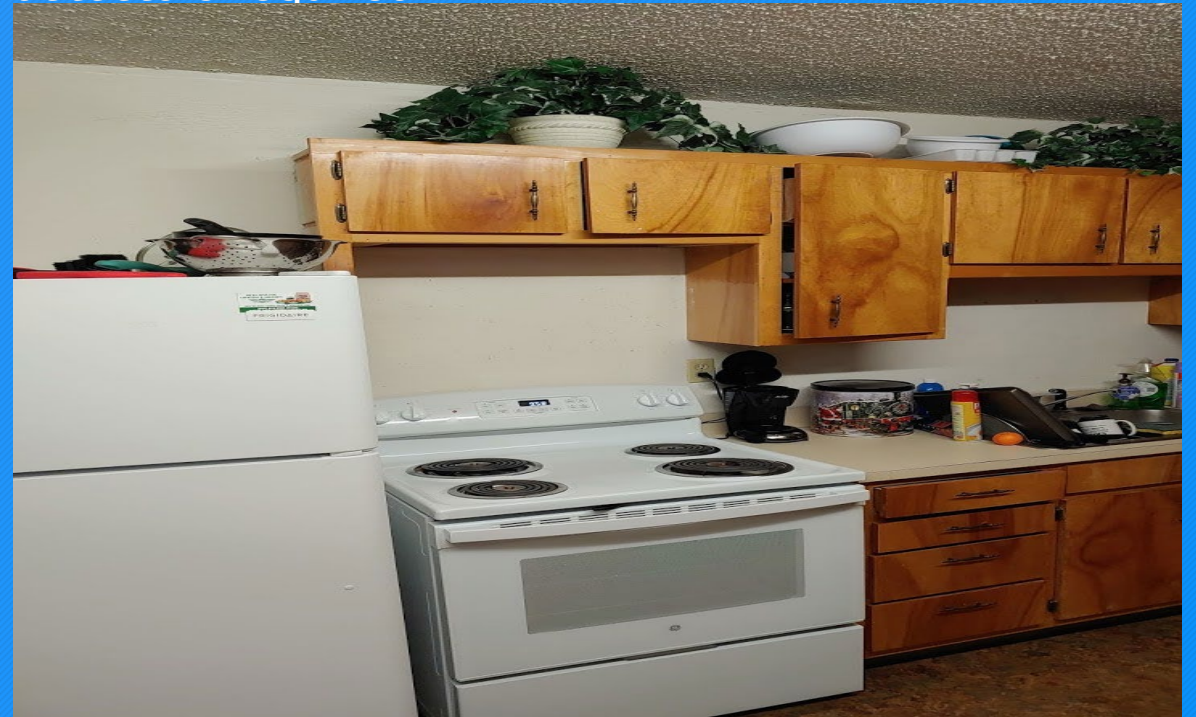
Commercial vent hood and hard-wired smoke detectors required

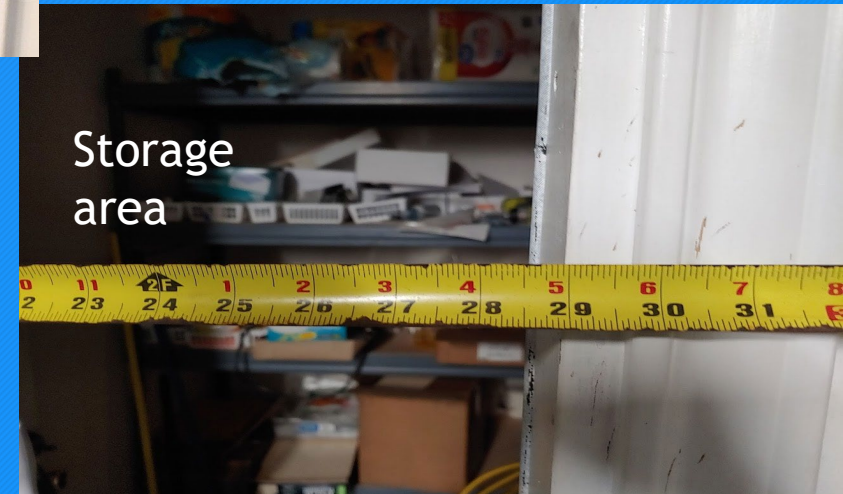
Storage  
area

Interior doorways  
do not meet ADA  
min.  
requirement of 32"

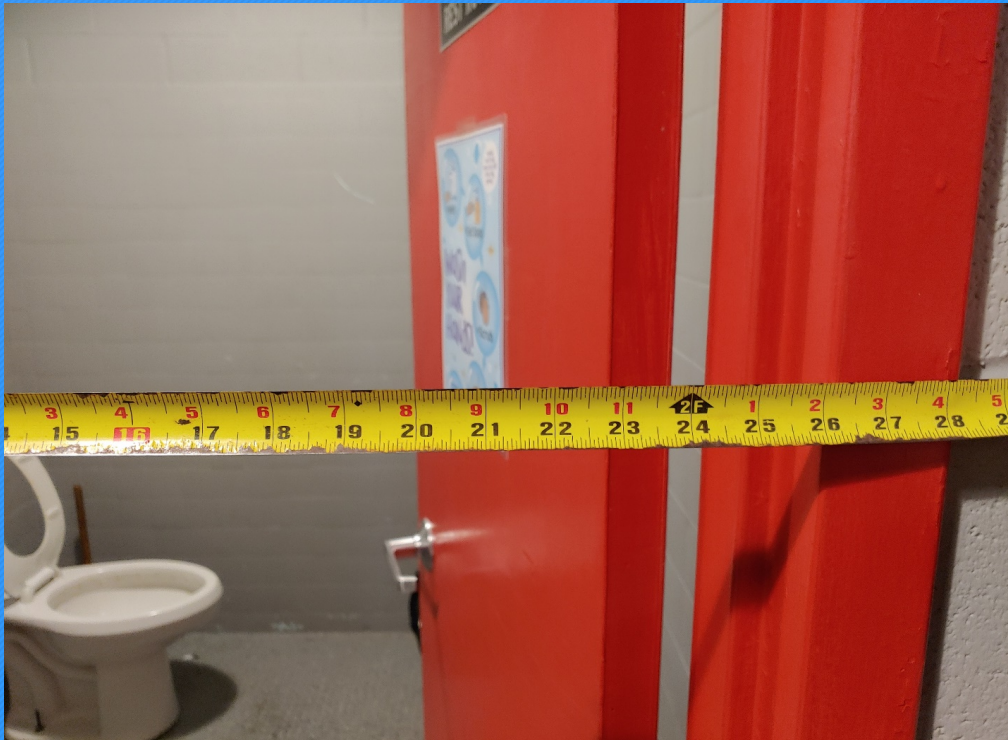
Bathroom next to bunk room - door doesn't meet min ADA requirements of 32". Metal door frame and walls are haydite/cinder block

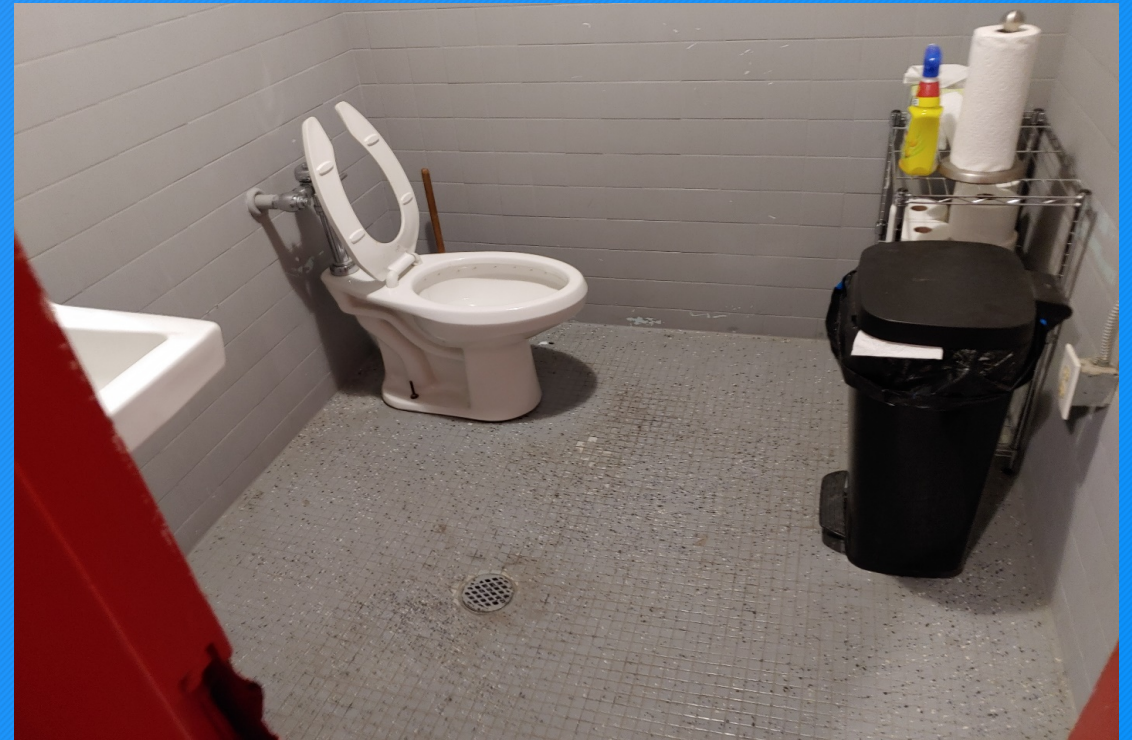
ADA requires 60" radius & handrails. Block will need to be pushed out to meet min radius req. and distance between toilet and sink

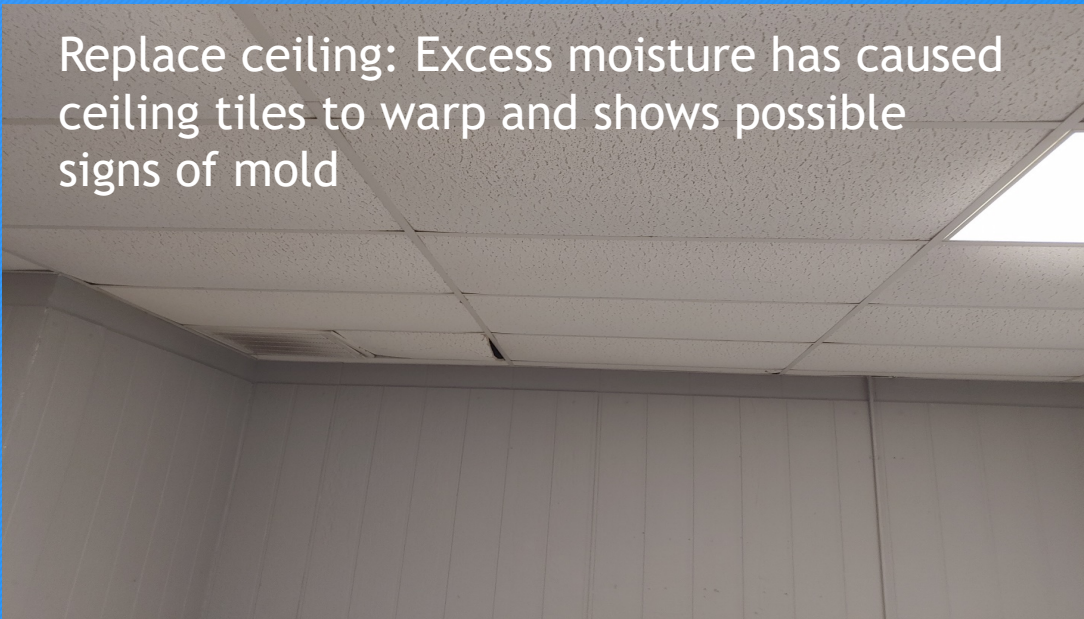
Replace ceiling: Excess moisture has caused ceiling tiles to warp and shows possible signs of mold

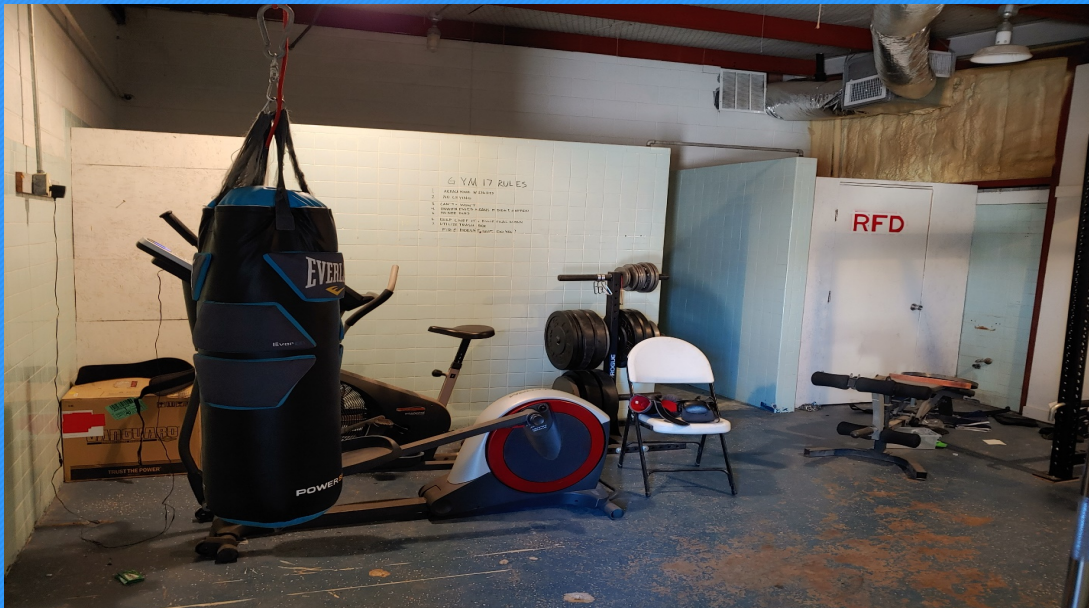
Workout/Shower Area: OSHA requirement is a min. of 2 separate bathrooms for places with 16-35 employees. This area could be designed for a separate female shower/dress area.

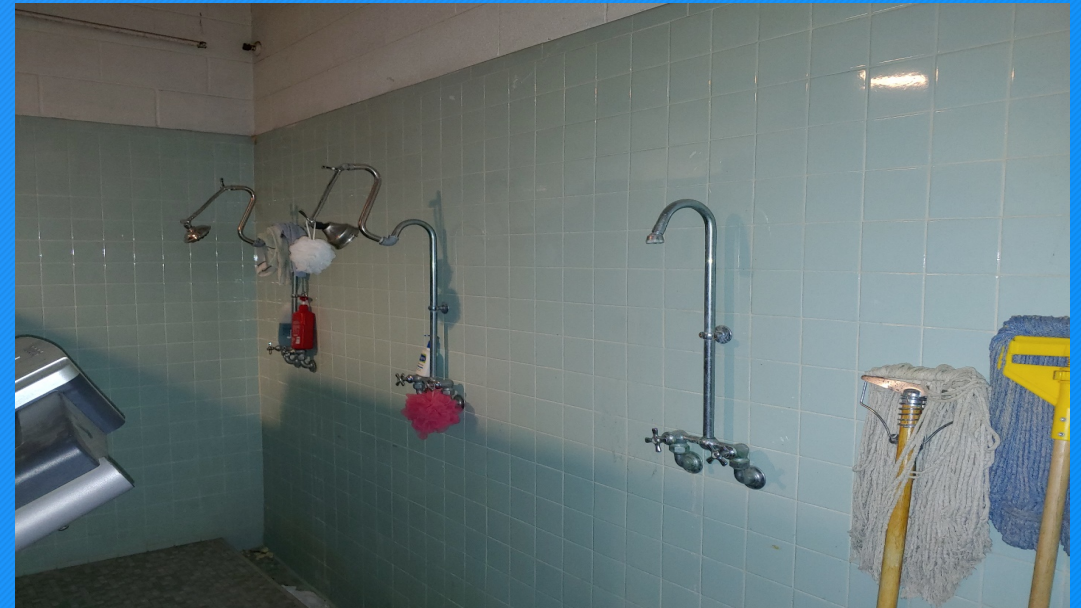
Shower area: All shower heads do not work. Floor Drain is an open channel and is not safe. This area will need to be re-designed to accommodate both male and female firefighters.

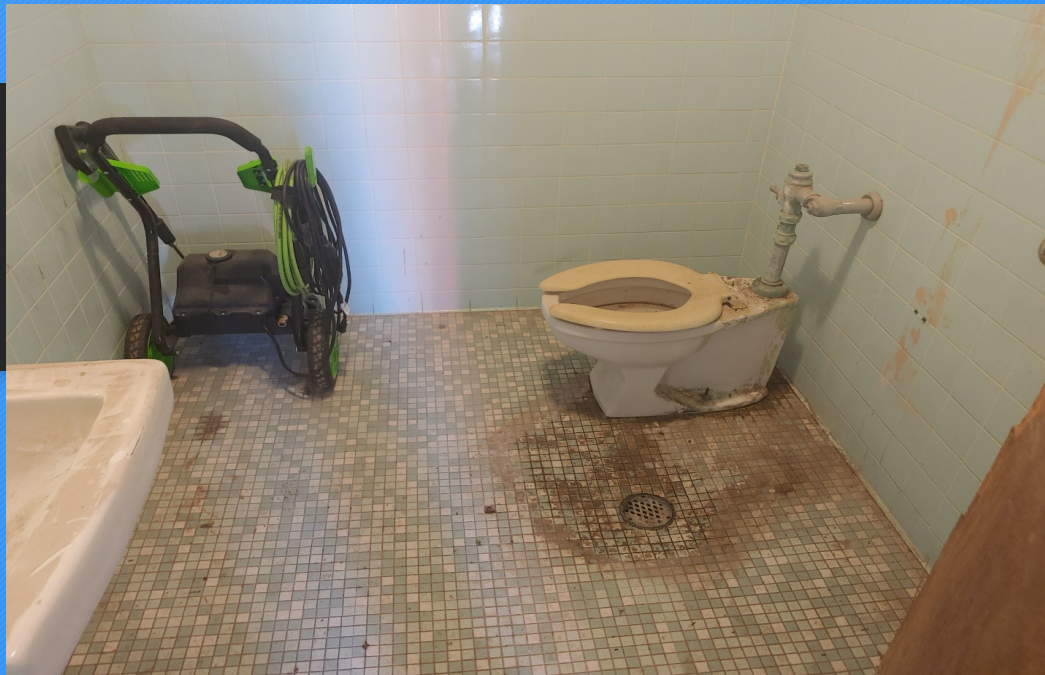
Does not meet ADA requirements

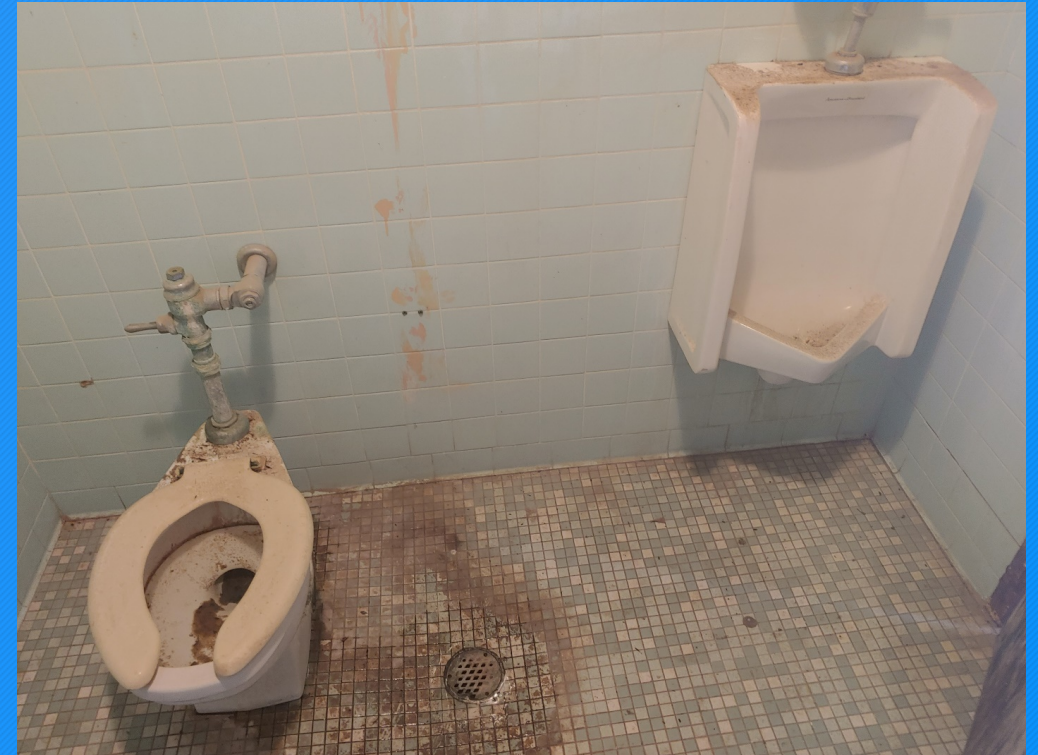
Door width doesn't meet ADA & metal door  
Frame and walls are Haydite/cinderblock

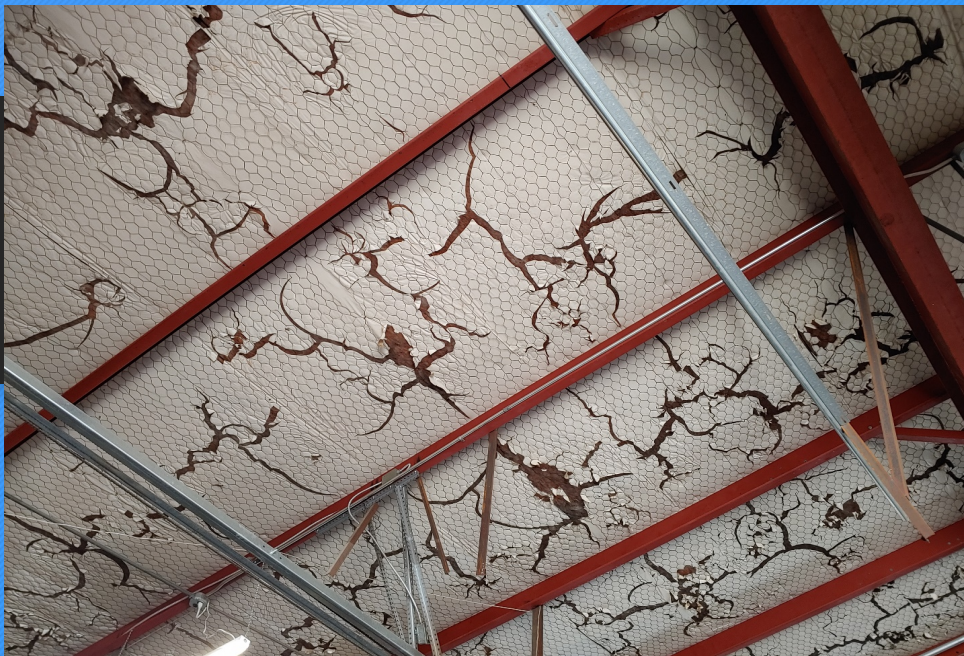
Roof/wall insulation needs to be replaced

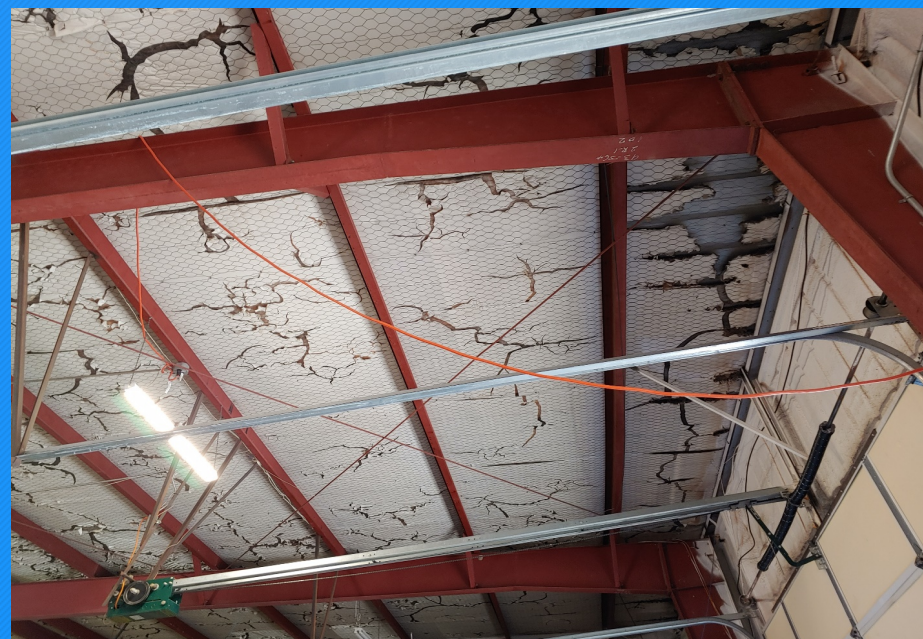
Extension cords used to power bay door opener and truck re-charge

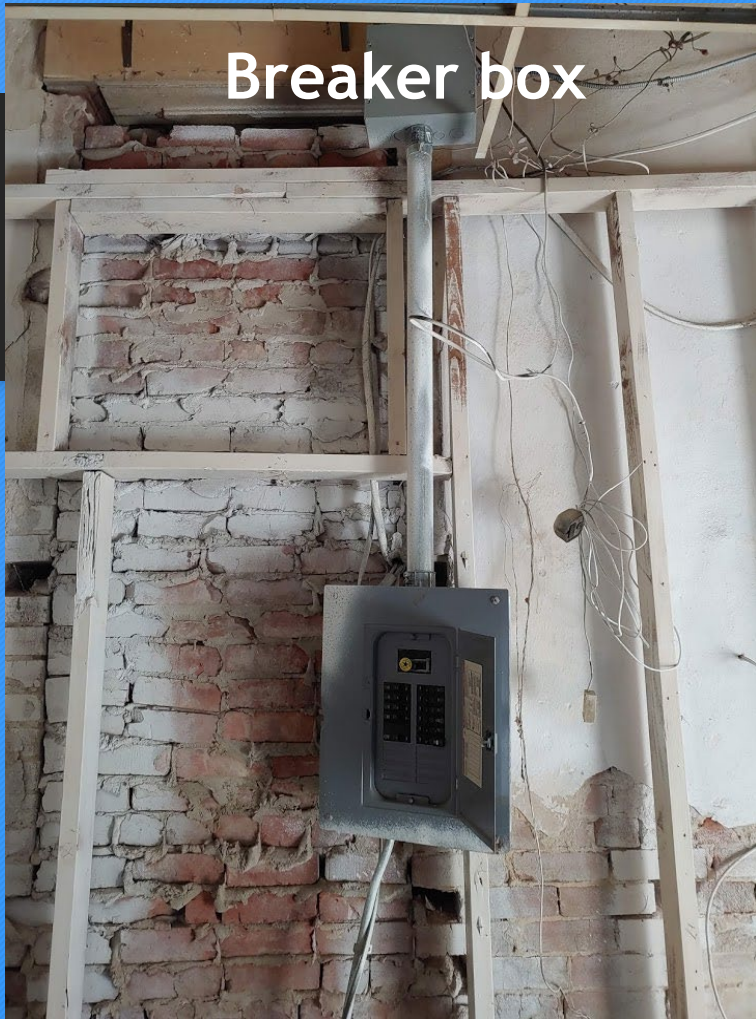
Breaker box

Old panel box and breaker box  
replaced/upgraded to meet code

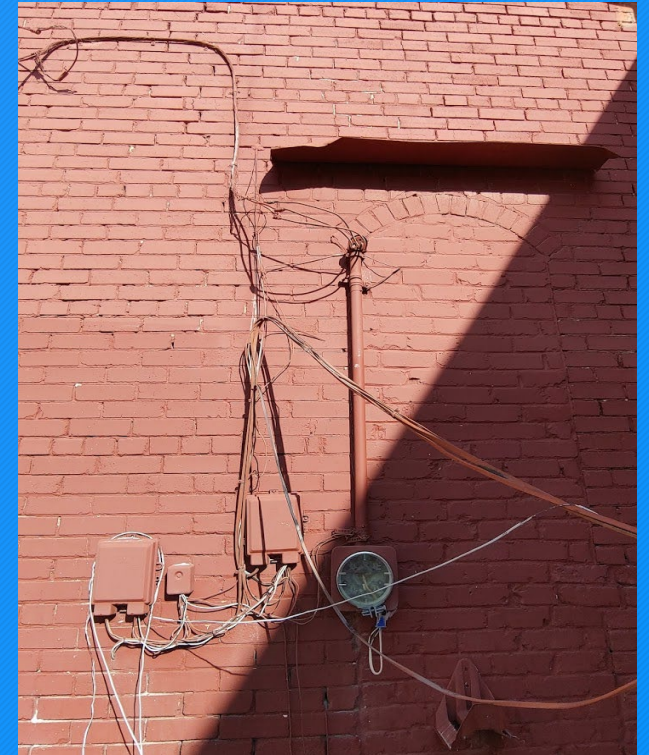
Weather head and meter  
base will need to be replaced

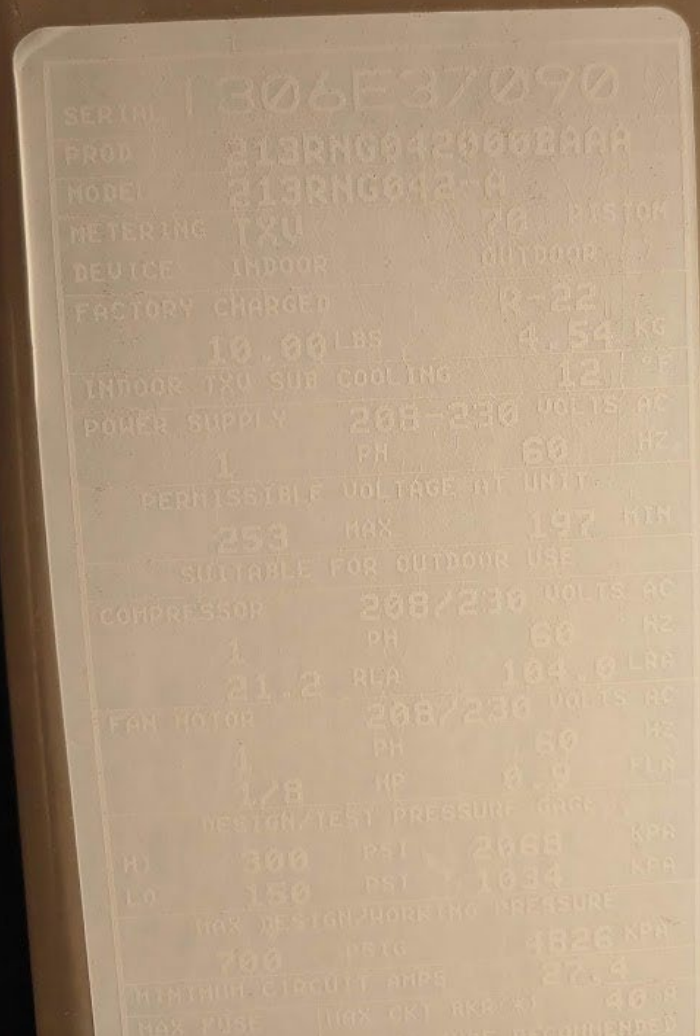
A/C is R-22; must be replaced with 410A unit

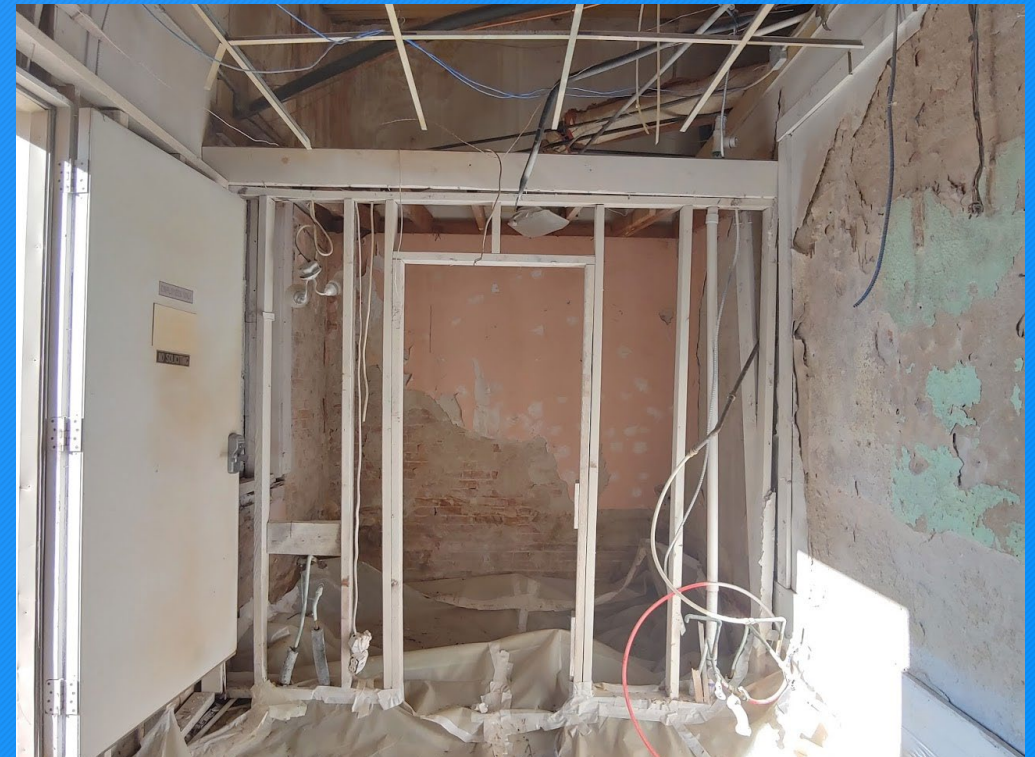
Demo existing framework: Floor plan needs to be designed to included new office floor layout

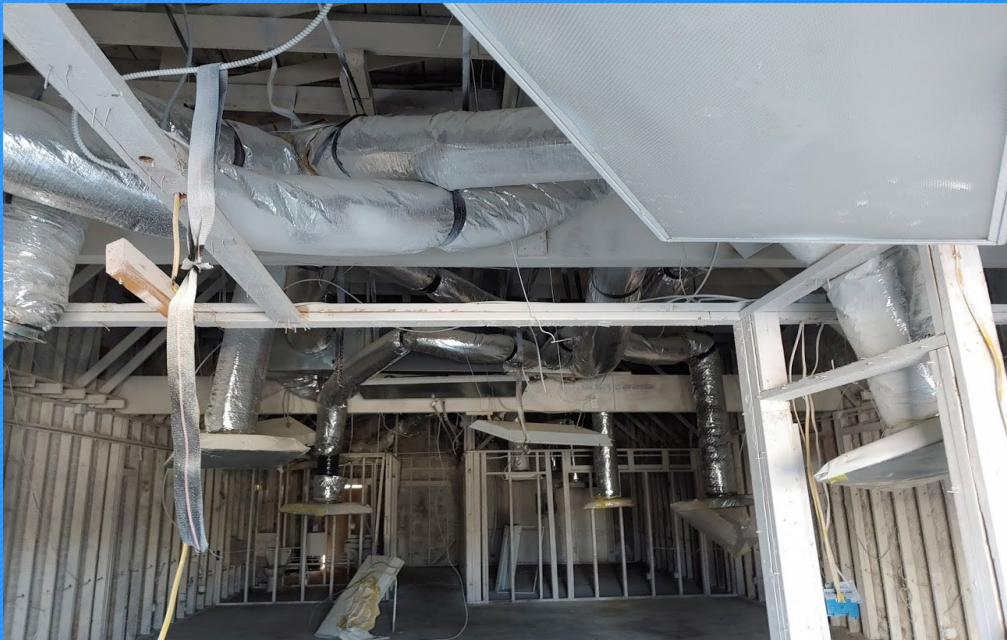
Duct work must be replaced/re-designed  
Based on new floorplan

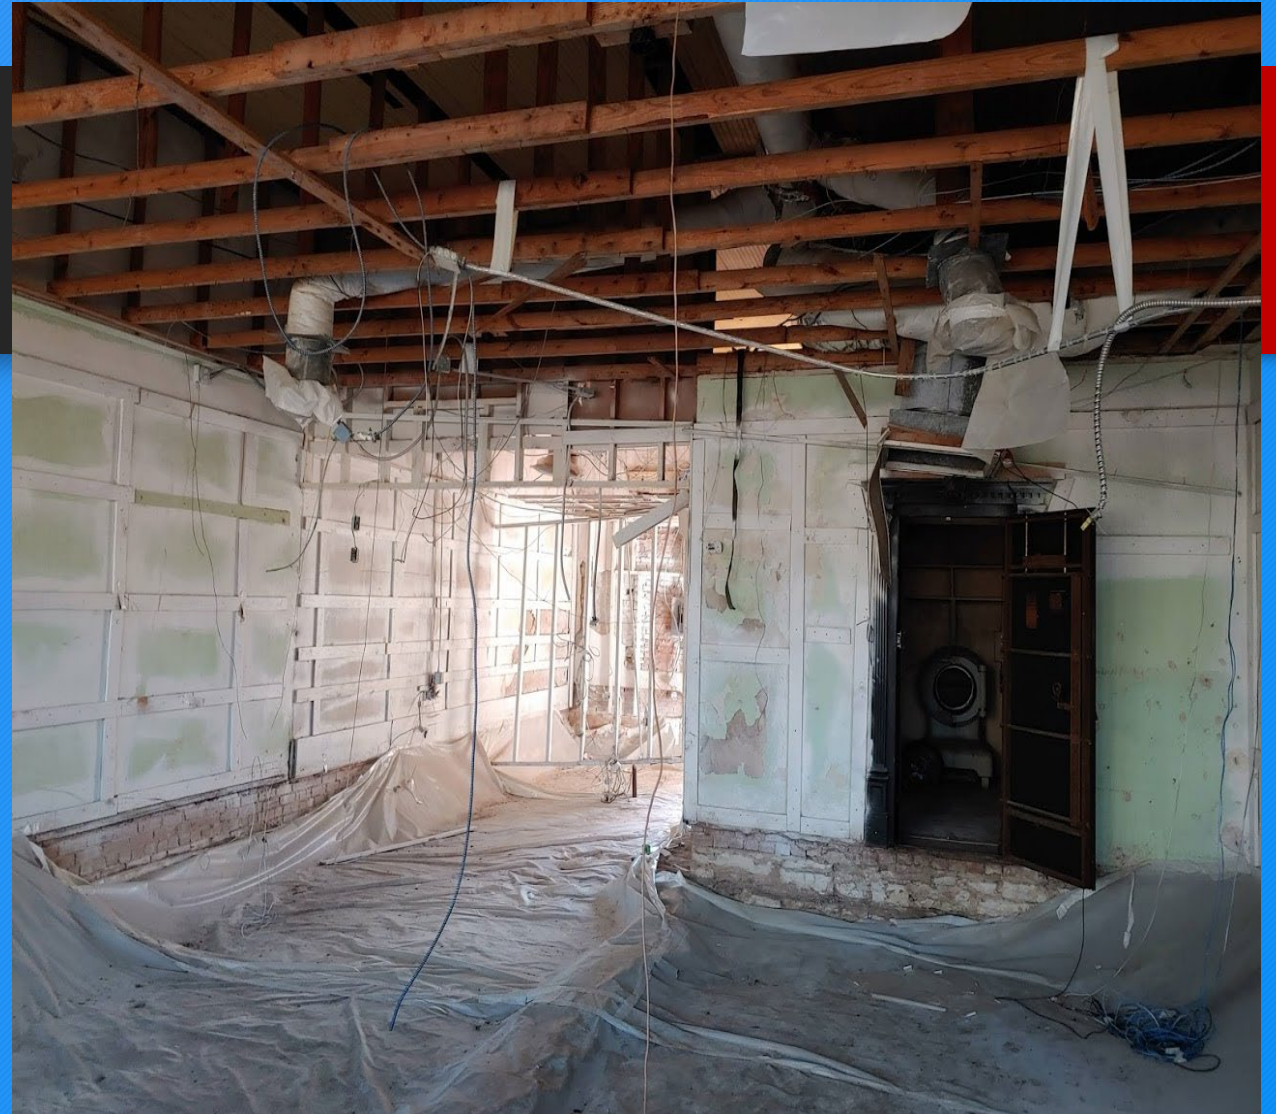
Needs new base floor installed
