# City of Rhode

City Council Meeting January 14, 2021  
Facilities Assessment/Conditions Report

# Facilities Assessment/Conditions Report

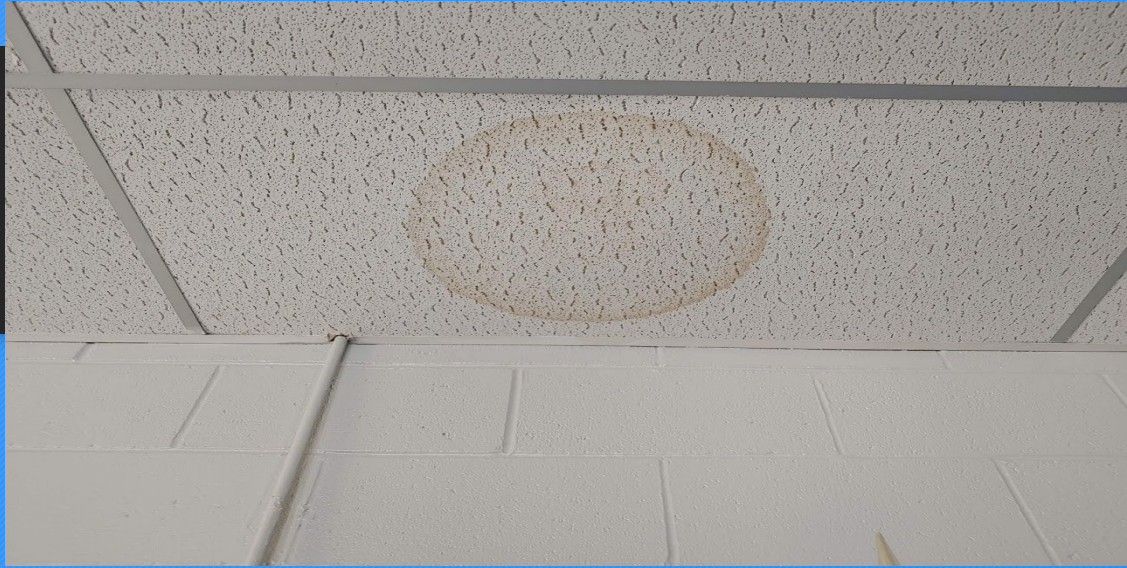
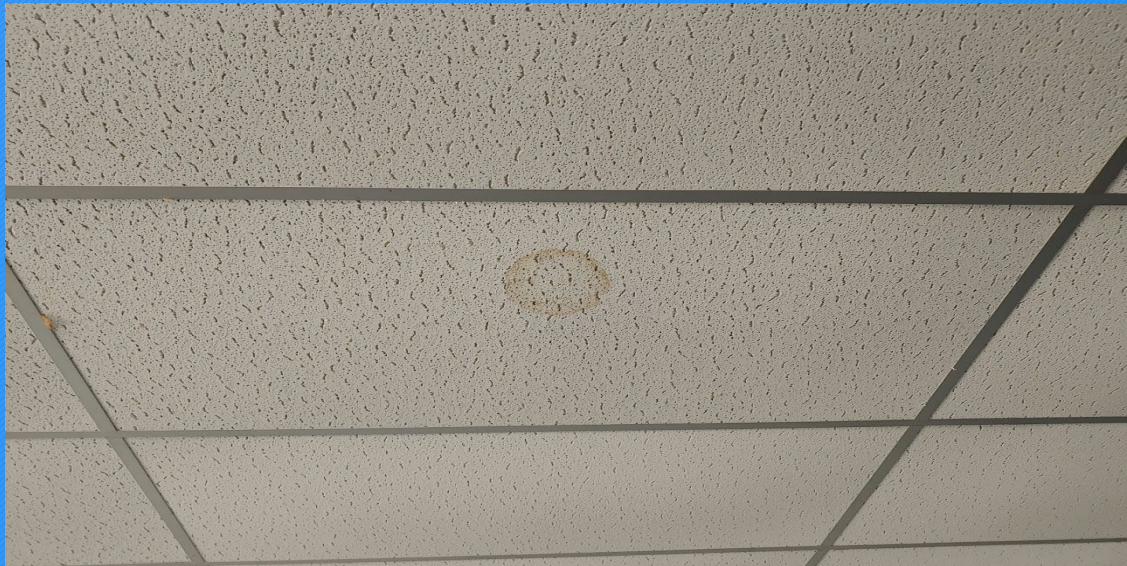
**Ceilings: Signs of roof leaks.  
TML adjuster has come to do  
inspection & waiting on report**

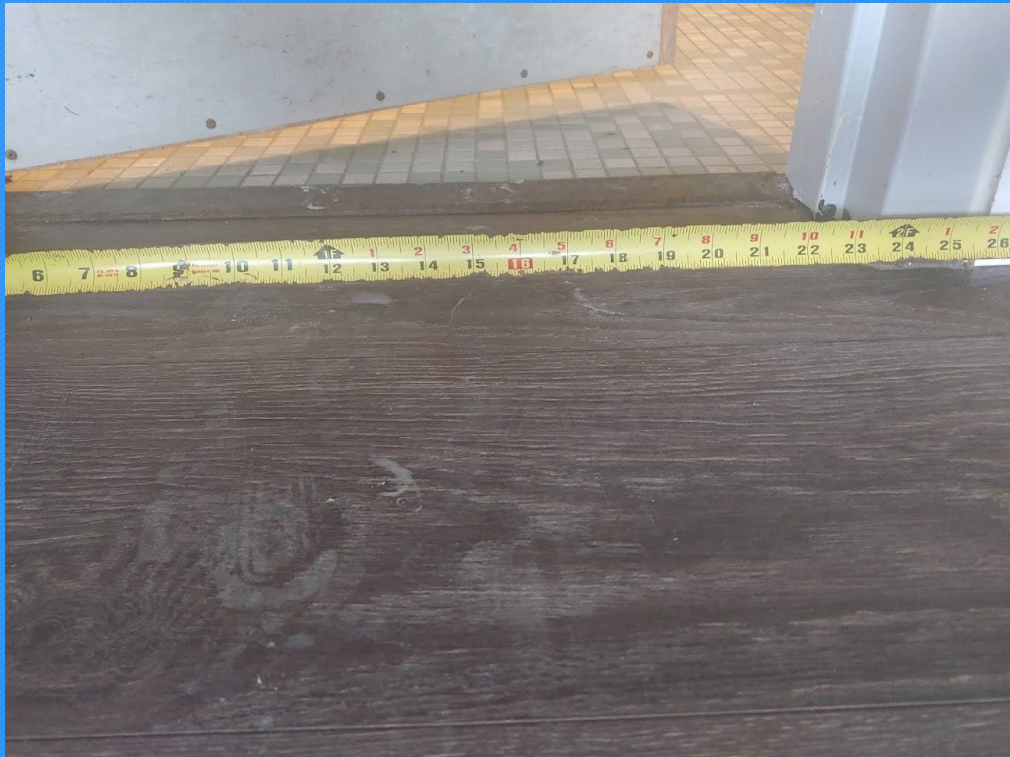
Bathroom doorway not ADA compliant

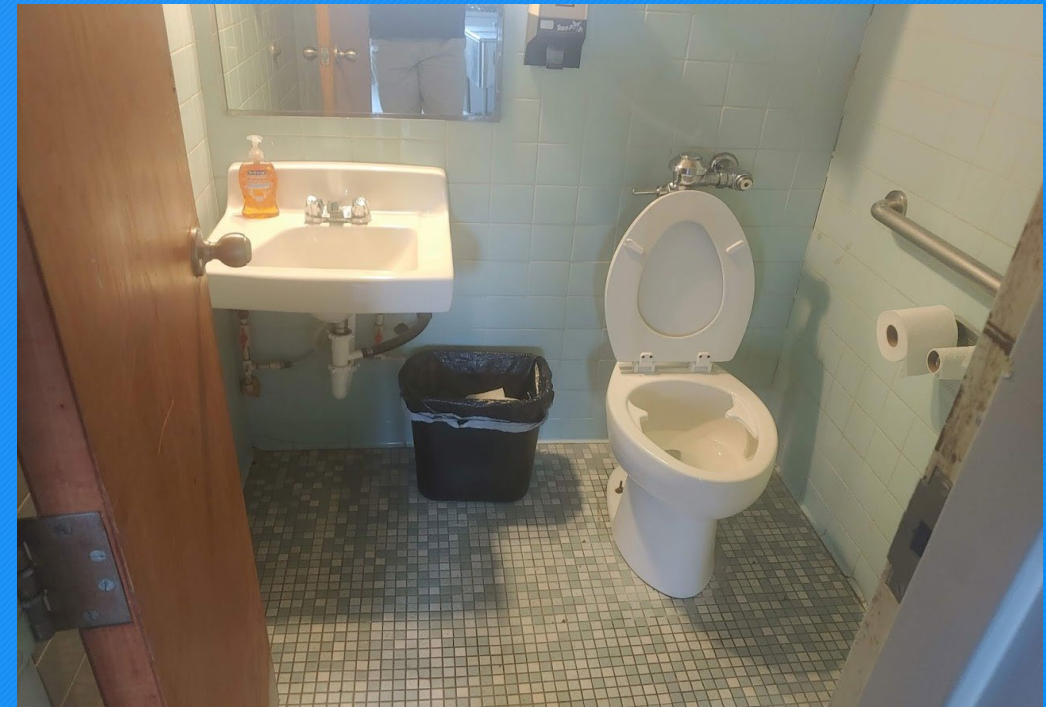
Number of bathrooms not ADA compliant

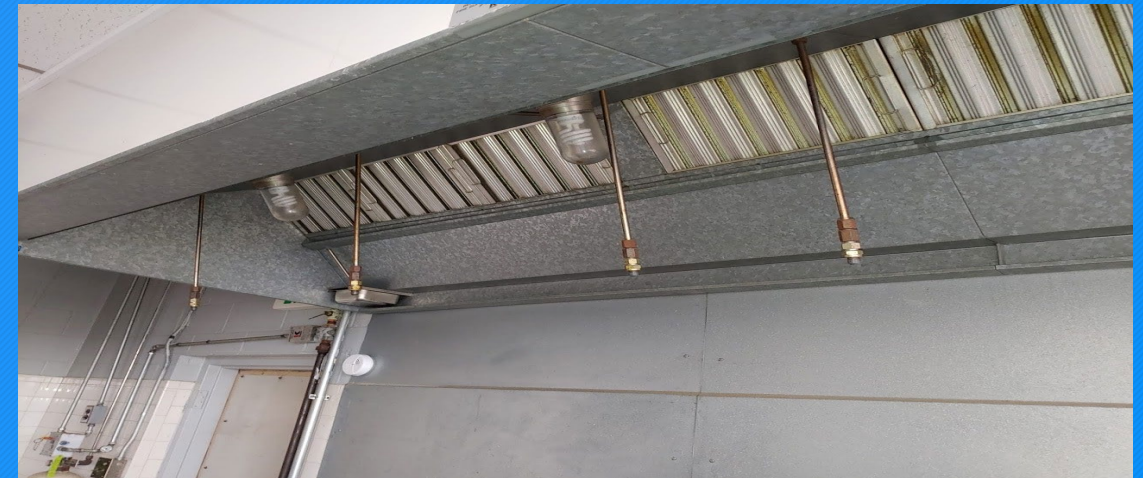
Kitchen: Fire suppression & fan equip. replaced,  
brought up to code

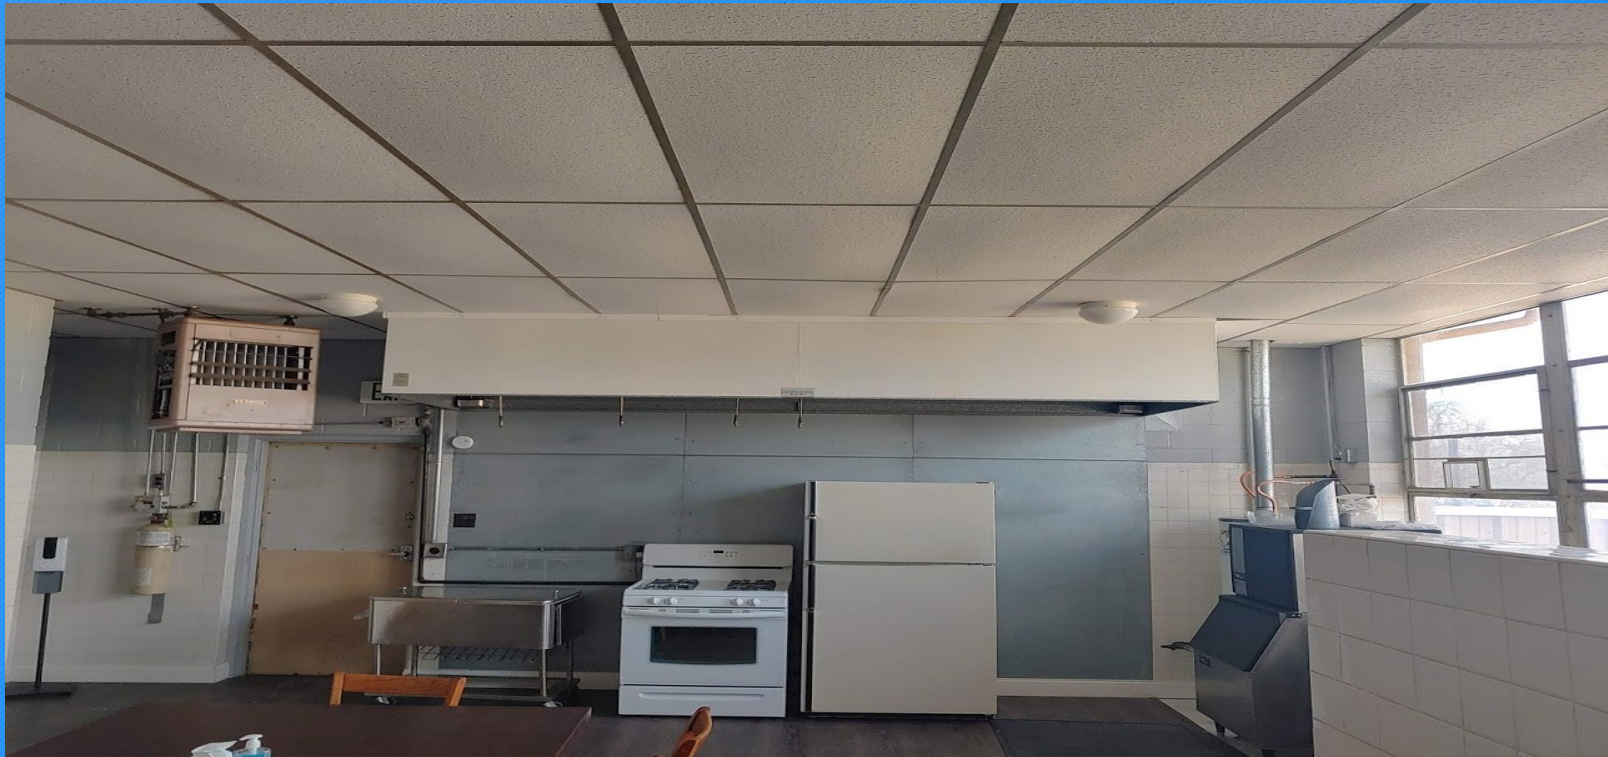
No smoke detection within building; needs to be brought up to code

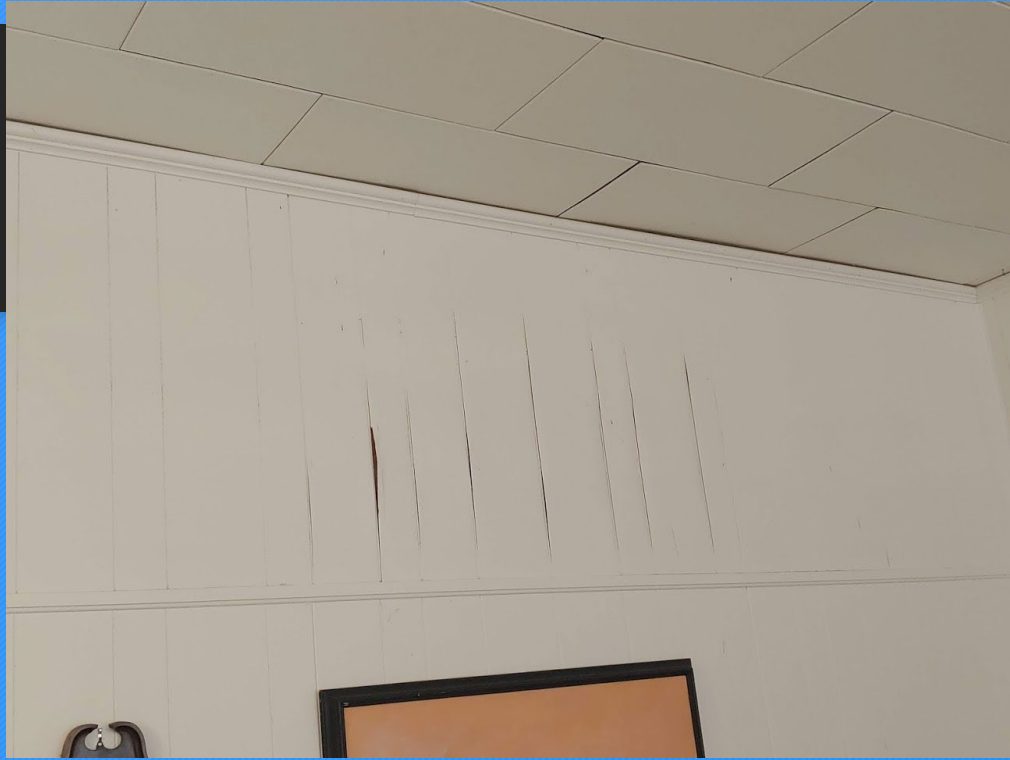
Wall panels showing signs of moisture.  
Remove and repair

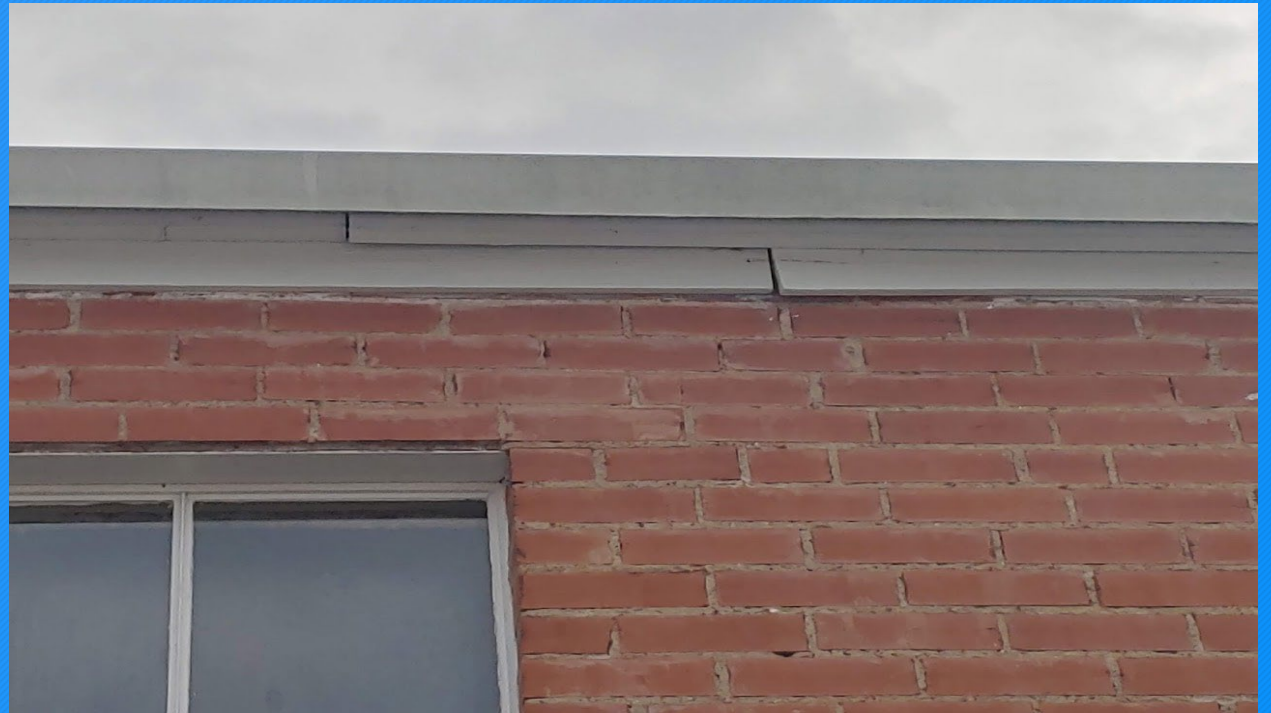
Repair/replace outside eaves

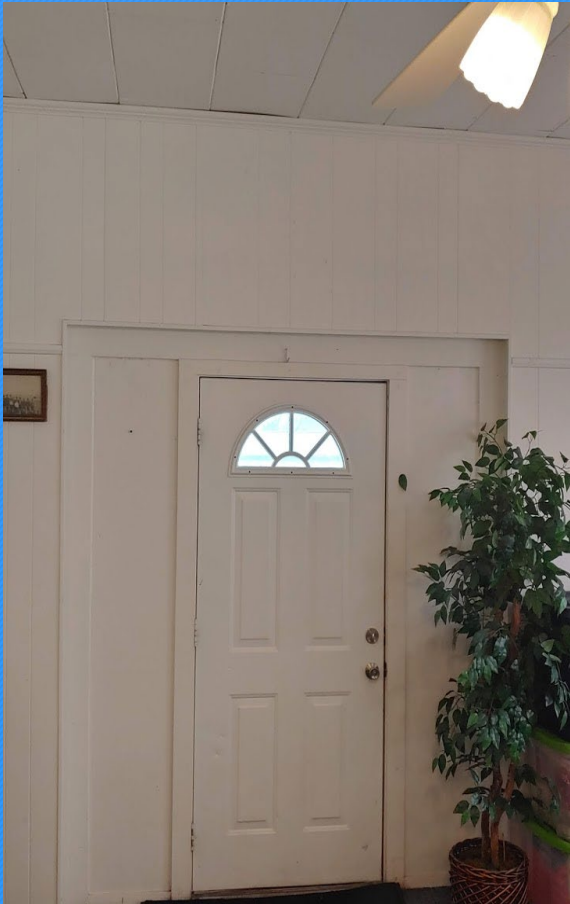
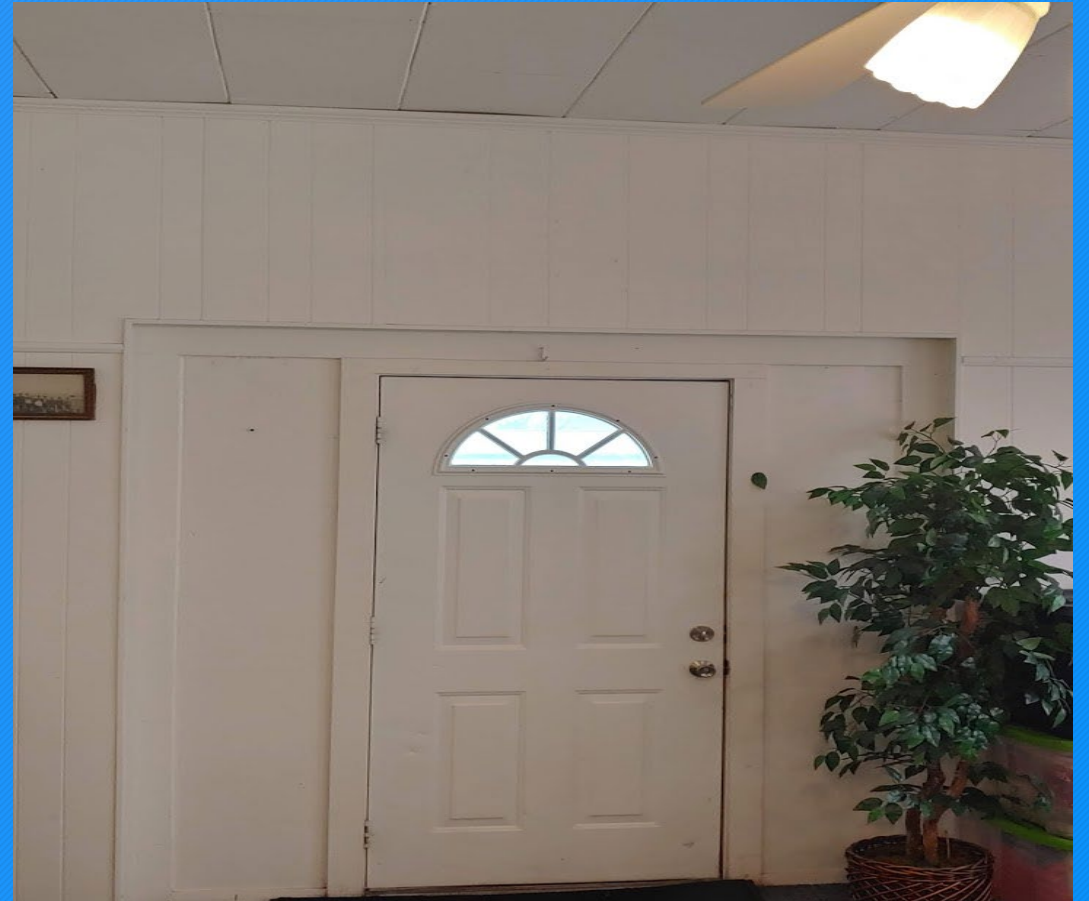
Front Door: No exit  
sign & must be hard-  
wired

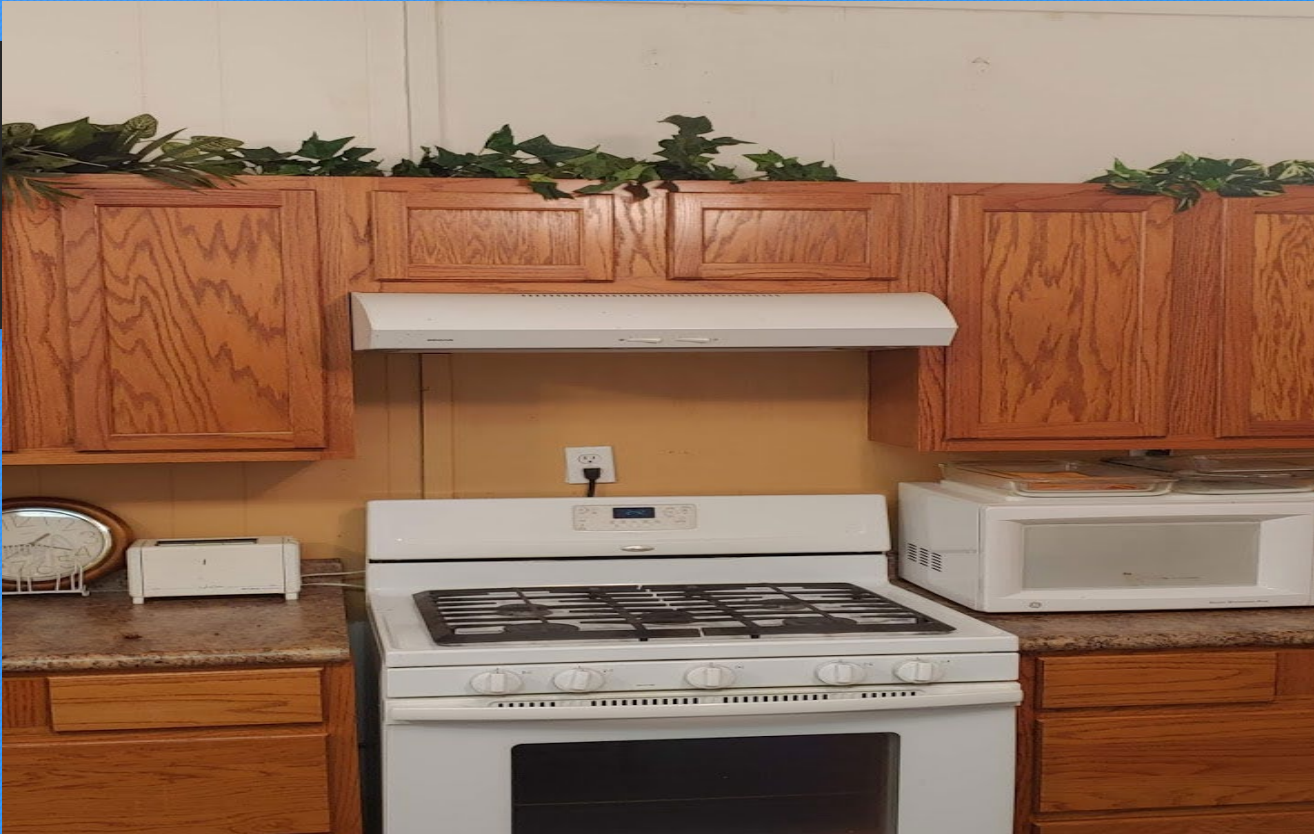
Needs commercial vent hood

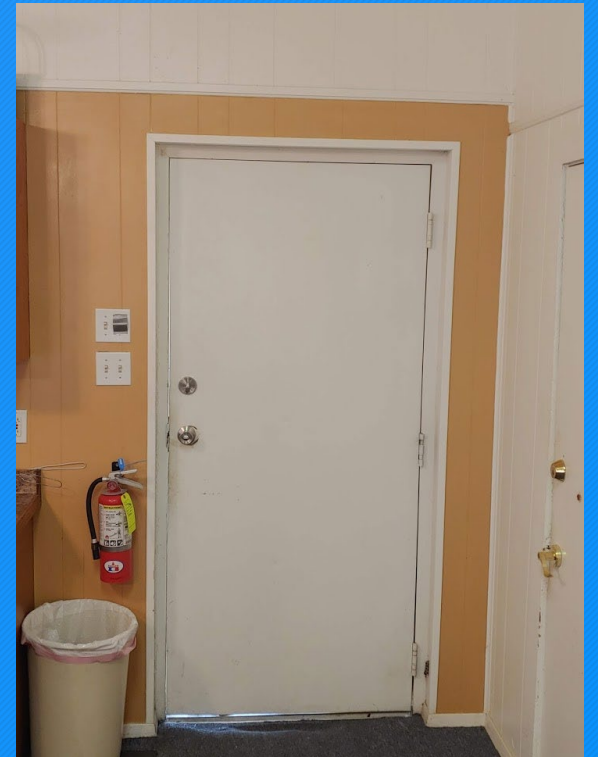
Back Door: No emergency  
Exit sign

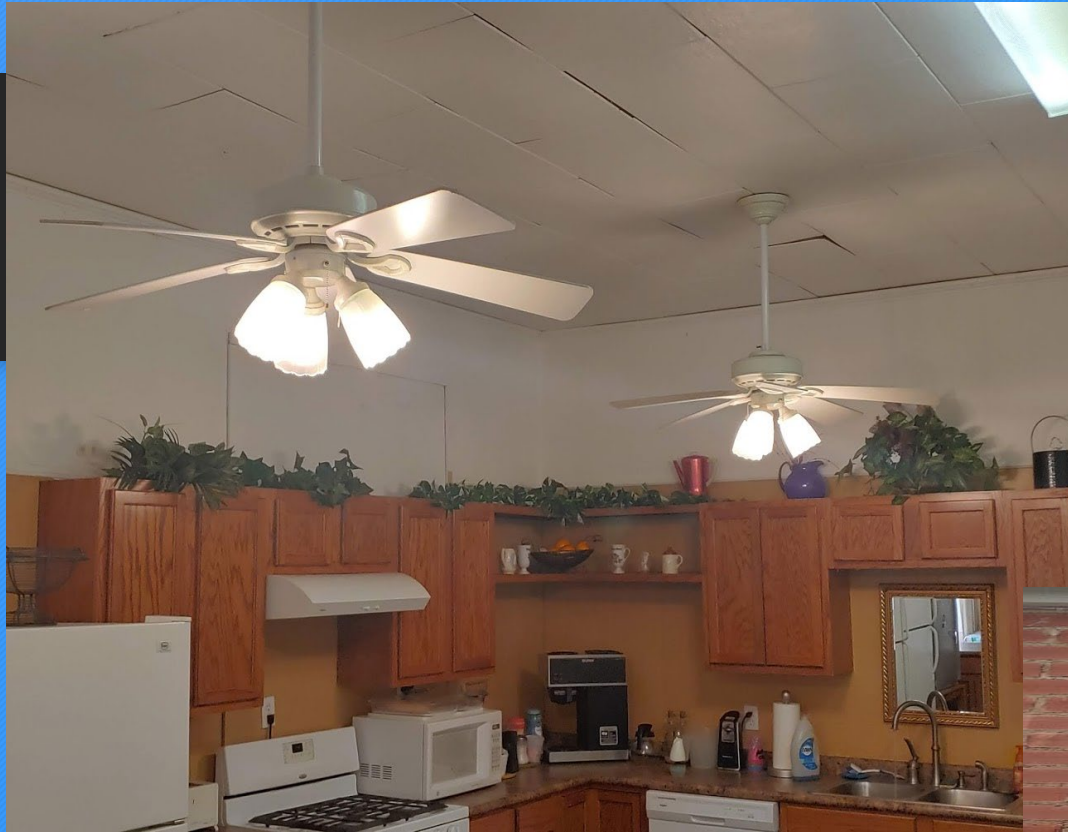
No smoke detectors

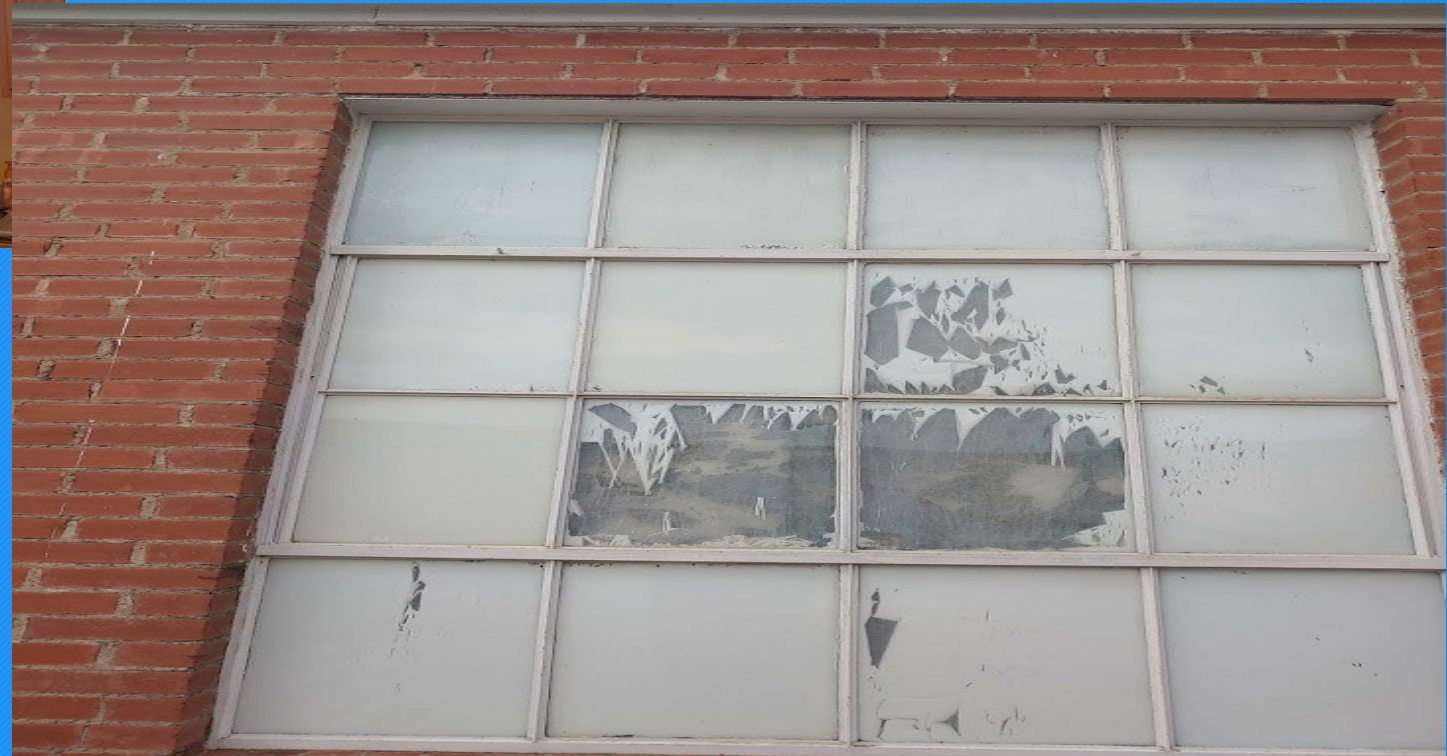
Replace window with  
energy efficient windows/panels
