Water System Study

**Village of Arena
Iowa County, WI
February 2021**

MSA Professional Services, Inc.
1230 South Boulevard
Baraboo, WI 53913
Phone: 608-356-2771
www.msa-ps.com

Project No. 00163048

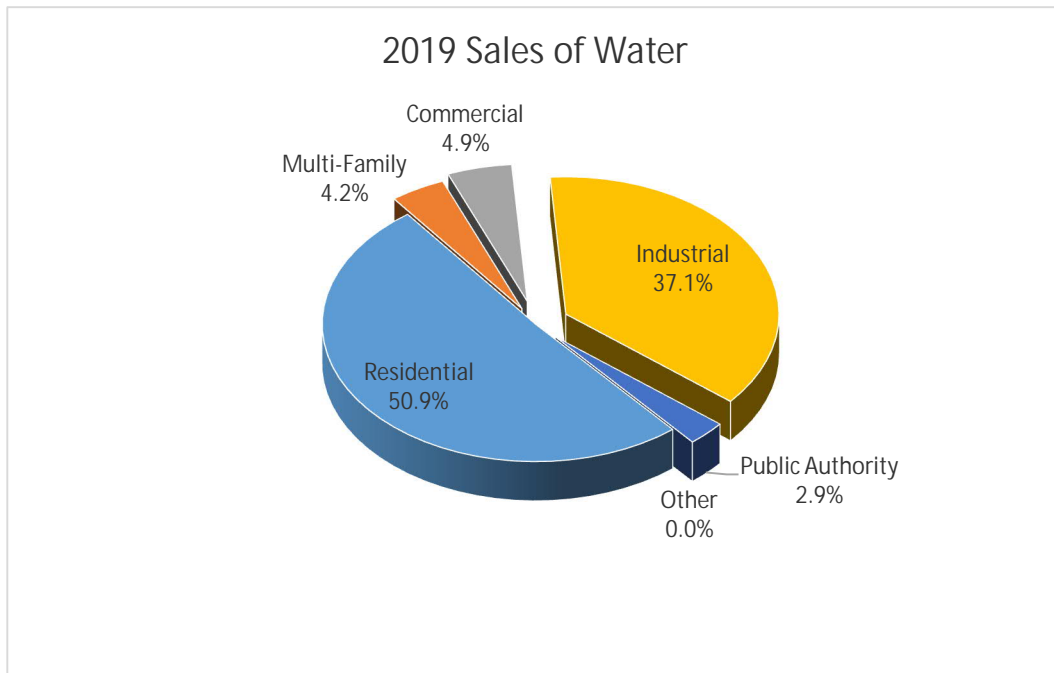
Figure 3 - 2019 Water Sales by Category

By analyzing a breakdown of water customers, the Village supplies approximately 55% of its water to residential users, and approximately 42% of its water to industrial and commercial users. See **Figure 3** below.

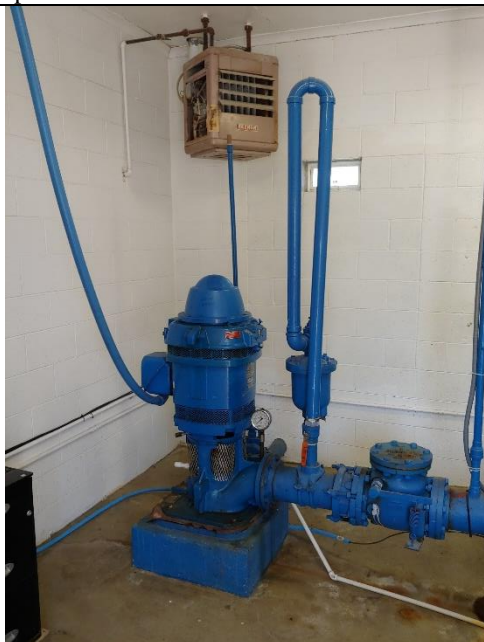
- Well No. 1 BF949

2. The current well (BF949) constructed in 1965 is grouted from 0-50.3'. Per NR 811.12(e)Minimum protective casing. All permanent wells shall have a minimum of 60 feet of grouted protective casing, wherever practical. Please note that continuous disinfection is a requirement (not just recommendation) to be provided for wells with less than 60 feet of grouted protective casing.

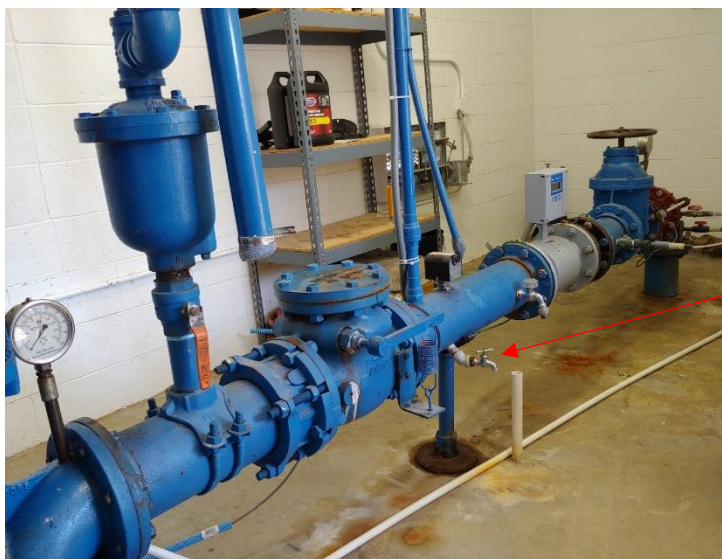
2

- Well No. 1 – Raw water sample tap

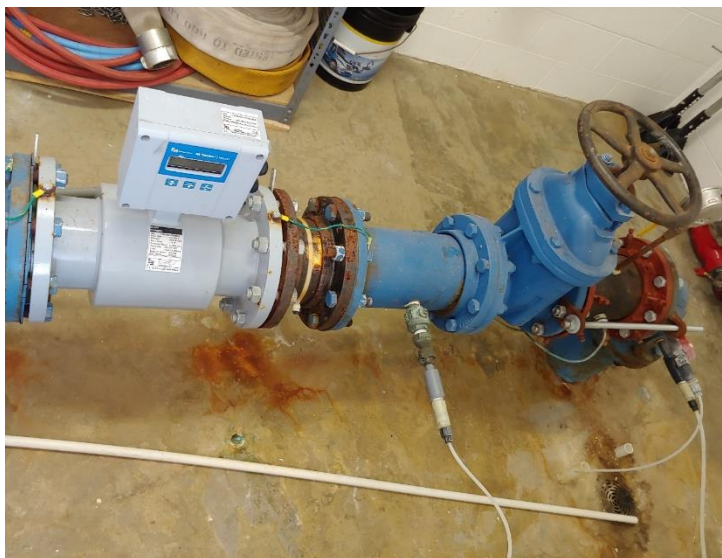
3

- Well No. 1 water meter and chemical injection

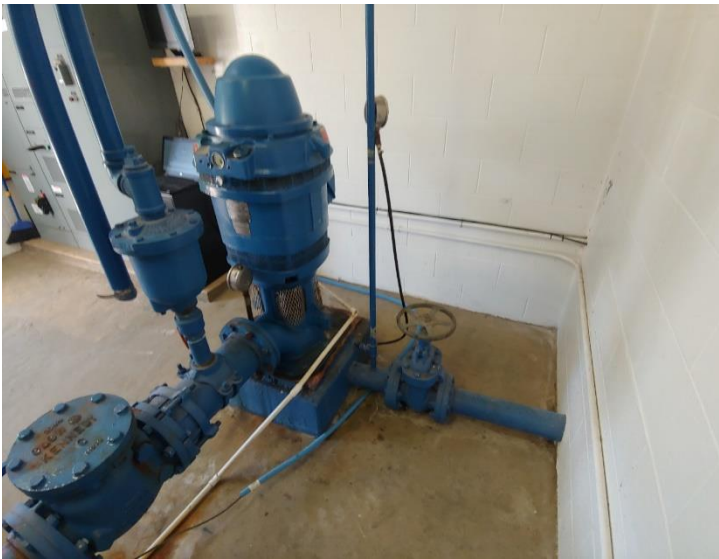
4

- Well No. 1 – pump to waste

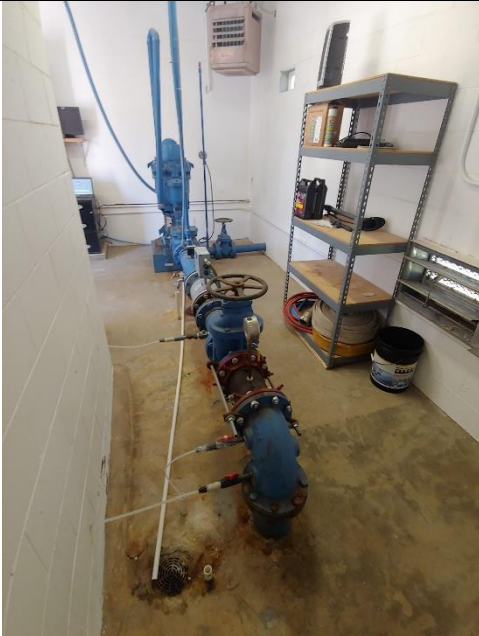
5

- Well no. 1 components
- Floor drain
- Chemical addition – Fluoride, phosphate, chlorine per direction of water flow

The 2020 DNR Sanitary Survey has identified a number of recommendations and non-conforming features at the existing wellhouse #1 facility, and include provision of secondary containment for each chemical, modify fluoride injection to be downstream of shut-off valve, direct venting of the fluoride tank, and the addition of a separate chemical room for fluoride.

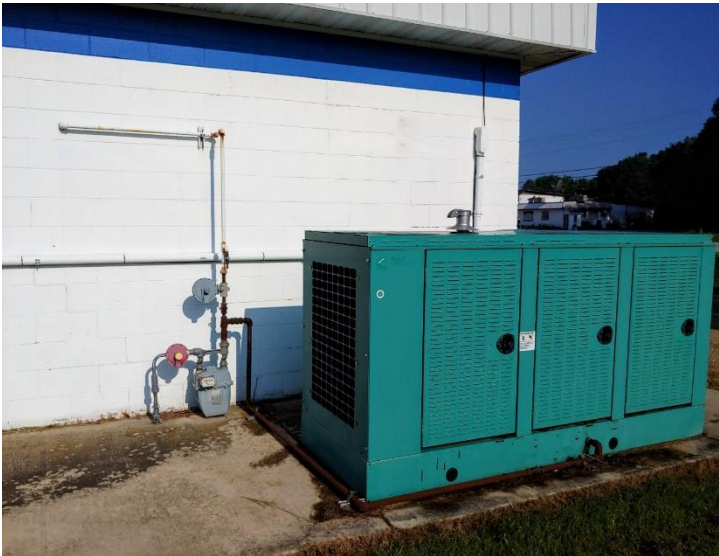
8

- Well No. 1 Emergency generator

Additionally, it is recommended that a VFD be installed at Well #1 to allow improved operation when the elevated water storage tank is taken out of service. It is also recommended that the manual transfer switch at this well be upgraded to an automatic transfer switch to allow more immediate well operation in the event of a power failure.

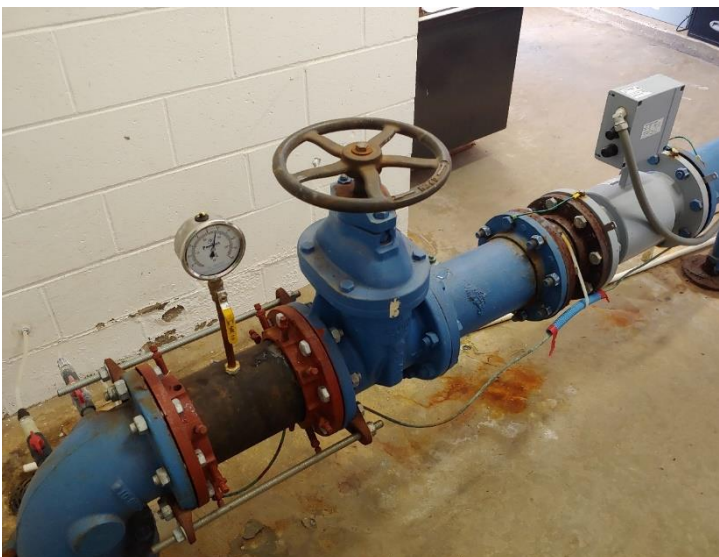
9

- Well No. 1 Water meter/ gate valve

In January 2020, the mag meter was calibrated. At that time it was observed that the mag meter was reading 8% higher than actual.

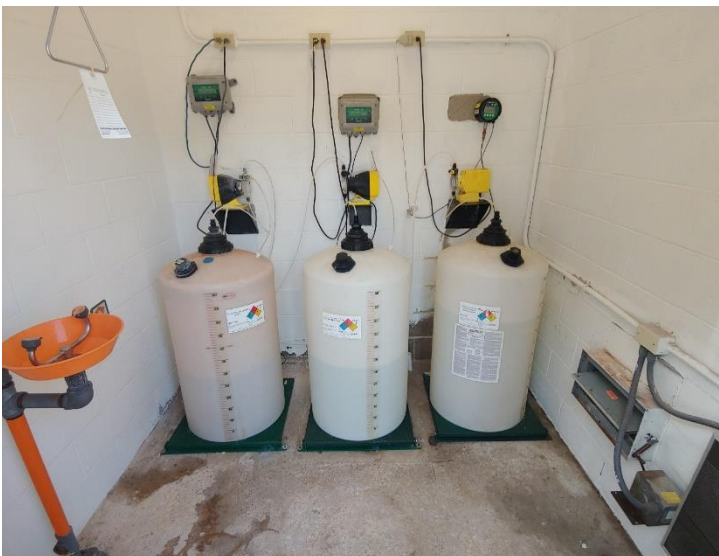
12

- Well No. 1 Chem room

2. It is recommended that secondary containment be provided for chlorine, fluoride, and phosphates. When the tanks are replaced, dual wall tanks should be purchased or some other means of providing secondary containment should be provided to bring the chemical storage up to present code standards.

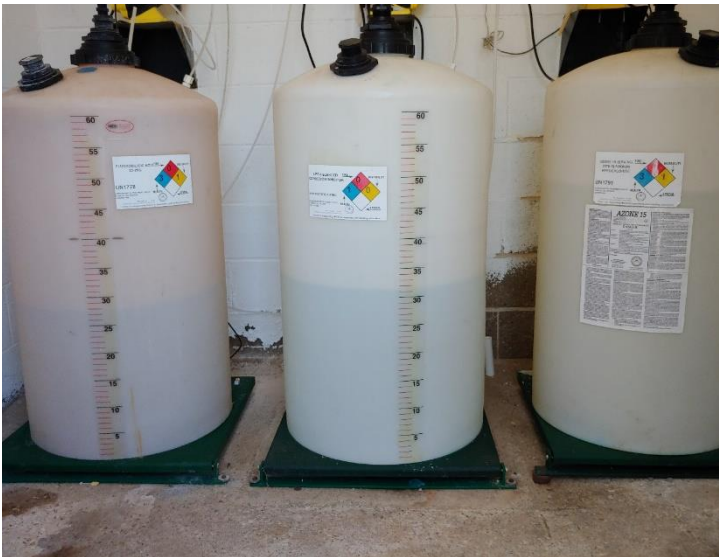
13

- Chemical labels
- Hydrofluorosilicic acid
- LPC-4 Blended corrosion inhibitor
- Azone 15

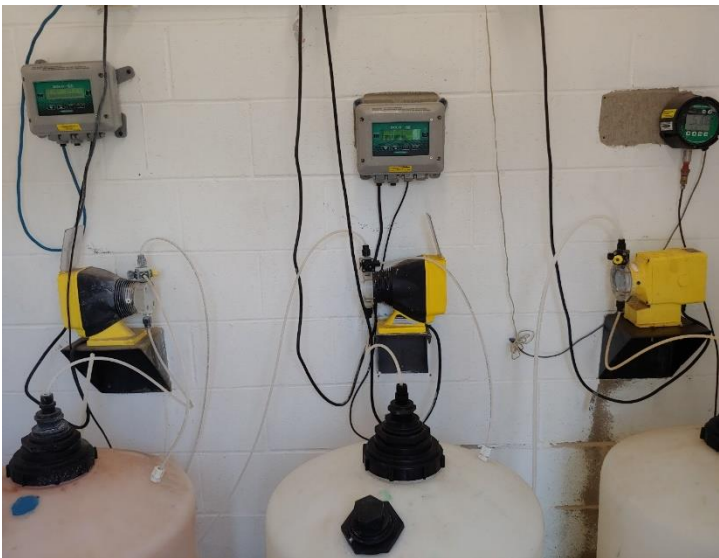
14

- Chem pumps

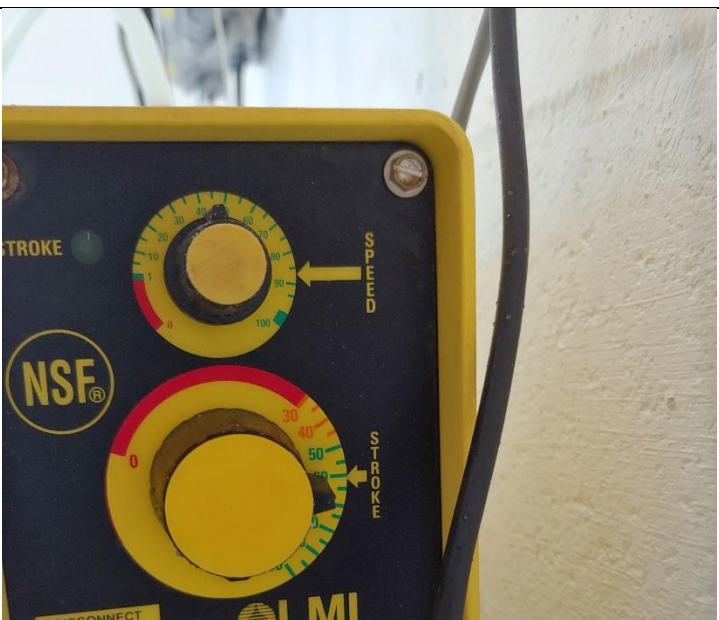
15

- Fluoride chem pump setting

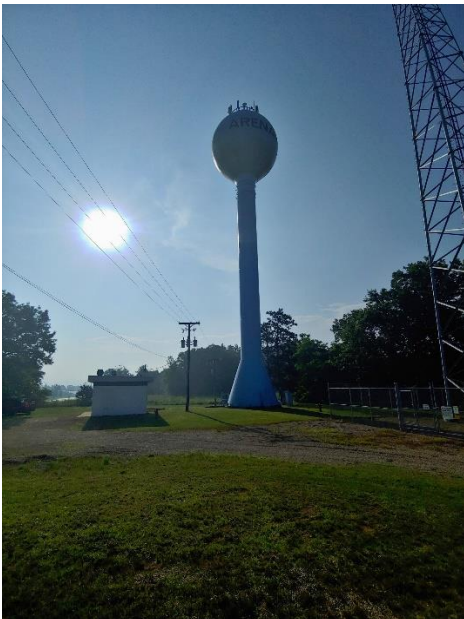
- Water tower (150k gallons)

The latest inspection completed on this storage tank was completed in 2019. (See Appendix D) This inspection report noted the tank interior platforms should be blasted and coated as soon as possible. Additionally, some minor rust spots on the exterior and wet interior were noted. A tank mixer is recommended based on the observed ice damage to the wet interior coating. The report noted that the tank exterior could be overcoated within the next few years. If rusting is not addressed, the exterior would need full removal and replacement, which would cost significantly more than overcoating.

The interior platforms are in need of rehabilitation as soon as possible. There are also minor repairs that could be done in the next year to extend the life of the coating systems, namely repairing rust spots on the exterior, repairing rust spots on the wet interior and installing a mixer in the tank to mitigate coating damage due to ice.

Since the cost of overcoating the tank is approximately half the cost of full removal and replacement, it is recommended that the tank be overcoated within the next 2-4 years. If coating systems degrade enough, full removal and replacement will be required. Ideally the overcoating project would take place after a VFD has been installed on Well #1, or Well #2 (with a VFD) is placed into service. By utilizing a VFD, more consistent system pressure could be maintained, and less water would be wasted while the tank is out of service.

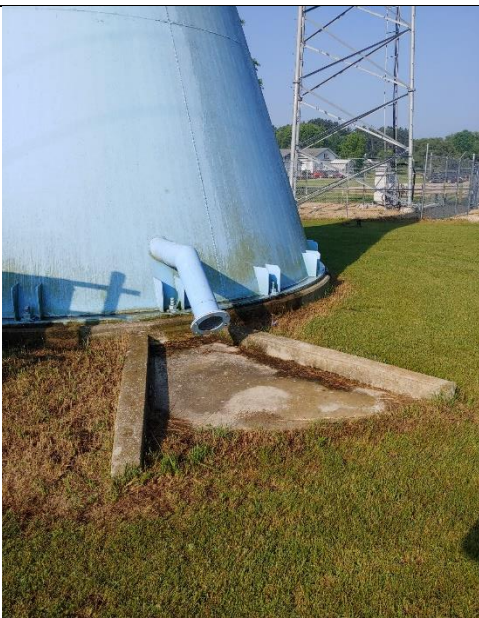
- Water tower overflow

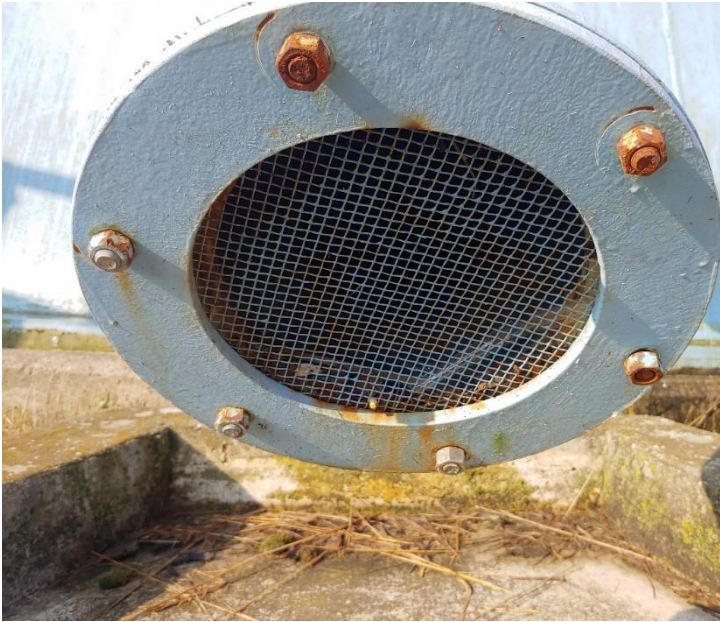
- Overflow screen

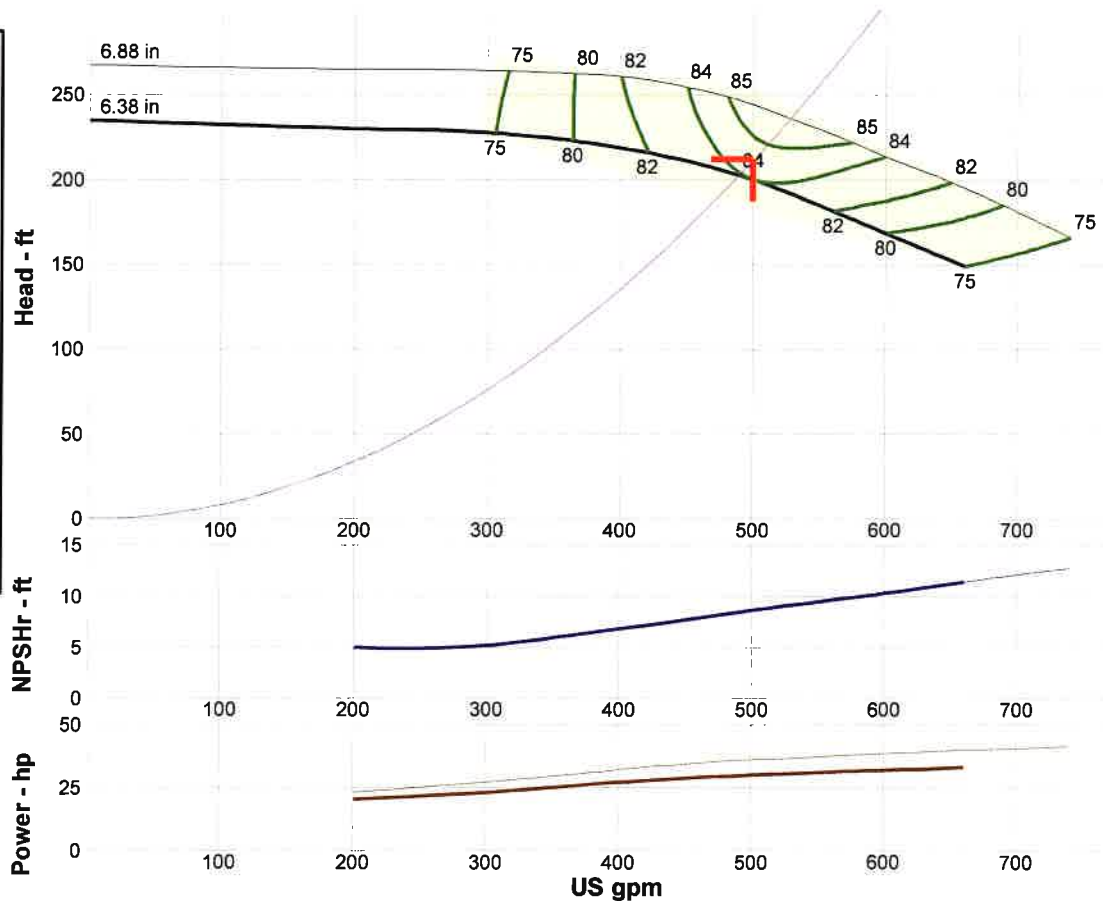
Data Point	
Flow:	500 US gpm
Head:	200 ft
Eff:	84%
Power:	30.1 hp
NPSHr:	8.64 ft
Design Curve	
Shutoff head:	235 ft
Shutoff dP:	102 psi
Min flow:	---
BEP:	84% @ 500 US gpm
NOL power:	33.1 hp @ 660 US gpm
Max Curve	
Max power:	41.4 hp @ 740 US gpm

Curves are certified for water at 60°F only. Consult factory for performance with any other fluid. Note: Contains unofficial Goulds Water Technology catalog content, not to be used for production.

construction report, and as 0 feet in the 2014 pump replacement data. The pumping water level was recorded at 44 feet deep while pumping 381 gpm, which results in a specific capacity of 8.66 gpm/ft. The vertical turbine well pump has an approximate maximum capacity of 500 gpm. The DNR approved capacity for this well is 280 gpm.
