Identification and Analysis of the Riparian Corridor in the Black & Oatka Creek Watersheds

Identification and Analysis
Of the
Riparian Corridor
In the
Black & Oatka Creek Watersheds

March 2005

With funding provided by the Great Lakes
Commission for the Controlling Sediment in the
Black & Oatka Creek Watershed Project

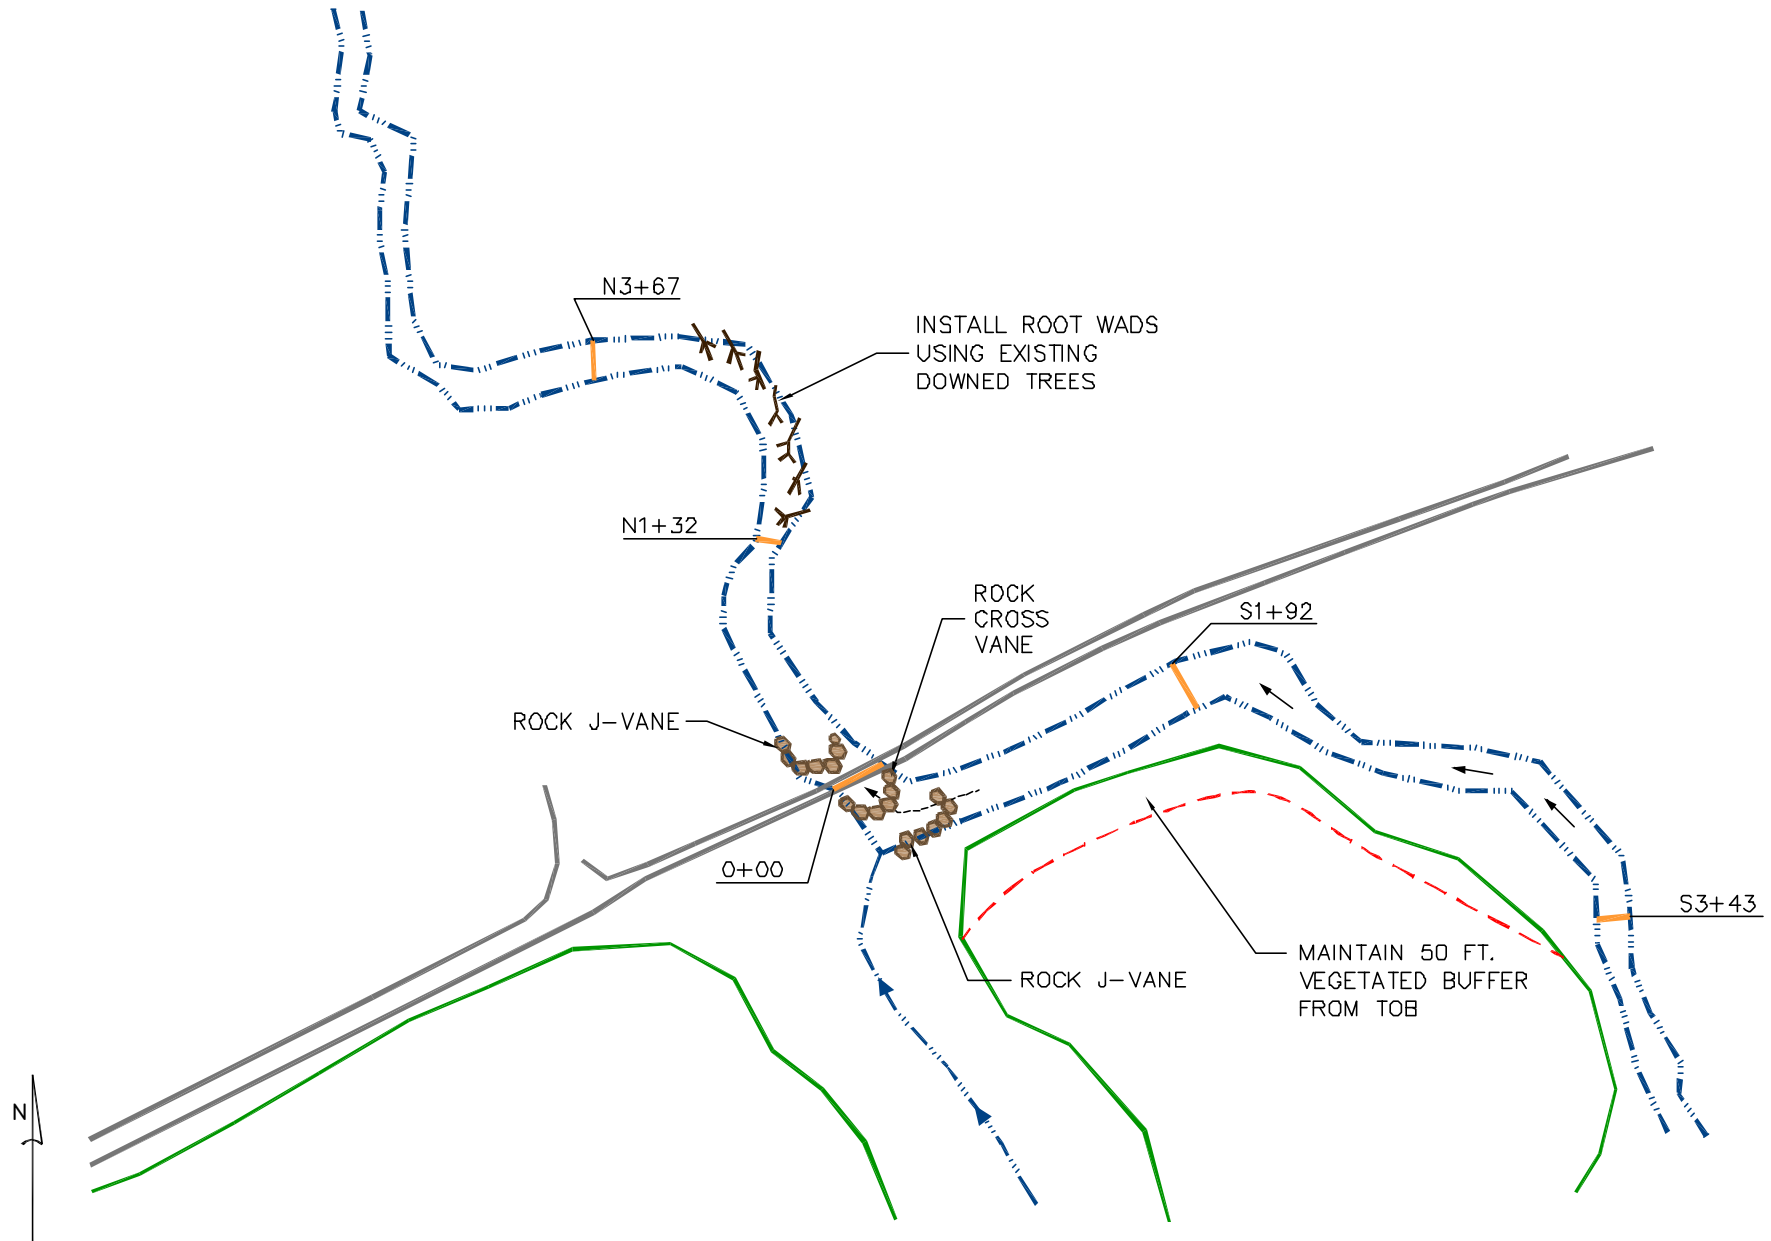
BLACK CREEK NEAR MORGANVILLE ROAD

Statement of Problem: A large scour hole has formed at the northwest abutment of the bridge site. This scour hole may eventually undermine the bridge foundation, causing collapse of the structure. High flows also deposit large amounts of sediment in the channel and cause the formation of gravel bars. A thin line of riparian shrubs is located along the west bank of the creek. Although this vegetation provides some protection for the bank, the field is cultivated as close to the creek as possible, contributing soil erosion to the channel. Some evidence of channel degradation is seen in the formation of mid-channel bars downstream from the bridge site. Downed trees deflect currents into the banks, causing additional undercutting north of the bridge.

1. Construct a rock J-vane to deflect flow toward the middle of the channel, away from the northwest bridge abutment.
2. Encourage farmers and property owners to maintain at least a 50 ft. wide buffer of woody riparian vegetation along the channel.
3. Utilize deadfalls in the stream as root wads to stabilize failing banks.

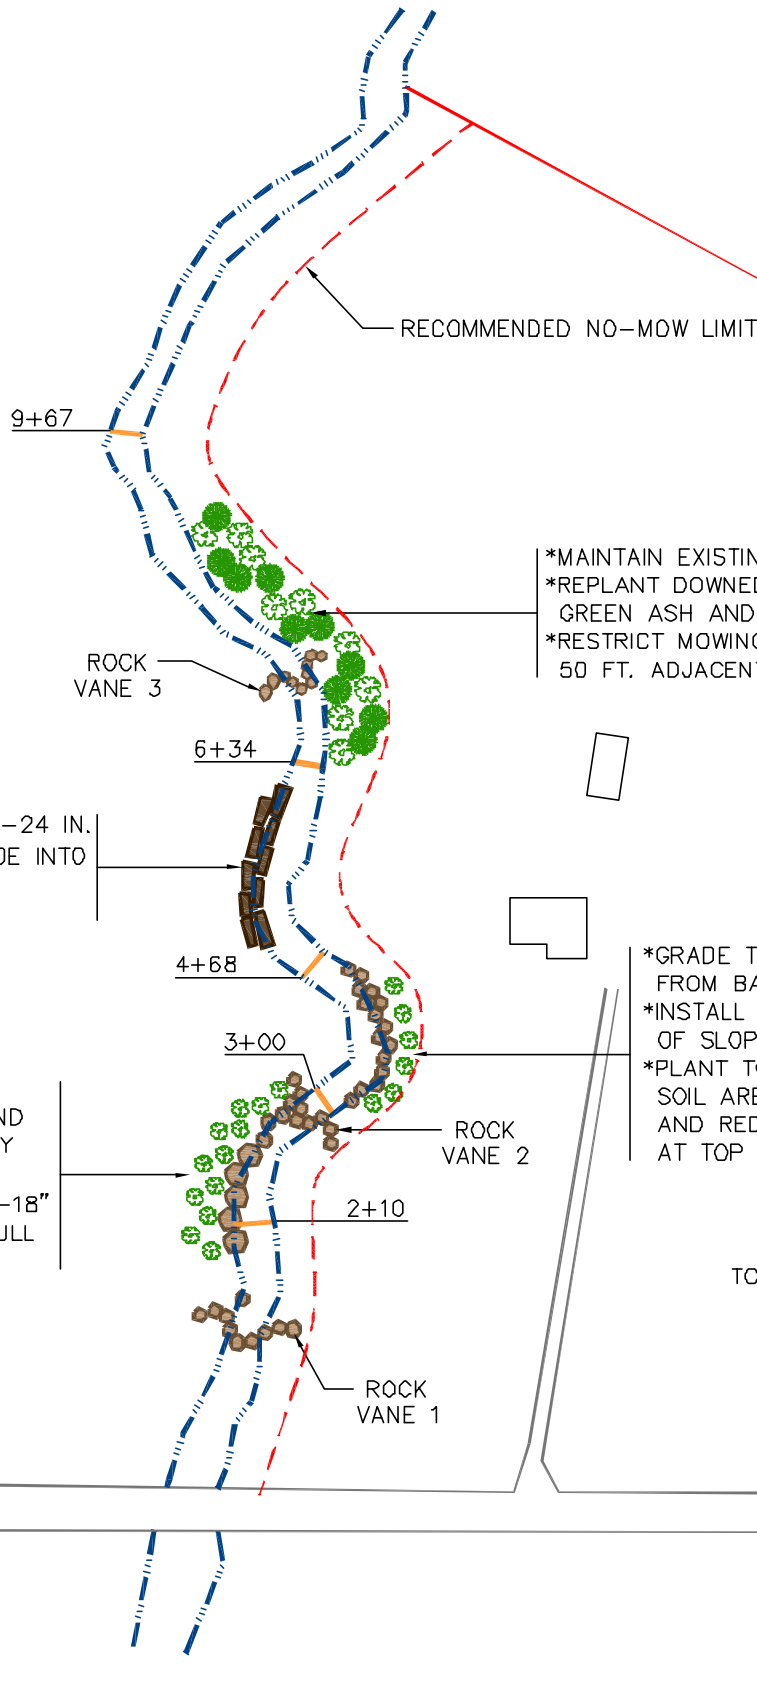
Statement of Problem: The stream channel appears to be downcutting actively at this site. Bank sloughing evident in Photo 3, exposed tree roots, and scoured, undercut outside meander banks all point to a channel in transition. Increased frequency of bankfull flows may contribute to the accelerated rate of channel degradation. Removal of woody vegetation from the top of bank on the east side of the channel has resulted in an accelerated rate of undercutting and bank erosion due to the loss of stabilizing plant roots. Channel currents are undercutting the east bank, causing significant soil erosion and increased channel deposition. Undercutting on the east side of the creek is creating a significant erosion hazard, and loss of property by adjacent landowner.

- *MAINTAIN EXISTING TREES.
- *REPLANT DOWNED TREES WITH GREEN ASH AND SILVER MAPLE.
- *RESTRICT MOWING FOR AT LEAST 50 FT. ADJACENT TO TOB.

- *SOAK WILLOW LOGS (12-24 IN. DIA.) IN WATER AND TOE INTO ERODING SLOPE.
- *BACK FILL AS NEEDED.

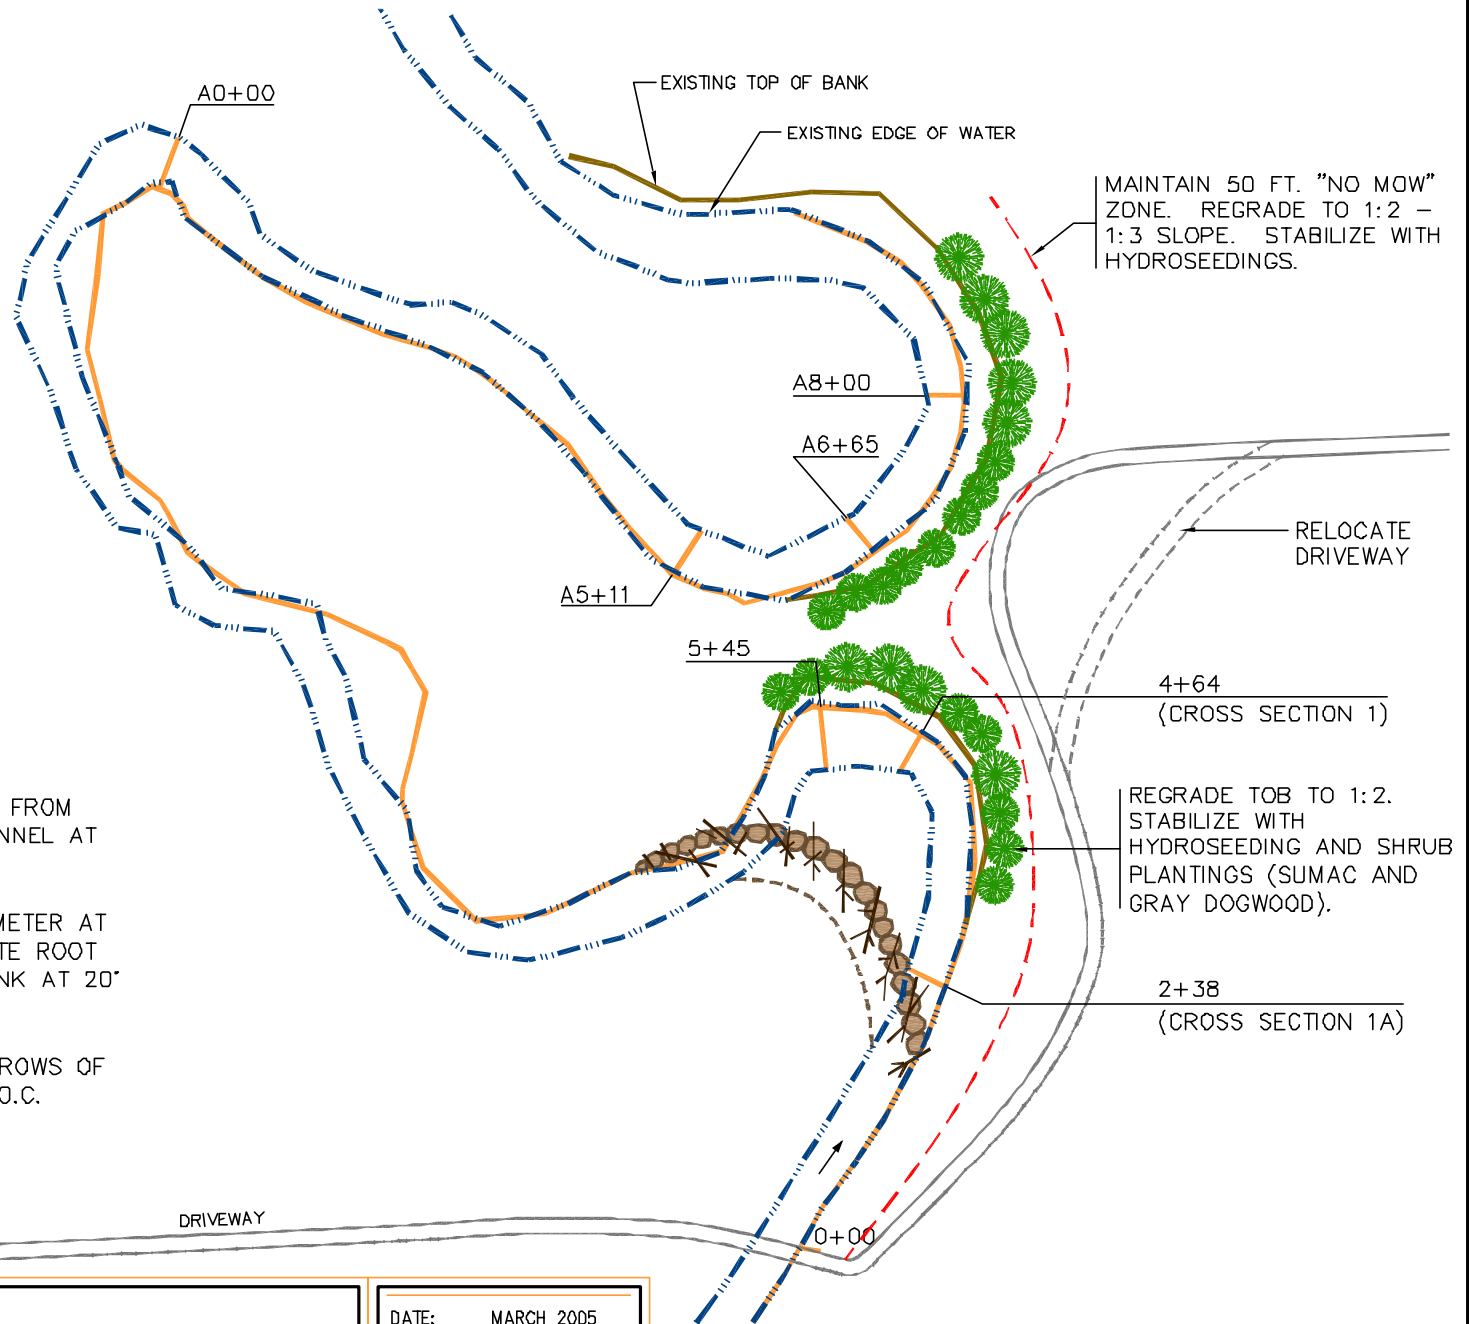
KENNEDY CONCEPTUAL DESIGN STREAM RESTORATION STUDY AREAS

Statement of Problems: Several long lengths of high eroding banks totaling 800-1000 linear feet are located within this reach. It has been estimated that this site alone contributes more than 70 T/year of sediment to the Oatka stream channel. Bank stability is reduced because woody vegetation has been removed from the top of the east bank. The owner has noted a severe loss of property adjacent to his driveway since its construction in the mid-1990's.

1. CREATE 250-300 FEET OF NEW CHANNEL WITH
A_{BKF} = 100 SQ. FT.
D_{BKF} = 2.5 FT.
W_{BKF} = 40 FT.
2. BEGIN CHANNEL AT STA. 2+00± FROM BRIDGE. TIE INTO EXISTING CHANNEL AT STA. 6+00±.
3. USE HEAVY STONE 12"-24" DIAMETER AT OUTSIDE BANK TOE, WITH ON-SITE ROOT WADS EMBEDDED IN OUTSIDE BANK AT 20' TO BANK DIRECTION±.
4. REINFORCE BANK WITH TWO (2) ROWS OF WILLOW STAKES PLANTED 2 FT. O.C.

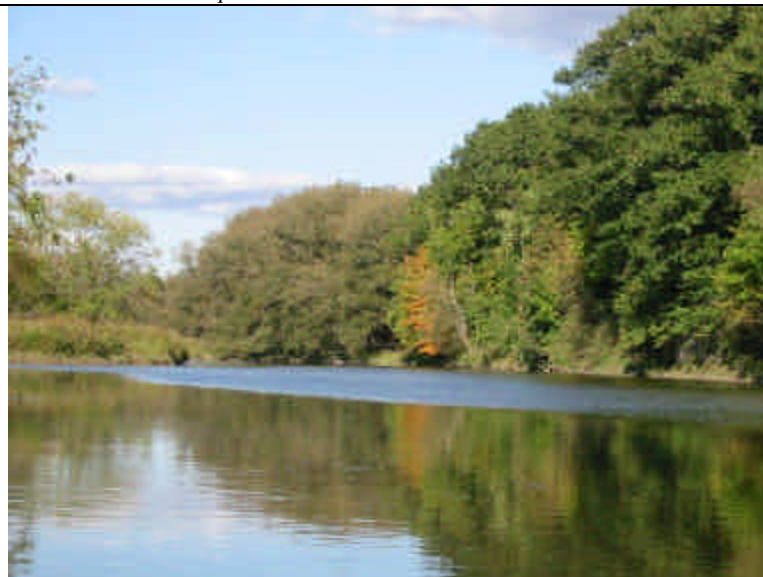
View of Oatka Creek looking downstream (east) from center pier of Rochester & Southern railroad bridge.

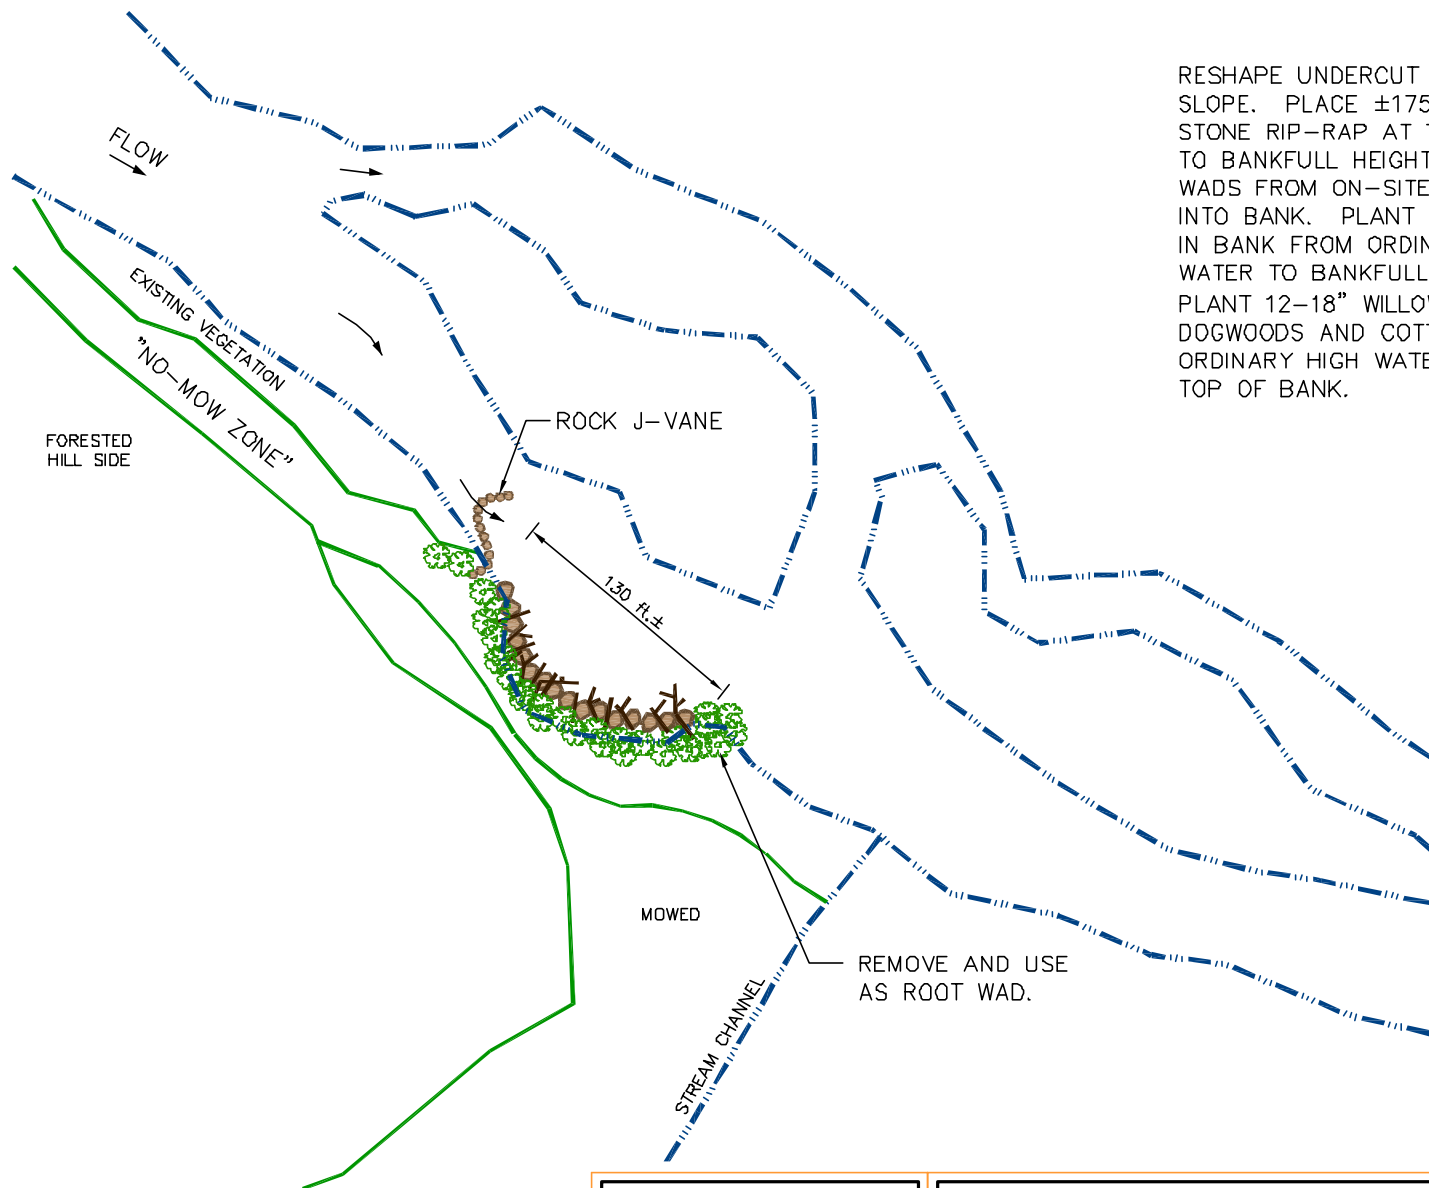
<p>Erosion on south bank of Oatka Creek at 1198 Quaker Road. Note slumping from undercutting of clay bank.</p>	<p>Single remaining black willow tree holds bank in place. Root system is completely exposed.</p>

RESHAPE UNDERCUT BANK TO 1:2 SLOPE. PLACE ± 175 LF OF HEAVY STONE RIP-RAP AT TOE OF SLOPE TO BANKFULL HEIGHT. EMBED ROOT WADS FROM ON-SITE MATERIALS INTO BANK. PLANT WILLOW STAKES IN BANK FROM ORDINARY HIGH WATER TO BANKFULL ELEVATION. PLANT 12-18" WILLOWS, SILKY DOGWOODS AND COTTONWOODS FROM ORDINARY HIGH WATER MARK TO TOP OF BANK.
