## Community Specific Design Guidelines

### LOCKPORT MAIN STREET, INC.

# Community Specific Design Guidelines Lockport Main Street, Inc.

**April 2013**

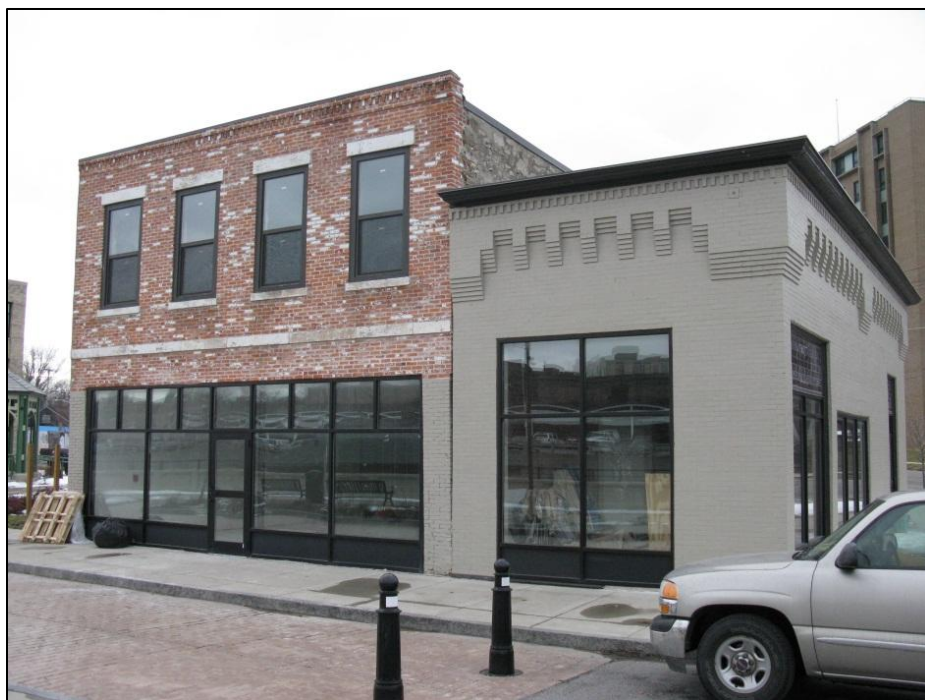
(Above) Circa 1852 two-story, former bakery at 79 Richmond Avenue (Canal Street) is a rare survivor of the local stone/brick façade type of commercial building once very common in downtown Lockport.

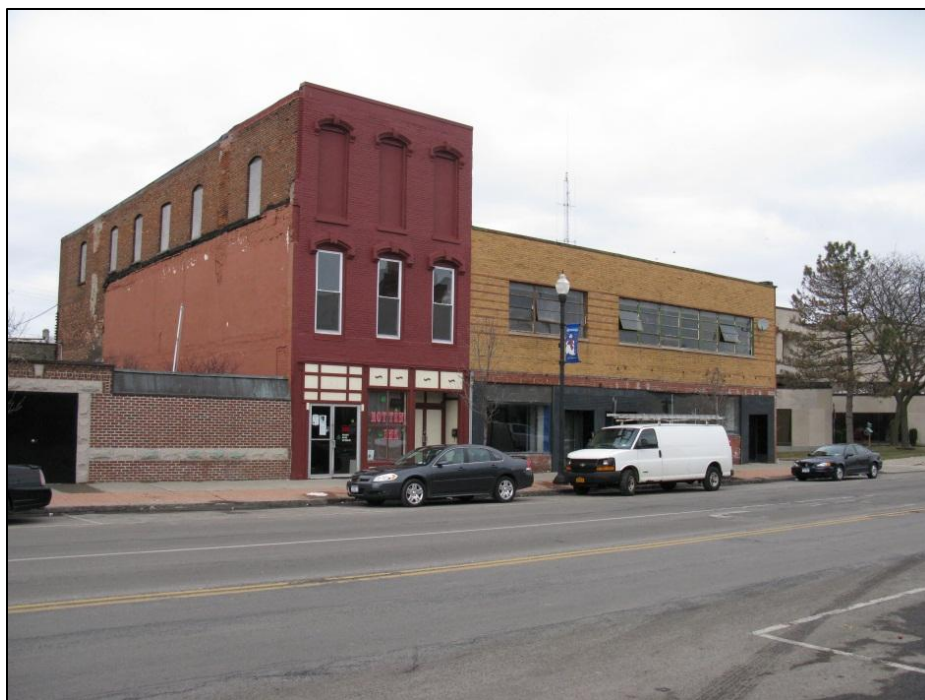
(Above) The three-story Italianate commercial building at 17 West Main Street retains its ornate window surrounds, although the heavy decorative cornice—which was likely constructed of metal—no longer exists.

Italianate storefronts were popular during the 1870s and 1880s and accomplished detailing through brick, iron-front, or wood construction. Windows were generally long and narrow. Metal was used for decorative details such as the cornice or pilasters. The first floor could be differentiated from the second floor by an ornamented beam or surface moldings that capped the display windows. In the evolution of commercial storefronts, the Italianate was one of the first styles successfully built from manufactured materials.<sup>13</sup> Brick-front and Italianate stores can all be found in communities throughout the Western Erie Canal Heritage Corridor.

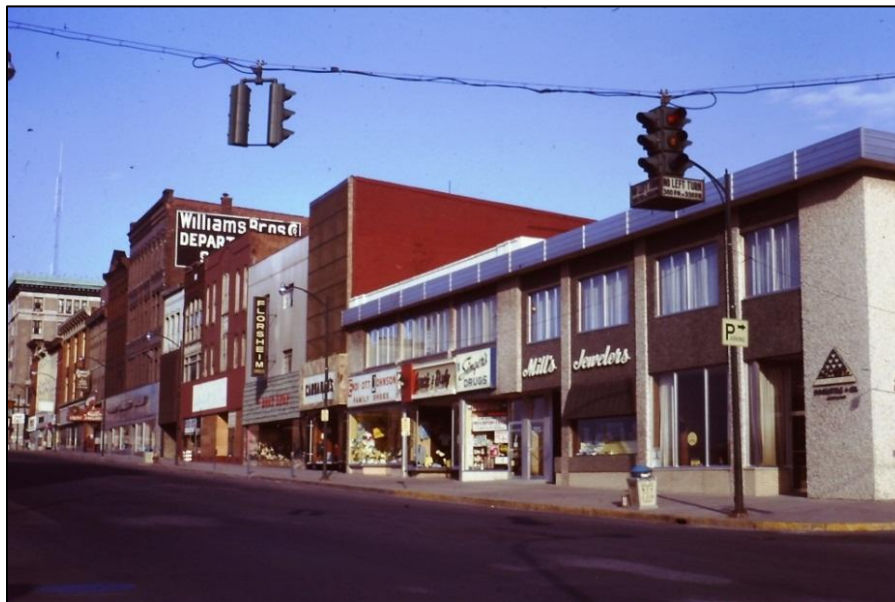
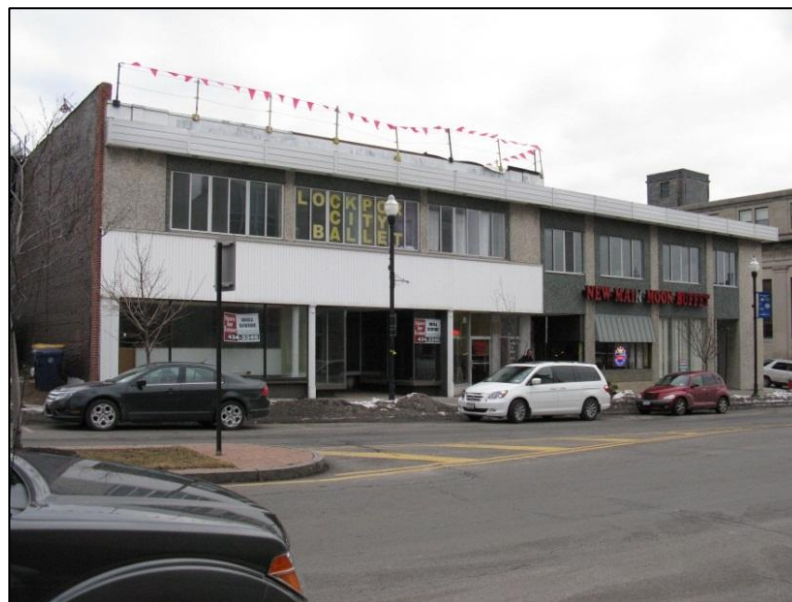
South Block before Urban Renewal (*left*) and the J.J. Newberry Company Building (*right*) as it appears today at 60 Main Street.  
Historic image courtesy of Niagara County Historical Society.

The Williams Brothers Department Store was a mainstay of commerce on Main Street in Lockport. Founded in 1879 at 78 Main Street, the Williams Brothers store was a Lockport landmark for many generations. Williams Brothers purchased the Prudden Brother's<sup>15</sup> furniture warehouse (known as the Prudden Block) in 1902.<sup>16</sup> In 1972, the store was forced to relocate—allegedly due to governmental pressures. A few lots to the west of the Williams Brothers Department Store was the F. W. Woolworth Company and the J.J. Newberry Company stores. The J.J. Newberry Company store was described in 1941 as an “architectural combination of black granite base with aluminum setting strips against a structural glass sign background, enhanced with gold leaf, aluminum letters with corresponding aluminum sign cornices.”<sup>17</sup> The area up to the J.J. Newberry Company, identified later as South Block, was lost to Urban Renewal in the late 1960s.

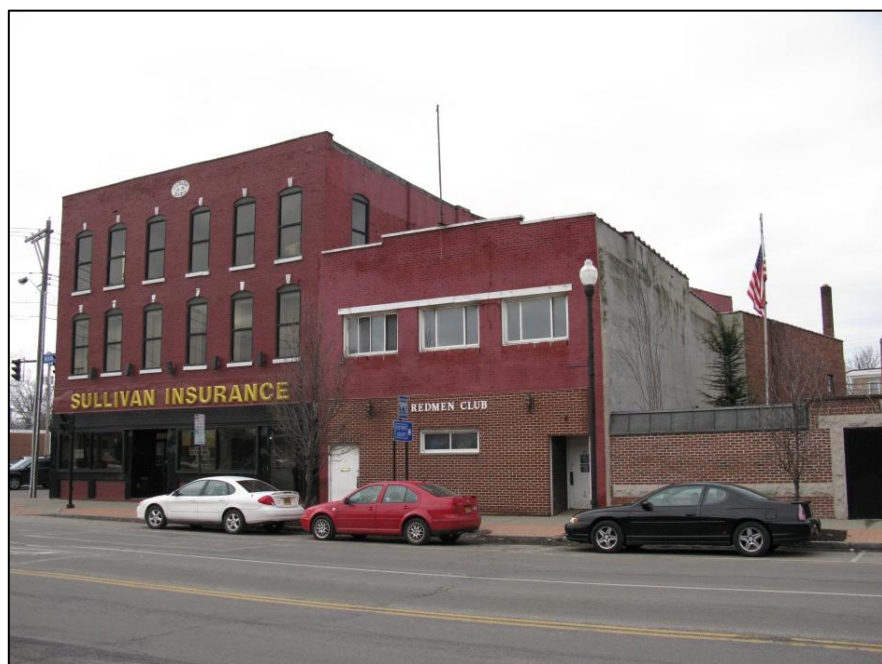
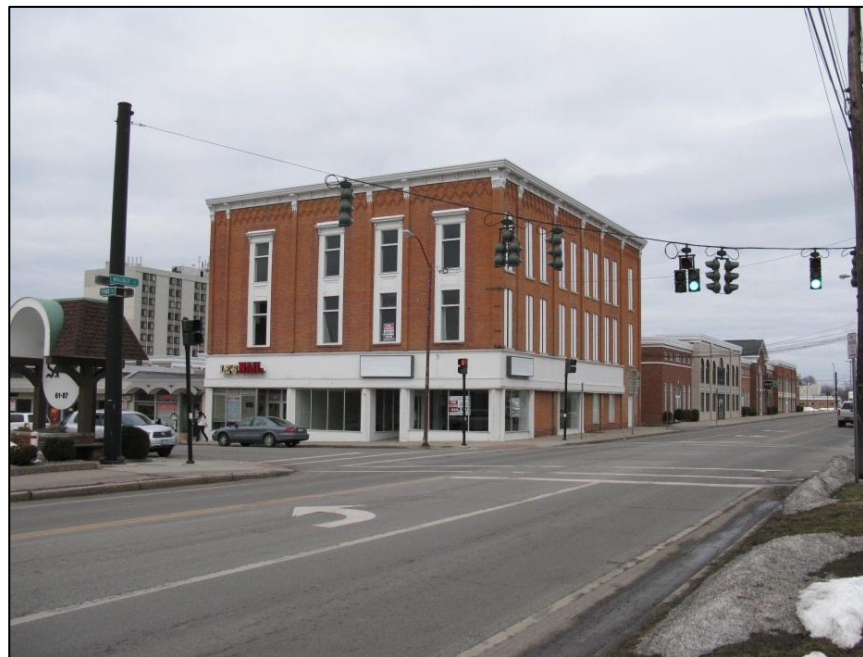
(Below) The J.J. Frazer (Sullivan Insurance) building at 29 West Main Street is an example of a business block. Upper-story space in these buildings was used for office space or apartments.

(Above) The cornice extends higher on the west and south elevations of the former Howard C. Korff Furniture Building at 54 Pine Street. The corner block marks the edge or the heart of a traditional commercial area.

The J.J. Frazer (Sullivan Insurance) building is one of a few surviving examples of a business block, displaying a uniform profile and symmetrical fenestration. From about 1878 to 1883, J. J. Frazer was a manufacturer of “fine carriages” and “sleighs of all descriptions,” with “repairing a specialty.” The business was located at 19 and 21 West Main Street.<sup>18</sup>

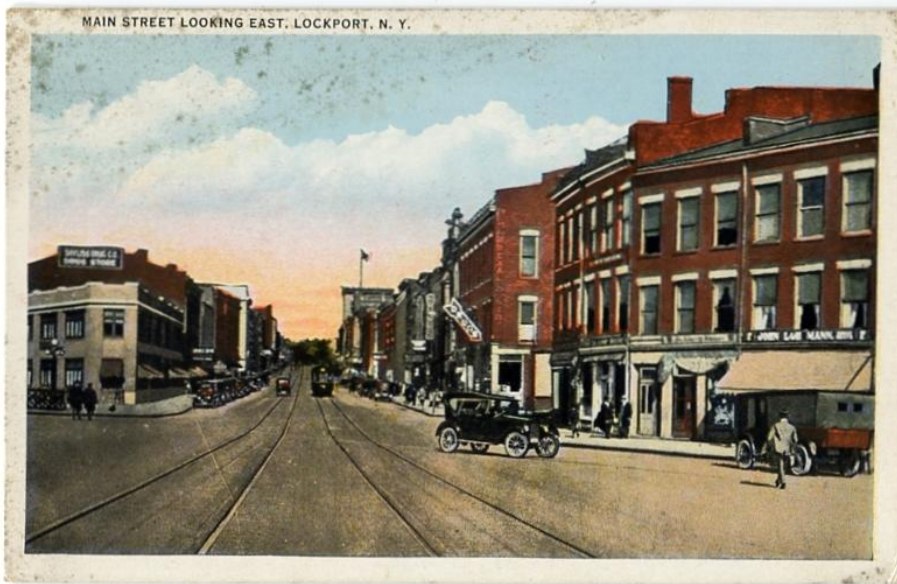
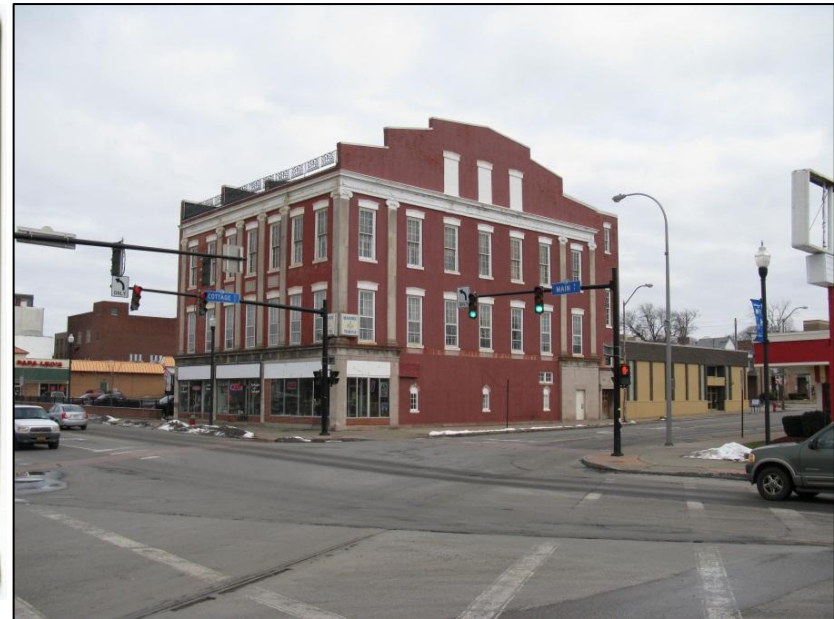
(Left) Simple surrounds and stepped parapetted gables can be seen on the Masonic Hall Building in the historic postcard (circa 1915-1930), compared to the current appearance of the building (right) with its prominent classical pilasters, balustrade, and entablature.

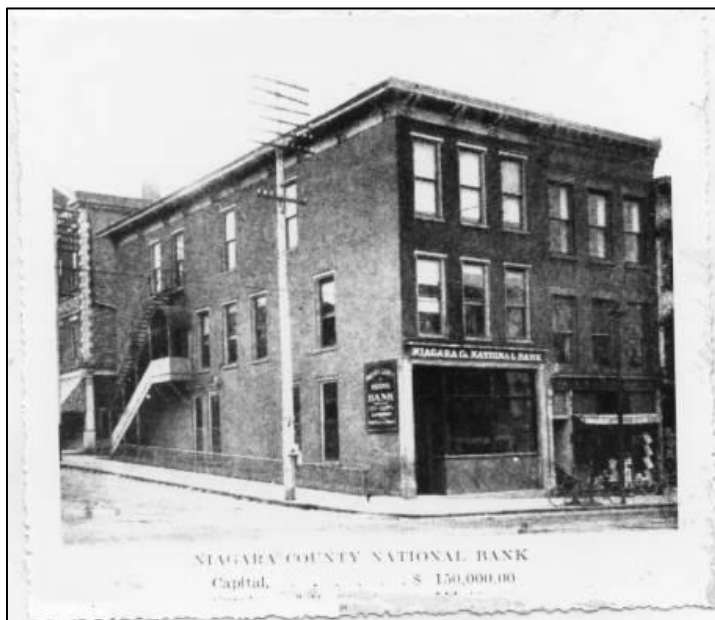
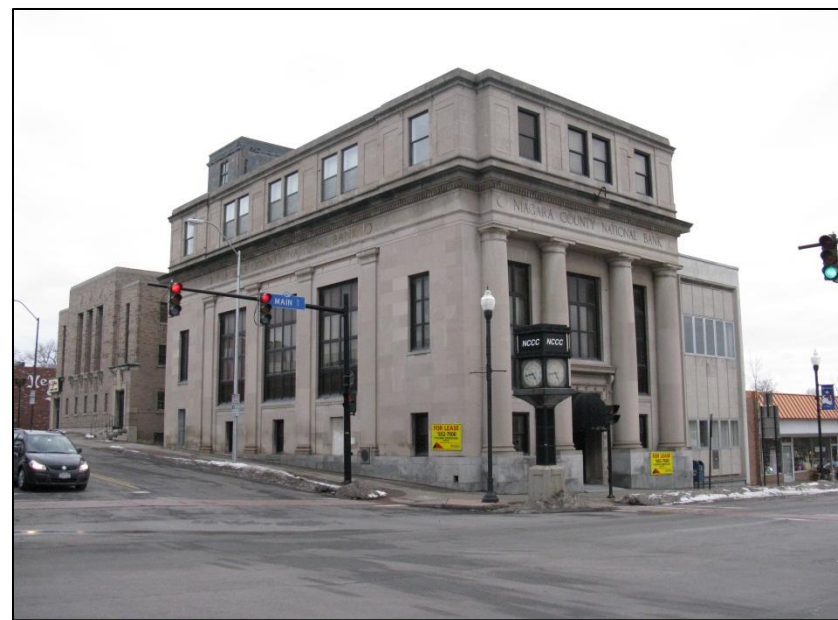
Niagara County National Bank circa 1910 (*left*) and the building's Neoclassical appearance today (*right*).  
Historic image courtesy of Polster Photographs of Lockport, NY.

Lockport had several banking institutions through the years, the first being organized in 1828. The National Exchange Bank was incorporated as a State institution in 1844 and then a national bank in 1865. It stood on the northeast corner of Main and Pine Streets. This bank was likely remodeled sometime in the 1920s, as it currently is an example of a vault-type commercial building with Neoclassical Style influences. The building is known as the former Manufacturer's and Traders (M&T) Bank. Niagara County National Bank was organized December 6, 1864 and is still situated on the southwest corner of Main and Pine Streets. This bank was also remodeled sometime in the 1920s and became Marine Midland Trust Company of Western New York through the 1950s. At the time of Urban Renewal, it was Marine Midland Bank. This bank is representative of a temple-front Neoclassical commercial building. The former Farmers and Mechanics Savings Bank at 116 Main Street was chartered May 11, 1870. It is an excellent example of the Beaux Arts Style.<sup>24</sup>

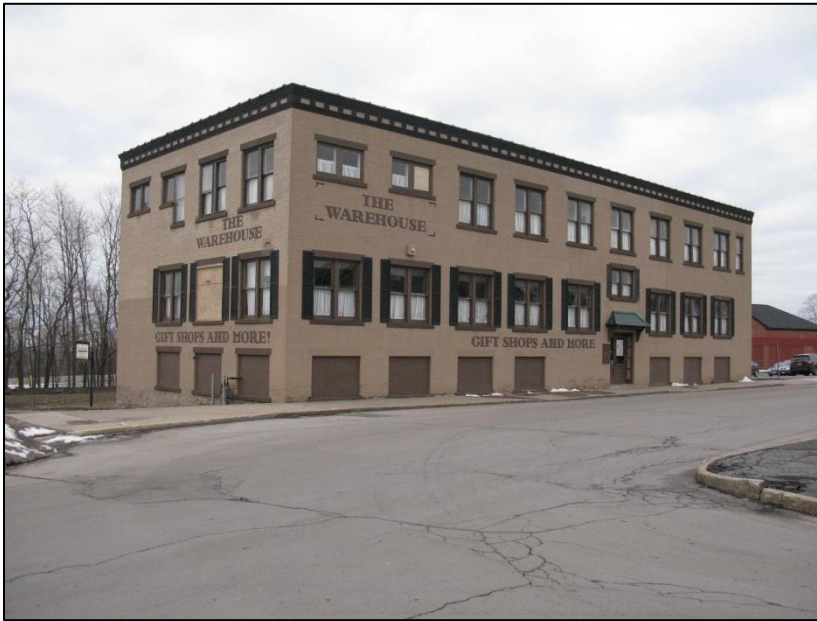
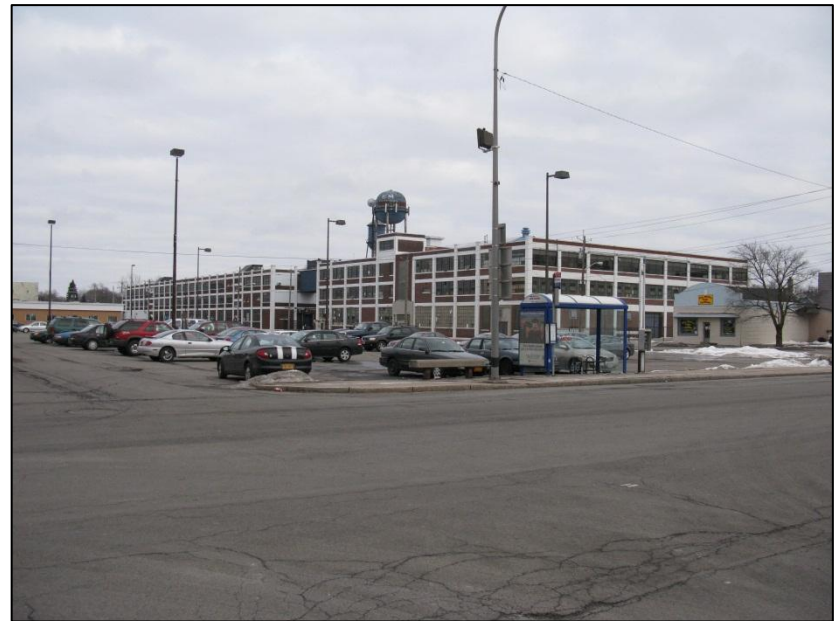
(Left) The Niagara Merchandising Co. Printers warehouse at 60 Chestnut Street features large openings on the first floor, orderly fenestration, and a well-marked entrance. (Right) The former Harrison Radiator factory complex at 160 Washburn Street is typical of factory design with its reinforced concrete structural members allowing for large metal windows to provide ample interior lighting. This “daylighting” design also shows how the special manufacturing process was carried out, utilizing workers with tasks along assembly lines. Accommodating the machinery contributed to the building’s overall size and shape.

Warehouses, factories, and mills played an important role in the development of towns and cities connected by railroads and waterways because they were usually grouped or clustered. With a tendency towards uniform shape and building materials, these buildings define industrial districts. By the end of the nineteenth century and into the twentieth century, locations along the railroad lines and interstate commerce highways became more prized than canal-side locations throughout the western canal corridor.

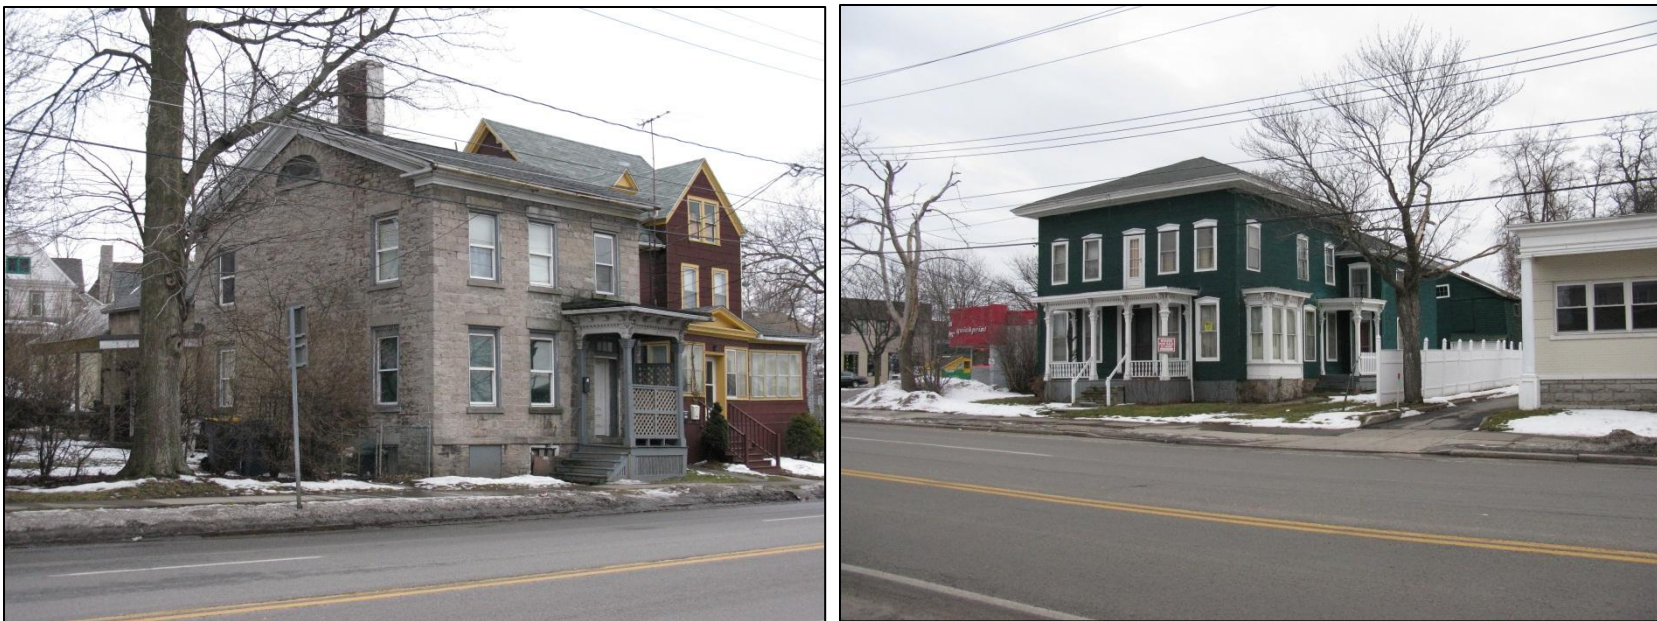
(Left) Vernacular example of a Federal Style residence at 6 Walnut Street with modest massing and details that reflects Lockport's early history. (Right) Italianate hipped (pyramidal) cottage at 146 Walnut Street features a low roof profile, strong vertical orientation, and turned pieces that ornament the porches. Many Italianate cottages are located on narrow lots and extend to a third floor.

In vernacular house designs, large geometric units like rectangles and squares are integrated. Wall planes, roof planes, and the planes of any secondary elements such as dormers, back or side porches, and porte-cocheres all fit into a cohesive form. Windows, doors, and building materials will reinforce the unity of the house design through repeats or irregular placement.

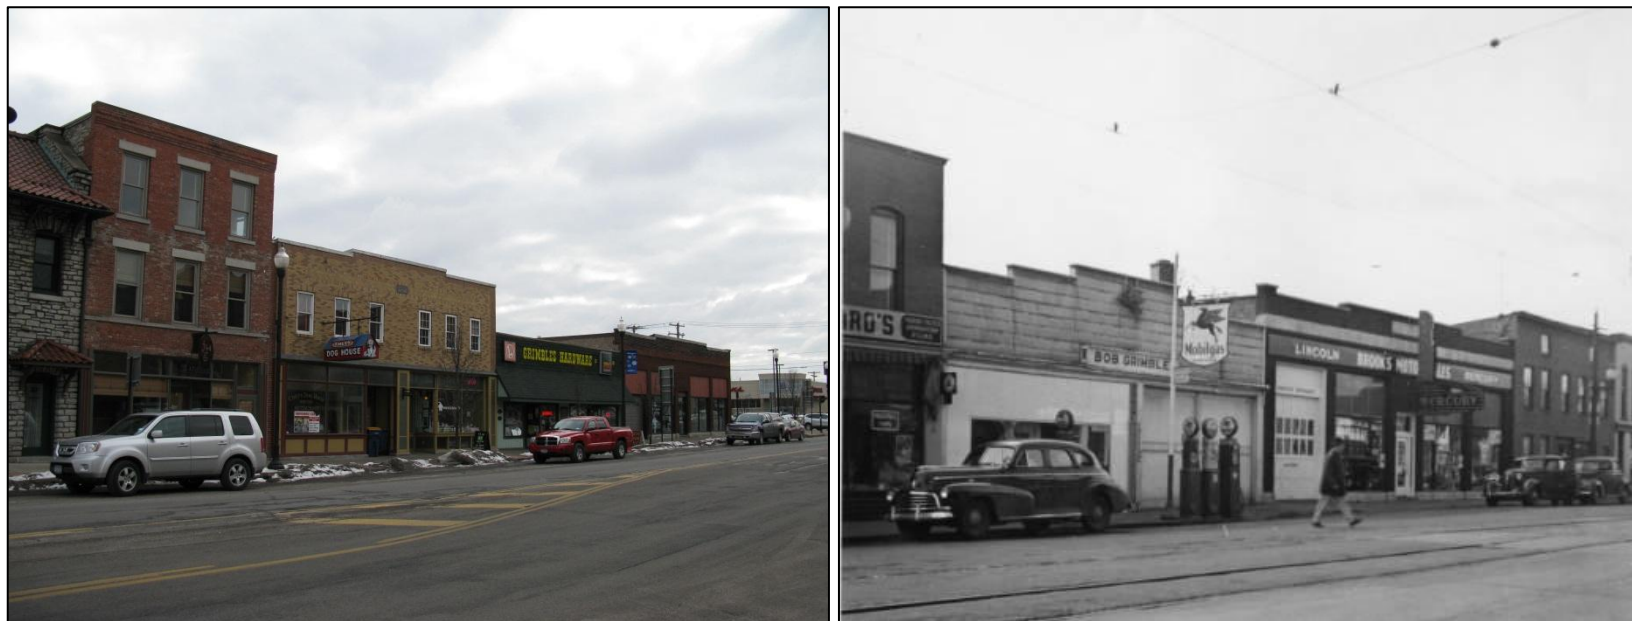
One-story broad-front stores along West Main Street today (*left*) and circa 1940-1949 (*right*). Note the stepped parapets and brickwork panels. Historic image courtesy of Polster Photographs of Lockport, NY.

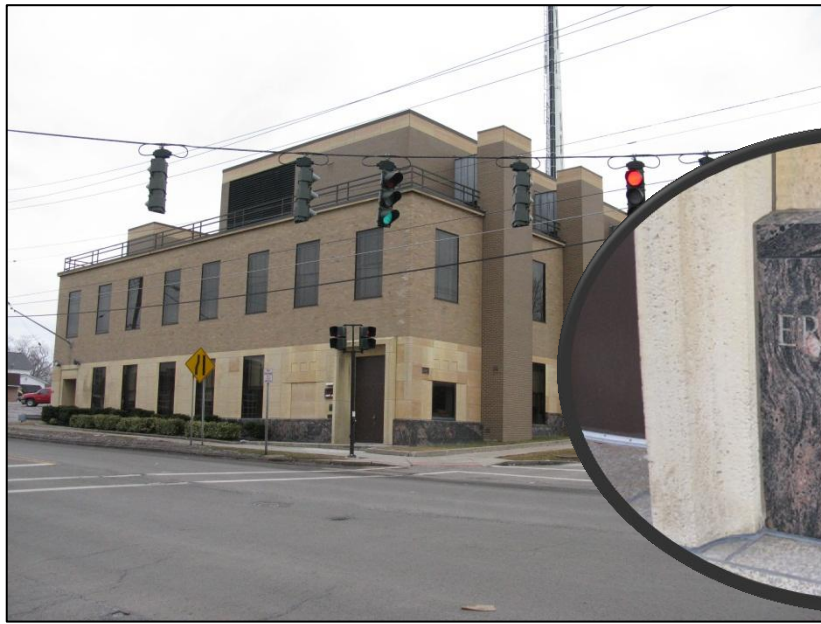
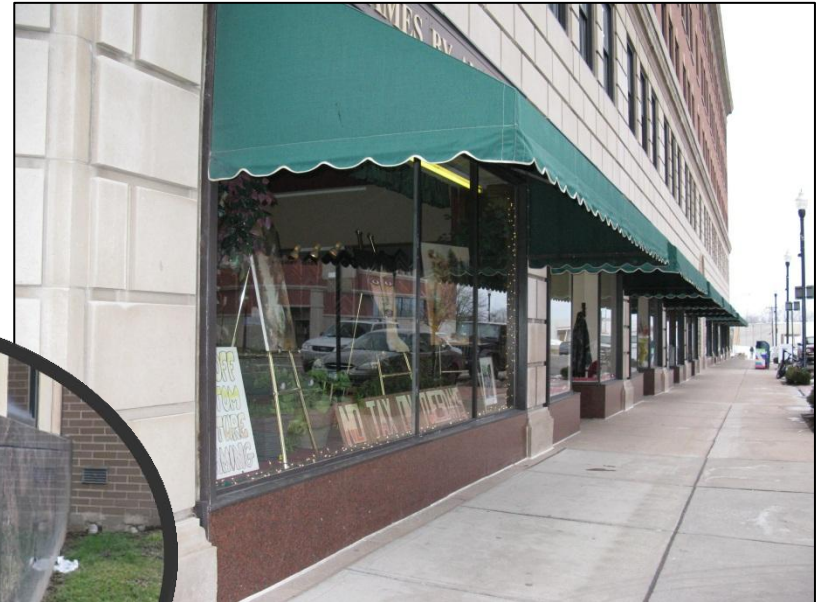
(Above) The ground-level at The Bewley Building features thin stone veneer.  
(Left) Granite veneer at the Former Bell Telephone Substation, corner of Walnut and Cottage Streets.

**Thin Stone Veneer** (*The Bewley Building and Former Bell Telephone Substation*) Before 1900, stone excavated from quarries for construction was finished by hand into thick slabs or blocks. The use of the term *veneer* to describe building stone can be traced to about the 1890s, when hand-cut stone between 2 and 4 inches thick was used on the exterior of Burnham and Root's Reliance Building in Chicago. By the early 1930s stone veneer began to gain acceptance for storefronts, bulkheads, and building interiors. Granite, marble, travertine, limestone, and slate were the most common stone materials used, treated with a variety of surface finishes and colors to achieve differing architectural effects. Veneer panels were typically laid up on mortar beds, and joints were finished with mortar in a manner similar to traditional masonry construction. In the late 1940s strap anchors became more prevalent for lateral support of thin stone veneer. And by the mid-1950s thin stone veneer construction became more refined with horizontal joints between panels sealed with sealant rather than mortar. The demand for thin stone veneer grew through the 1970s and 1980s. An overall increase in building construction in the 1980s resulted in a 600 percent increase in the use of marble and a 1,735 percent increase in the use of granite between 1980 and 1985.

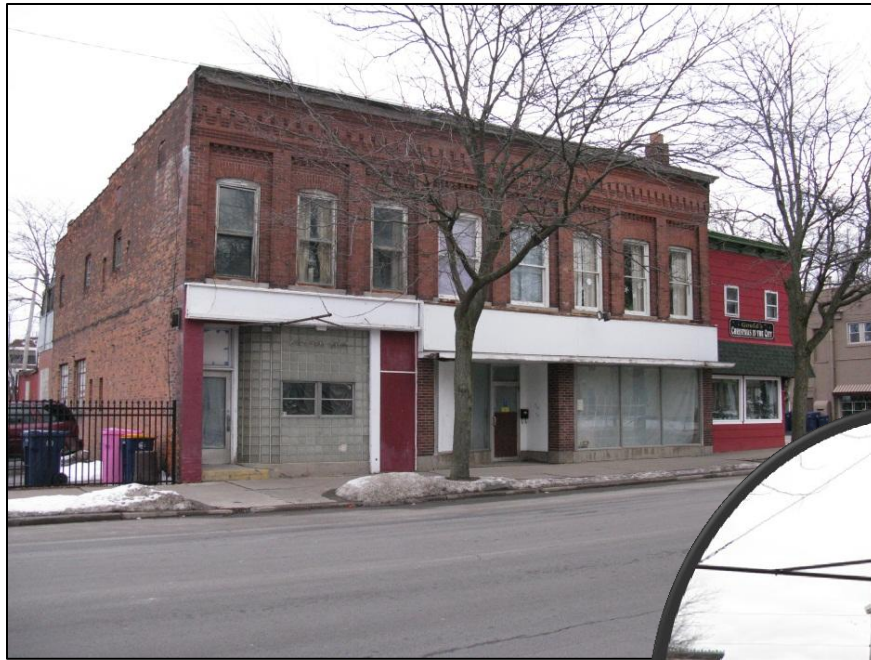
**Glass Blocks** (69 Locust Street) are two shallow rectangular cups sealed together at high temperatures along their open faces. Since their introduction in the 1930s, they have typically been built using the techniques and materials of masonry construction. Several American glass producers experimented in the early 1930s with solid and partially evacuated blocks. In 1929, the Structural Glass Corporation introduced several sealed hollow glass blocks and the Owens-Illinois Glass Company introduced the first pressed glass block in 1932. In 1935, Owens-Illinois introduced Insulux, the first widely used hollow glass block that was sealed with lead. It was advertised and used for exterior windows and partition walls for factories, offices, and apartments. Pittsburgh-Corning, an enterprise of the Corning Glass Works and the

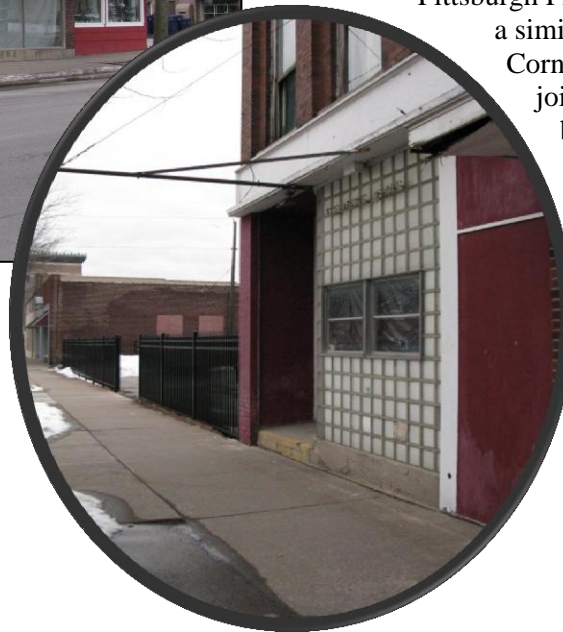
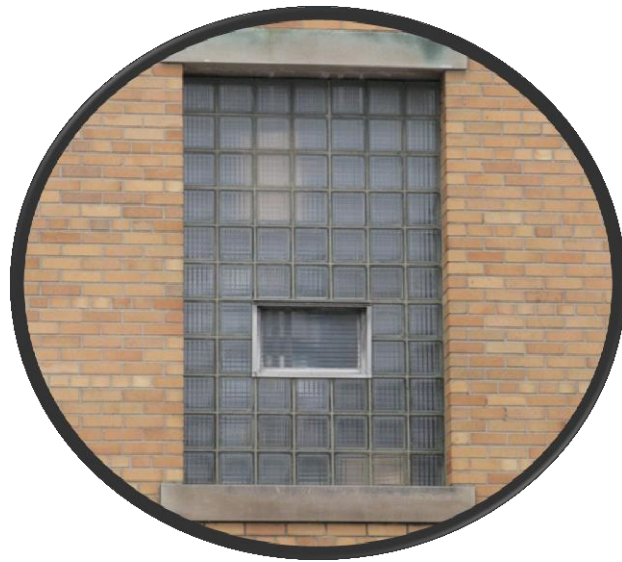
(Above) Glass blocks used in the display window at 69 Locust Street and (left) in the window opening at St. Mary's Roman Catholic School Building Addition.

Pittsburgh Plate Glass Company, was formed in 1936 to develop a similar product. Corning Glass Works had presented its Corning Steuben Block to the public in 1935, but this joint venture led to its perfection and mass production beginning in 1938. This block, known as PC block, was made from Corning's heat-resistant Pyrex, which reduced its expansion and contraction considerably. The glass block suffered a decline in popularity in the late 1970s, although it is still produced in many of its original forms by the Pittsburgh-Corning Company.

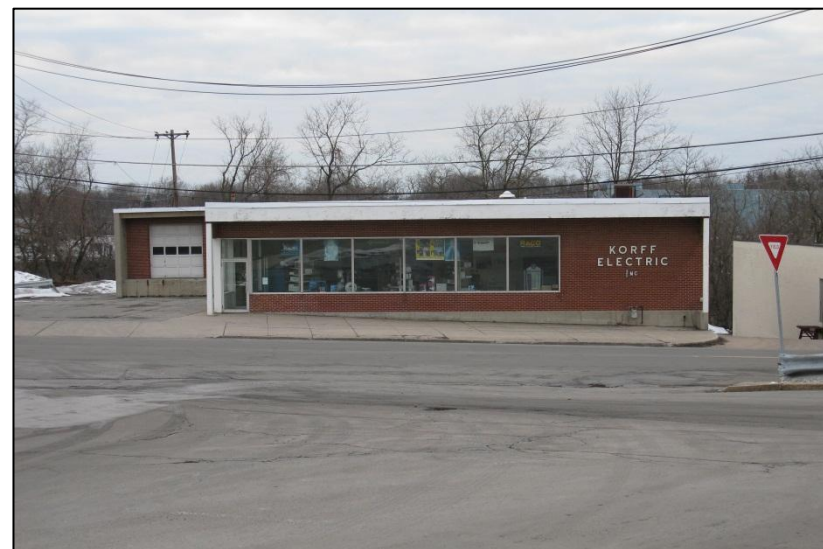
**Plate Glass** (*60 Market Street, right*) Before 1850, rough plate glass typically used in storefront windows measured five to six feet in height, with as few as four panes of glass in each window. Most plate glass was imported from France. It was produced by casting and rolling large sheets that were then ground and polished. Polished plate glass was first successfully and continuously manufactured in the United States in New Albany, Indiana when John B. Ford opened a glassworks in 1865 using imported grinding and polishing machinery from England. By the late nineteenth century the plate glass industry had grown rapidly. By 1900, only 15 percent of plate glass for domestic needs was still being imported—twenty years later, domestic production constituted 99 percent of total consumption. Storefront window openings continued to increase in size over the next several decades. The introduction of the float process in 1959 eliminated the

need to grind and polish plate glass and revolutionized plate glass manufacture. The greater thickness and availability in larger sheets made all-glass buildings more commonplace in the postwar period. The use of steel and concrete as structural elements made the load-bearing wall unnecessary. This new structural framework could accommodate large expanses of glass to fill the open interiors with light.<sup>41</sup>

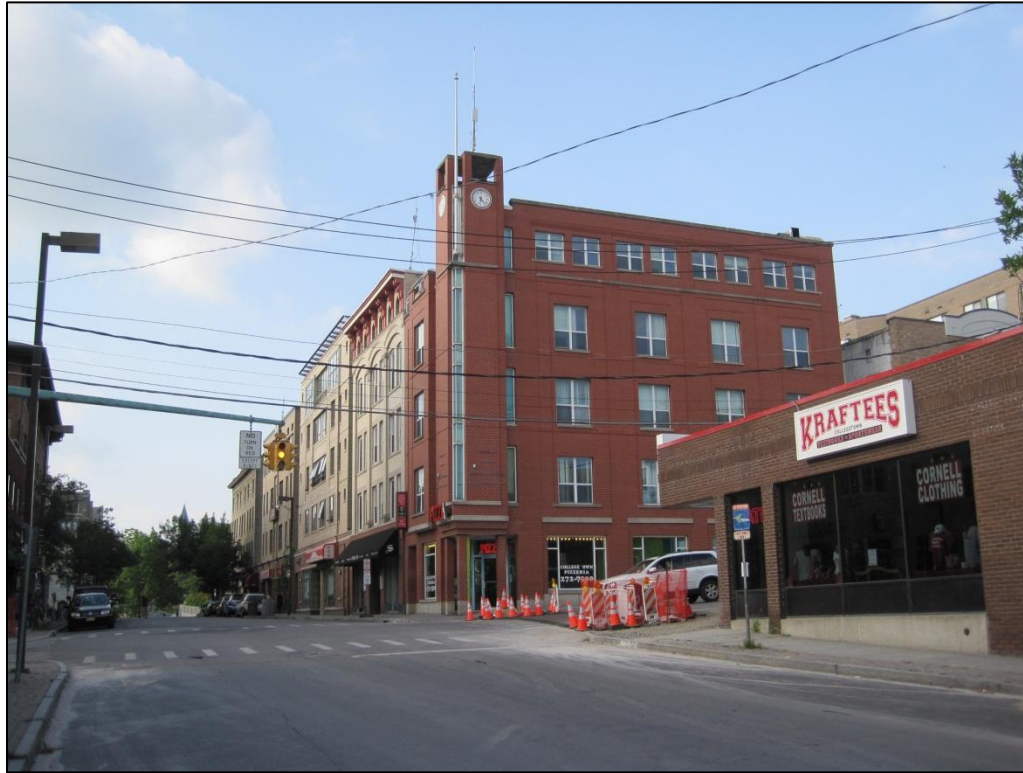
(Above) Intersection of Dryden Road and College Avenue in Collegetown, City of Ithaca. Both the corner building and third building down are good examples of infill construction that respects the existing historic buildings (the Larkin Building, in between), are distinguishable as new construction, and principally embodies good urban design (retail space with plenty of glazed area at the street entrance level, appropriately-scaled floors matching up with existing buildings, and the inclusion of a cornice on the building third from the corner). Photo courtesy of Kristen Olson, Preservation Services Coordinator, Historic Ithaca, Inc.

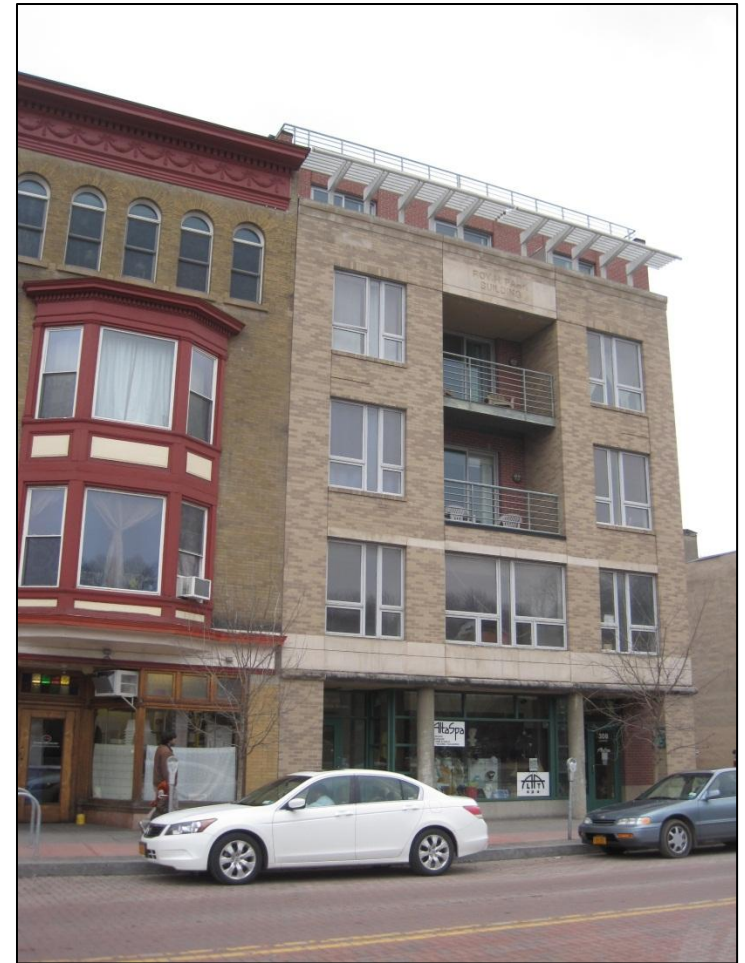
(Above) The Roy Park building on East State Street in the City of Ithaca continues the cornice line of the historic Wanzer Block. A fifth-floor is tucked behind the main façade. Photo courtesy of Kristen Olson, Preservation Services Coordinator, Historic Ithaca, Inc.

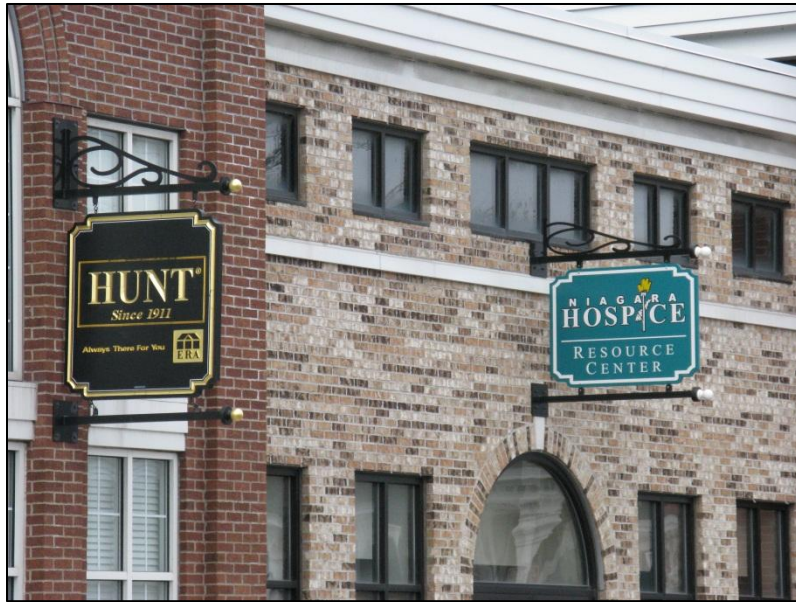
(Above) Example of new projecting signs in the Main Street Target Area that are appropriate for the historic business district. (Bottom right) Example of a roller awning with a metal cylinder around which the canvas is stored when the awning is retracted. The fringe or skirt of the awning also provides the opportunity for sidewalk pedestrians and people in the street to see the name of the business.  
*Note: This image is not from the City of Lockport.*

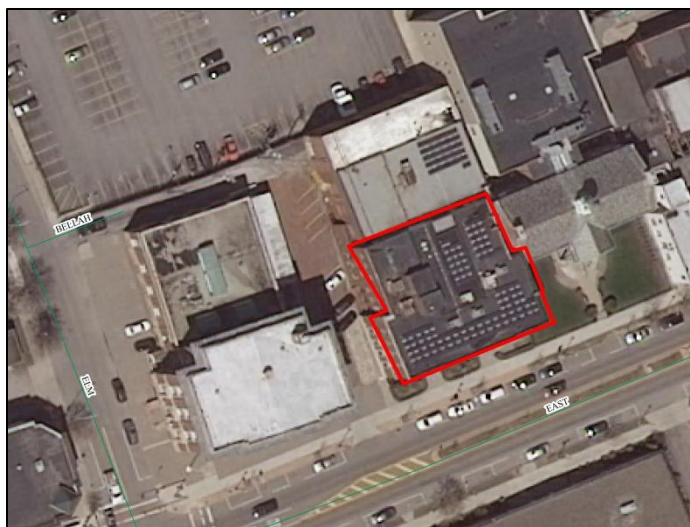
(Above) Solar panels are placed on the flat roof of the Lockport Family YMCA at 19 East Avenue where they are minimally visible from the public right-of-way. Image courtesy of New York State Information Technology Services, 2013.

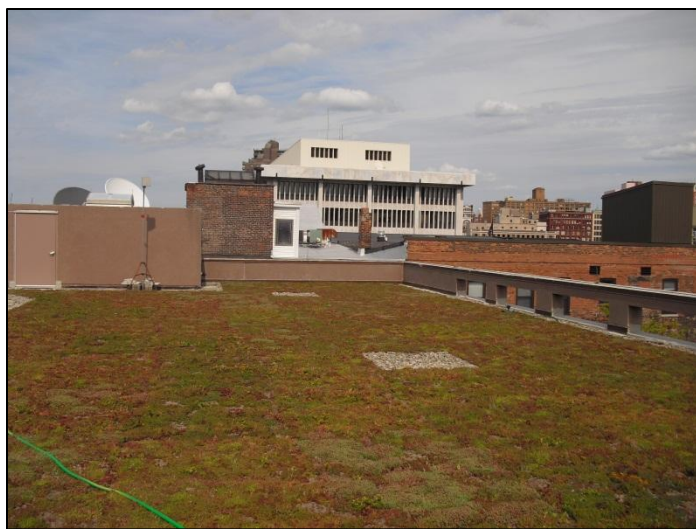
(Above) Green roof at Rochester City Hall. Photo courtesy of Leo J. Roth Corporation.

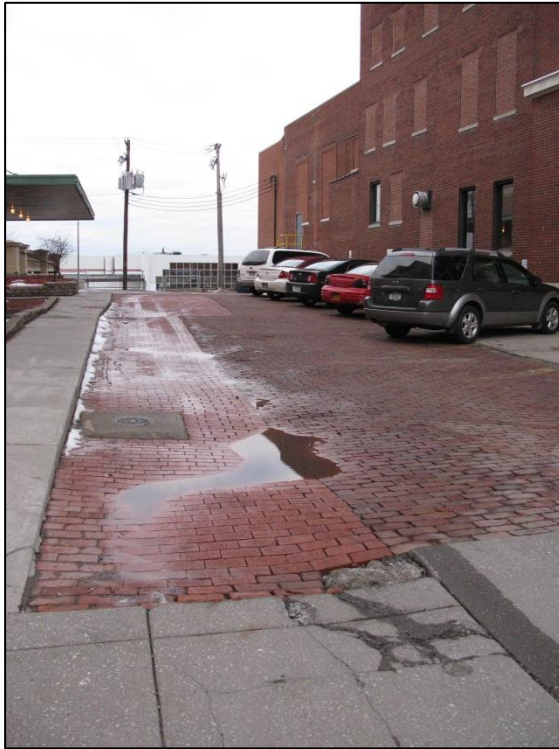
(Above) A narrow alley leads to a small brick paved lot along the east side of the (old) Lockport Post Office building.  
(Bottom right) Evidence of Medina sandstone used in sidewalk paving and curbing.

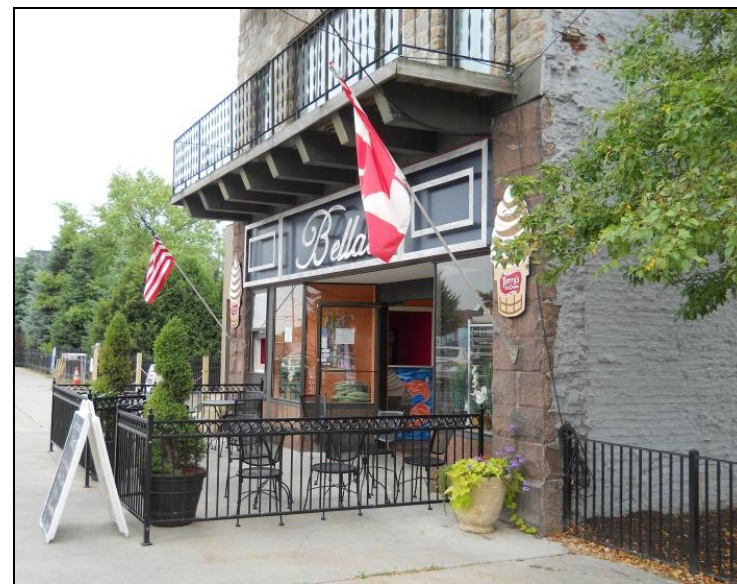
(Above) This storefront features metal lattice café furniture. (Left and below) Examples of “cut off” or shielded exterior light fixtures. Gooseneck lights are featured on the storefront below. *Note: Images on this page are not from the City of Lockport.*

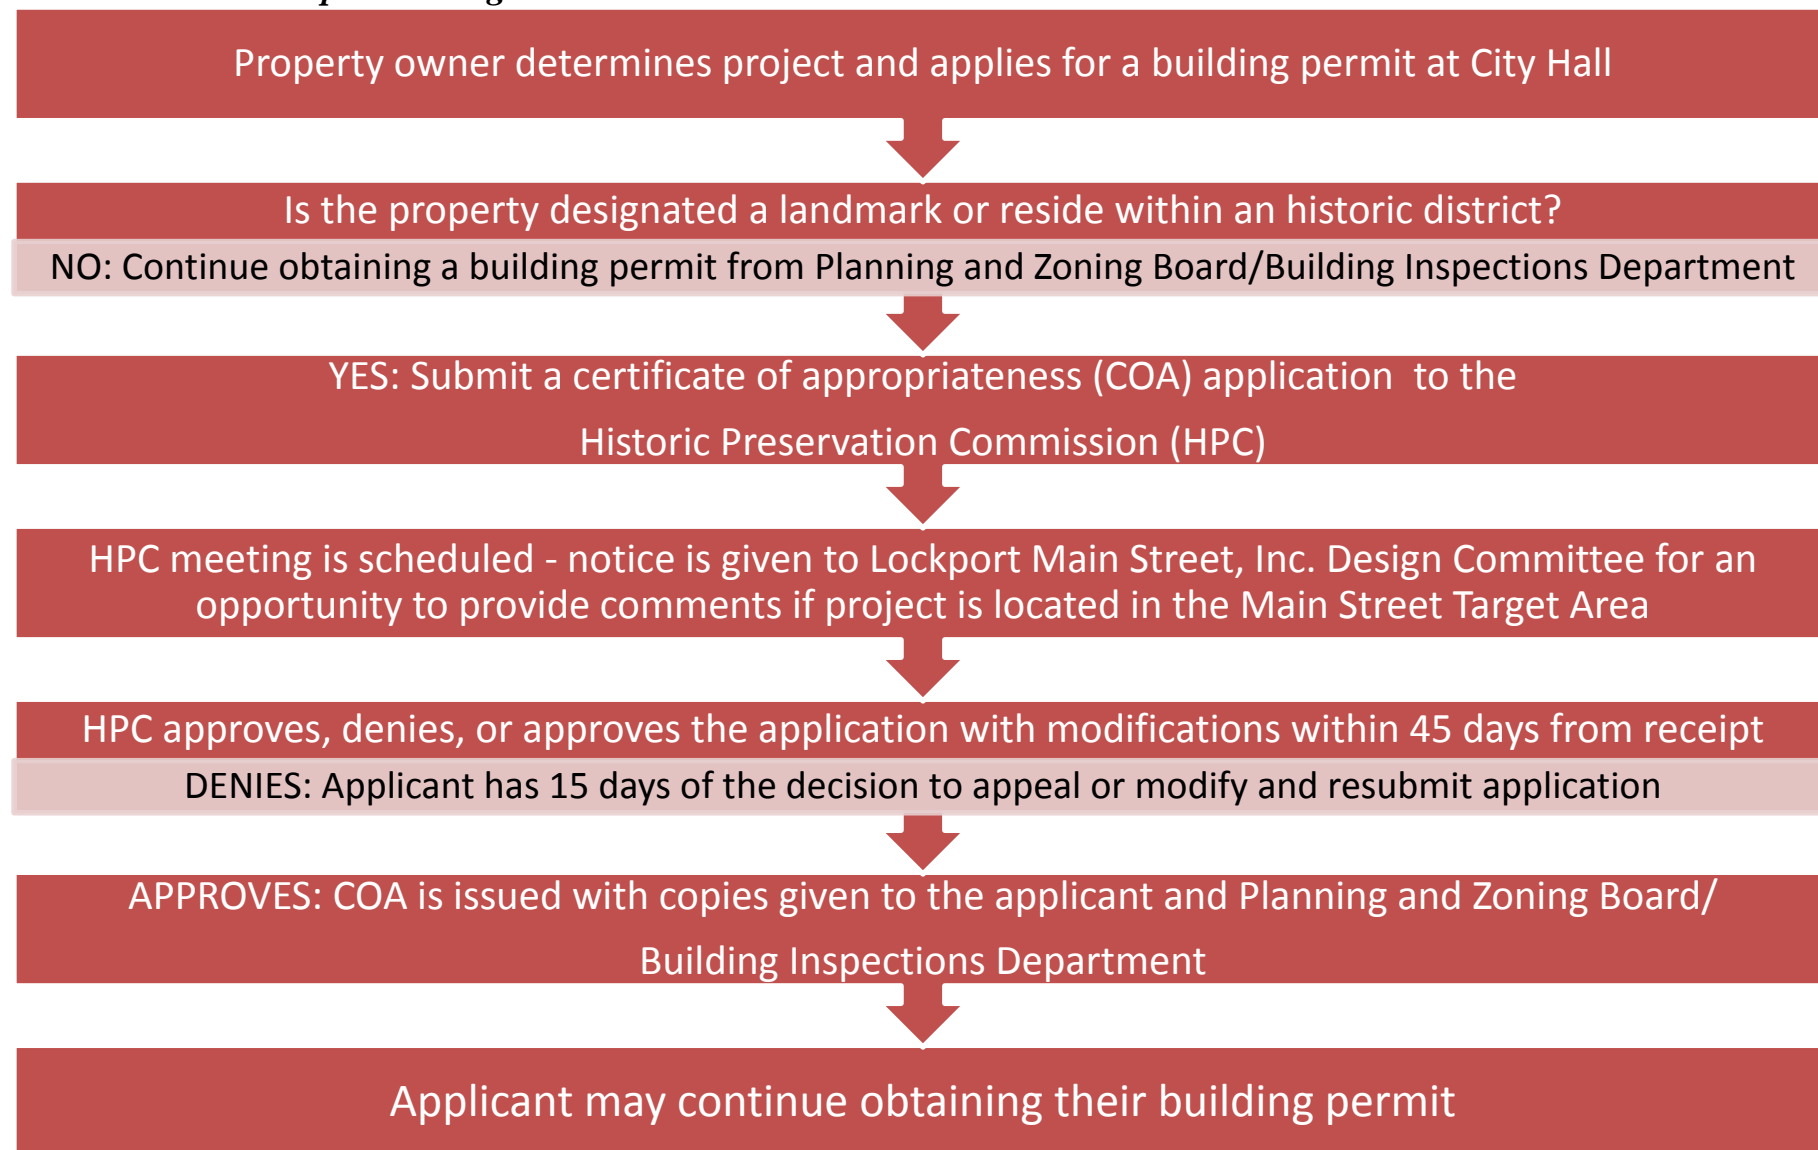
## **APPENDIX B - *Proposed Design Review Flowchart***

The following section outlines nineteenth and twentieth century architectural styles that survive within the Main Street Target Area. A proposed design review flowchart for historic commercial, public, industrial, and residential buildings designated as landmarks or residing within an historic district in the Main Street Target Area is provided as Appendix B.
